SERVICE NEWS

VOLUME 32

NOVEMBER, 1960

NUMBER 11

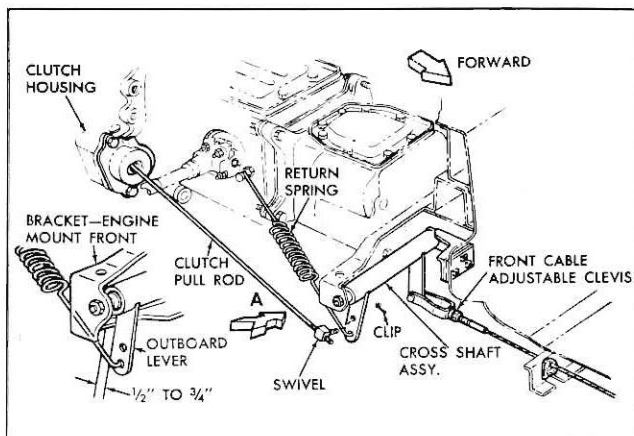
Fig. 1—Adjusting Corvaire Clutch Linkage

NOTE: *Lever setting specified in step 2 of "Linkage Adjustment," on page 6B-2 of the 1961 Corvaire Shop Manual is incorrect.*

1. Disengage clutch pull rod from cross-shaft.
2. Adjust length of front control cable, at cross-shaft clevis, to obtain $\frac{1}{2}$ " to $\frac{3}{4}$ " spacing between cross-shaft pull rod lever and edge of transmission mounting bracket. (Fig. 1).
3. With pull rod held forward to remove slack at the clutch fork, align rod swivel with upper hole in the cross-shaft lever; then back-off swivel three complete turns and install pull

rod assembly in upper hole of lever.

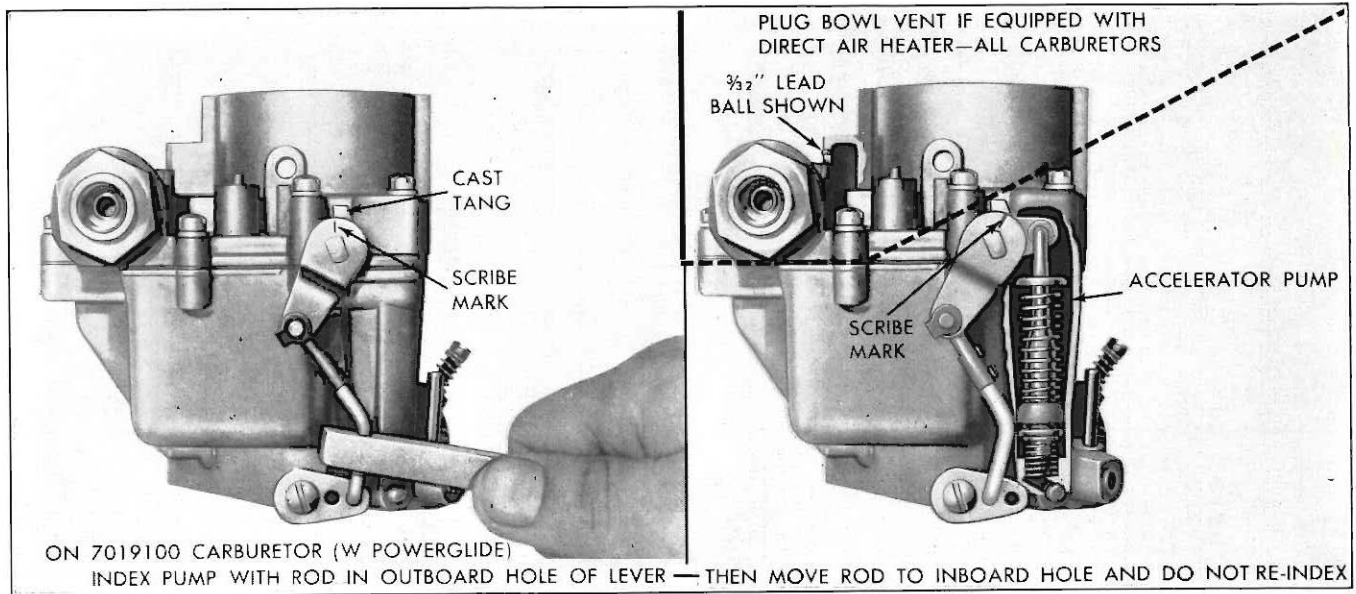
Fig. 2—1961 Corvair Carburetor Modifications

At start of 1961 production on Corvaire and LDFC models, accelerator pump travel on 7019100 carburetor (Powerglide) was found to be in excess

of that required and would therefore produce a flat spot on acceleration. To correct this condition, by reducing pump stroke, production at that time incorporated an inboard hole in the pump actuating lever and attached the link rod at that point.

In many cases, however, after the link rod was assembled in the lever inboard hole, the pump was then re-indexed. This re-indexing defeated the original intent and resulted in the pump having virtually the same capacity as before rework of the linkage.

If a flat spot on acceleration occurs with 7019100 carburetors, which have two holes in the actuating lever, check if the pump is on index. If the pump is on index, it is not properly adjusted and the procedure listed below should be followed to correct the condition.

Corvair and LDFC carburetors (Nos. 7019100, 7019101, and 7019107), when used on vehicles equipped with a direct air heater, have under certain driving conditions emitted gasoline fumes. This odor is carried into the passenger compartment when the heater air mixing valve is opened. The main source of the fuel vapor is a $\frac{1}{16}$ inch external vent hole located in the air horn casting (Fig. 2).

1. Disconnect the pump rod from the inboard hole of the pump lever.
2. Connect the pump rod to the outboard hole of the pump lever (Fig. 2). Bend pump rod to align the pump index mark.
3. Disconnect the pump rod from the outboard hole and connect it to the inboard hole of the lever. The pump index markings should then be disregarded. Do not re-index.

To eliminate objectionable gas odor in vehicles using a direct air heater, the carburetor external vent should be closed with a $\frac{3}{32}$ " lead ball or other suitable soft metal plug.

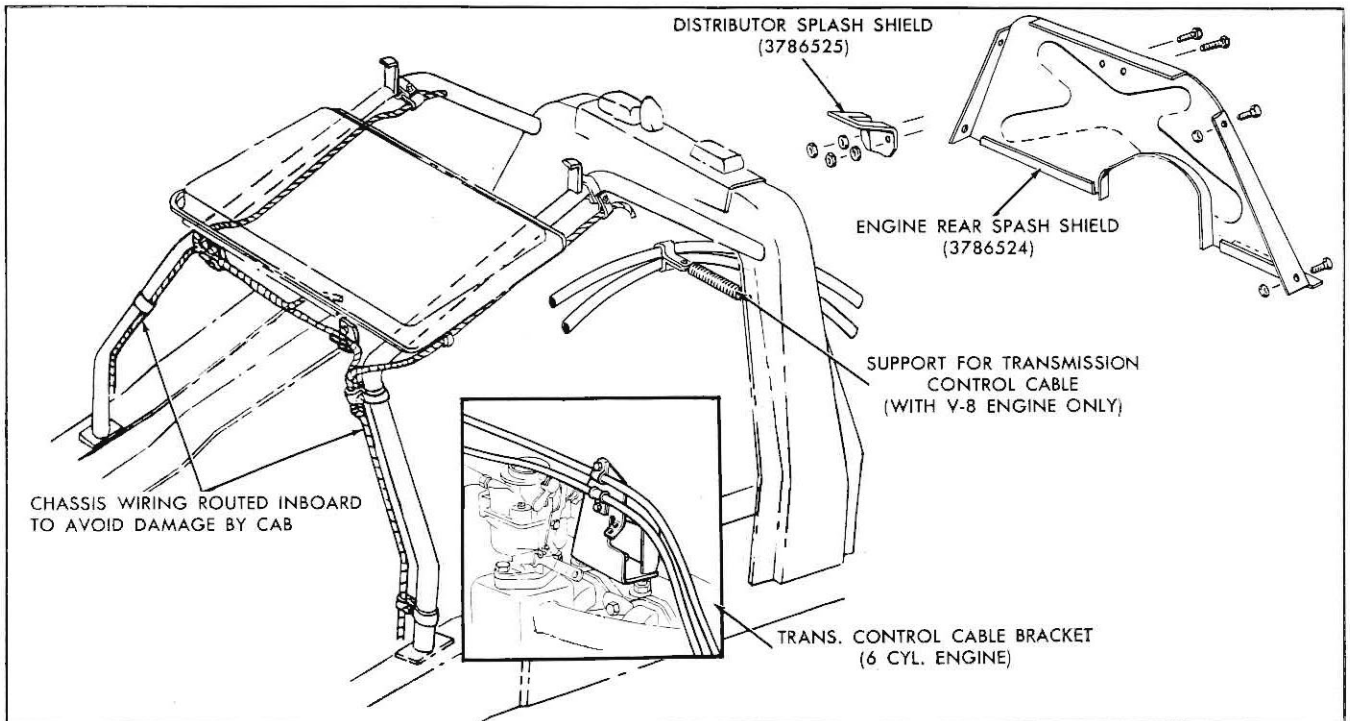
Fig. 3—Tilt Cab—Chassis Wiring, Transmission Cable Supports, and Splash Shields

- To avoid possible damage to chassis wiring routed along the transmission control island support legs, the wiring harness leads should be positioned on the inboard side of the support legs, as shown in Figure 3.
- A transmission control cable bracket of the type shown in Figure 29T, on page 10 of the 1960 Tilt Cab Shop Manual, was never used in production. The transmission control cable supports used in 1960-61 vehicles are shown in Figure 3 of this issue.
- To minimize road splash entering the engine

compartment of Tilt Cab trucks, an engine rear splash shield (fig. 3) is now being installed in production. On V-8 engine equipped models, an ignition distributor shield is also being used.

Engine Rear Splash Shield 3786524 and Distributor Splash Shield 3786525 are available, through Chevrolet Parts channels, for installation on 1960 and early 1961 vehicles. When installing Shield 3786524, the shield itself will be used as a template for drilling the attaching screw holes in the cab rear support cross-member.

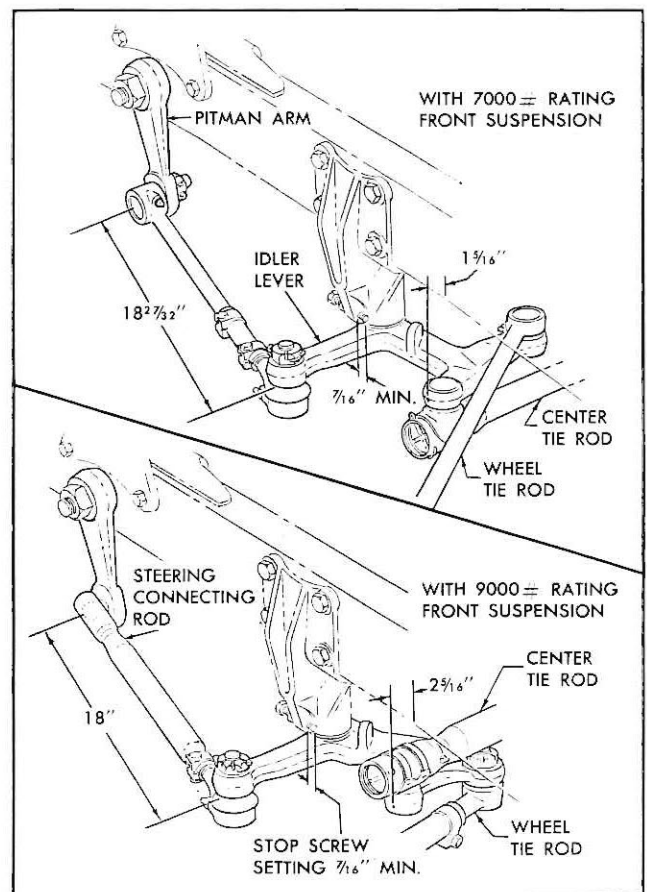
Fig. 4—Tilt Cab Steering Linkage Adjustment

Either a front axle of 7000 pound rating or one of 9000 pound rating is used on 1960-61 Tilt Cab models. Figure 4 provides linkage adjustment specifications for both type axles. Steering linkage adjusting dimensions shown on page 10 of the 1960 Tilt Cab Shop Manual are applicable to only the 7000 pound rating axle; however, the linkage adjustment procedures detailed in the Shop Manual are otherwise applicable to both axles.

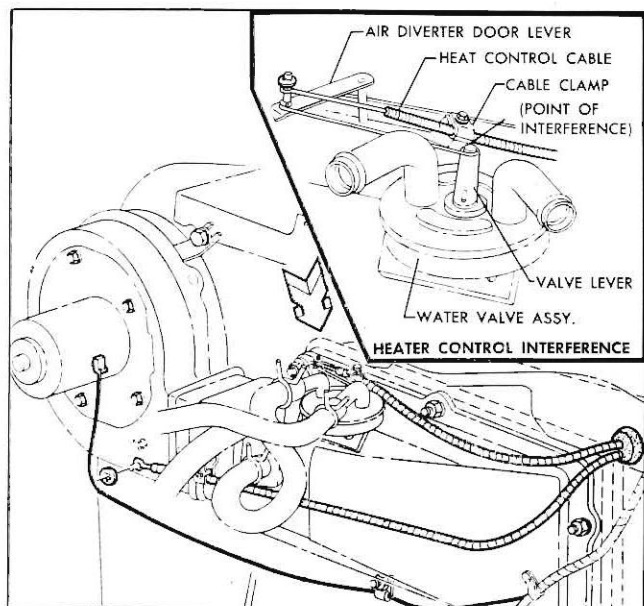
Fig. 6—1961 Passenger Car "Deluxe" Heater

An interference condition present in the control linkage of the "Deluxe" heater on some early 1961 Passenger Cars restricts movement of the controls and results in insufficient heat.

Interference between the water valve lever and the heat control cable clamp restricts movement of the air diverter door and the water control valve, resulting in limited water circulation and air by-passing the heater core.

Correction can be made by bending the control

cable clamp upward to clear the water valve lever (Fig. 6), thereby allowing the controls to travel the required arc.
