# CHEVROLET

# SERVICE NEWS

MAY, 1960

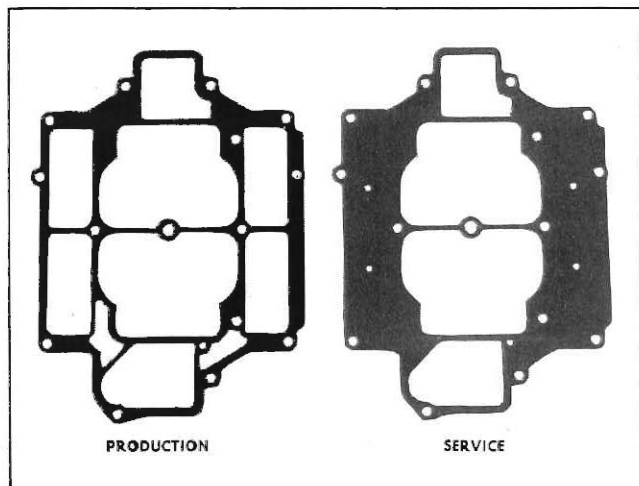
Some servicemen have expressed concern with regard to the construction of the air horn gasket supplied with Kit 7015827. The service gasket, (fig. 6) is made slightly different than the production gasket to eliminate the possibility of the engine cutting out on turns during hot weather operating conditions.

Fig. 6—Air Horn Gaskets—Production and Service

confronted with this problem of the difference in construction of the original equipment gasket compared to the service replacement gasket, by referring to Figure 6 he can be assured that the service replacement gasket being installed is correct.

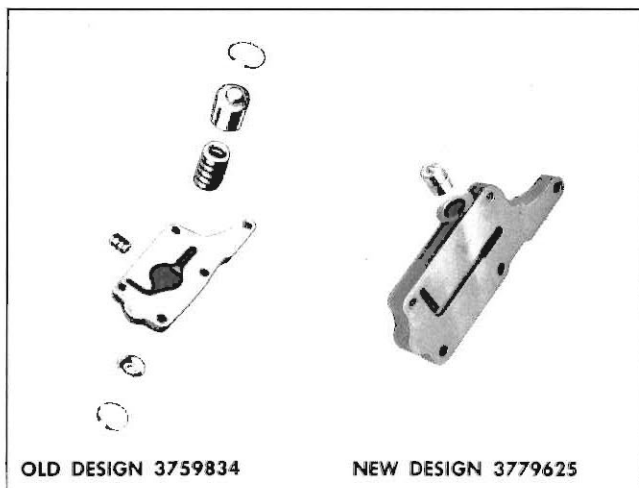
The 1959-60 Turboglide transmission was modified to provide a minimum mainline pressure of 80-90 psi instead of the 45-60 psi used in the 1957-58 models. This change eliminated the need for the vacuum modulator accumulator valve, located in the hydraulic modulator valve body.

A new hydraulic modulator valve body, Part No. 3779625, without the vacuum modulator accumulator valve (fig. 8) is now being installed in the Turboglide transmissions. The previously used valve body, Part No. 3759834 (fig. 8), is available as a service replacement part for 1959-60 transmissions with either the early production valve body, Part No. 3759834, or present production valve body, Part No. 3779625. When valve body Part No. 3779625 becomes available for service replacement it cannot be used for 1957-58 transmissions. The 1957-58 transmissions require an accumulator and also have different diameter hydraulic modulator valves. Use original equipment valve body, Part No. 3745605, for 1957 transmissions and valve body Part No. 3750652 for 1958

Fig. 8—Old and New Design Hydraulic Modulators—Turboglide

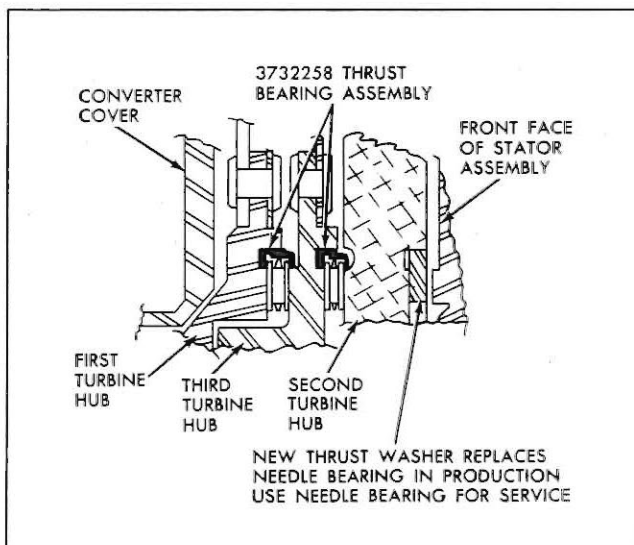
The 2nd turbine thrust washer used in the torque converter of the Turboglide transmission has been changed in production from a needle-type thrust washer to a plain, steel-backed thrust washer. Until the present time, three needle-type thrust washers have been used in the torque converter, one for each turbine, 1st, 2nd and 3rd (fig. 9).

Fig. 9—New Design 2nd Turbine Thrust Washer—Turboglide

The steel-backed thrust washer is used with service replacement, second turbine assembly Part No. 3760597 as well as being used in the complete transmission assembly Part No. 3759863. However, the new thrust washer will not be serviced separately. Use needle-type thrust washer, Part No. 3732258, as a service replacement part.

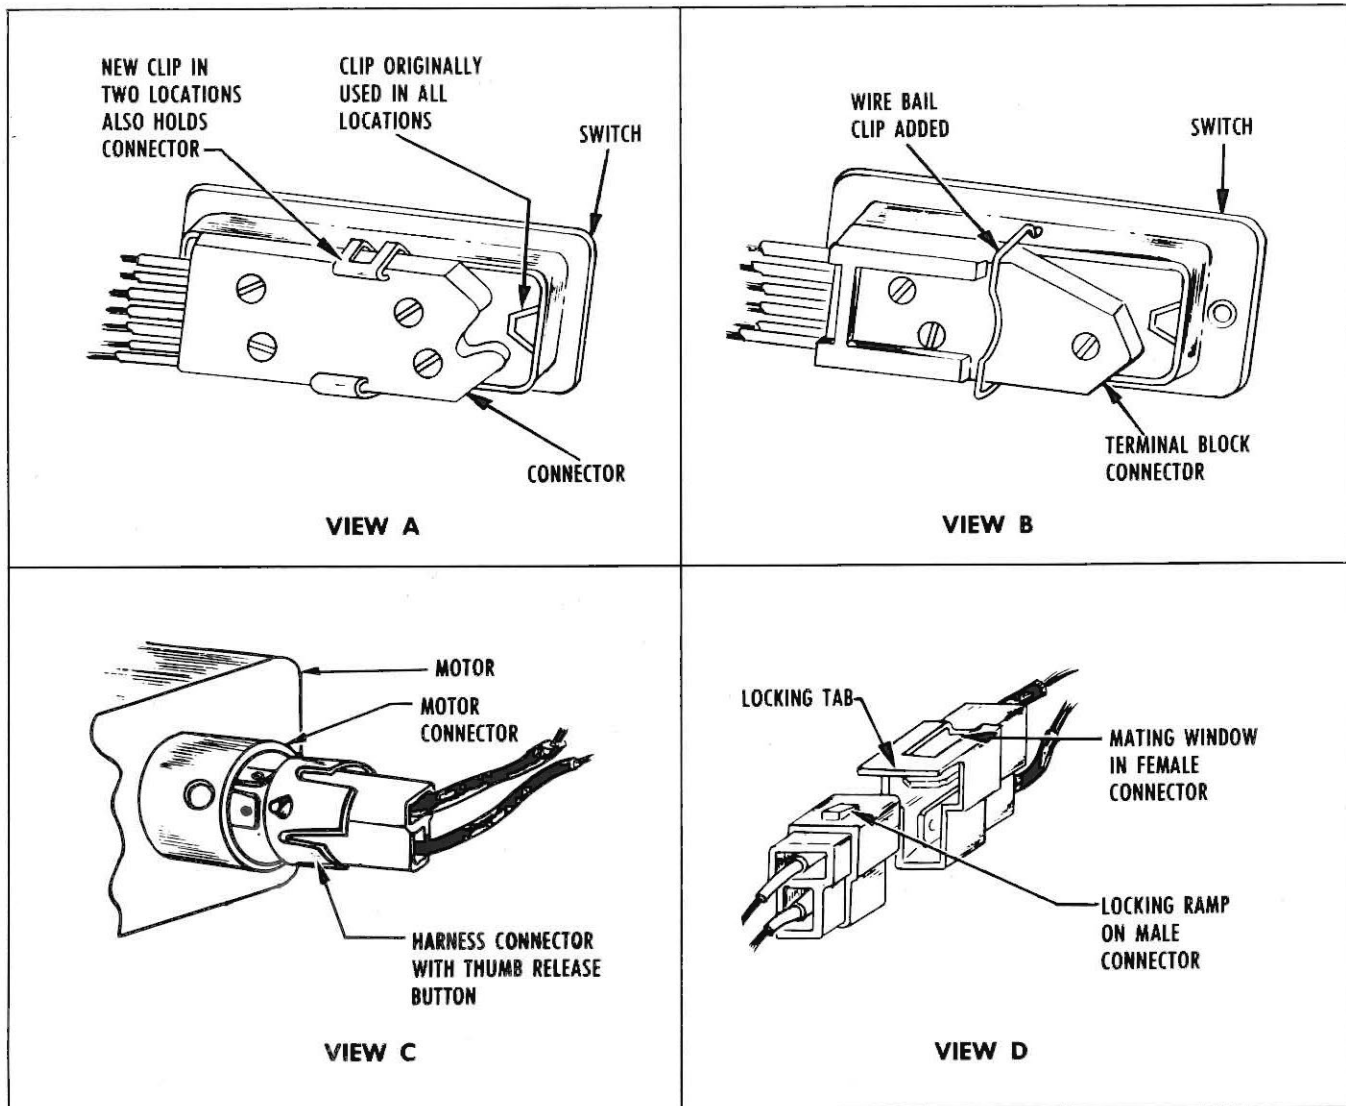
The construction of the body electrical connectors has been redesigned to improve their retention. This will minimize the possibility of electrical failure due to disconnected wires, switches, etc.

Figure 10 illustrates the constructional changes. Knowledge of this information will assist the serviceman when removing these connectors.

Fig. 10—Redesigned Body Electrical Connectors

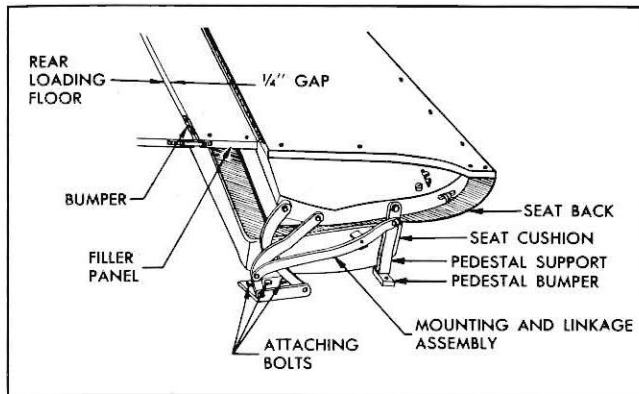
Cases have been reported of the folding second seat back on station wagon models being difficult to lock in the lowered position or to unlock from the lowered position. This condition may be corrected by adjusting the seat according to the following procedure:

NOTE: With the seat back in this position, the linkage pedestal supports should rest flat on the rubber bumpers attached to the floor pan. Also, the floor filler panel should lay flat

Fig. 11—Station Wagon Folding Seat Alignment

2. If adjustment is necessary, loosen the three bolts at each side of the seat assembly attaching the folding seat back mounting and linkage assembly to the floor pan.
3. Position seat assembly as required so the gap between the metal edge of the filler panel and the metal step on the rear loading floor is 1/4" wide along the full length of the filler panel.
4. Tighten the three attaching bolts at each end of the seat assembly.
5. Check the locking and unlocking action of the folding seat assembly.

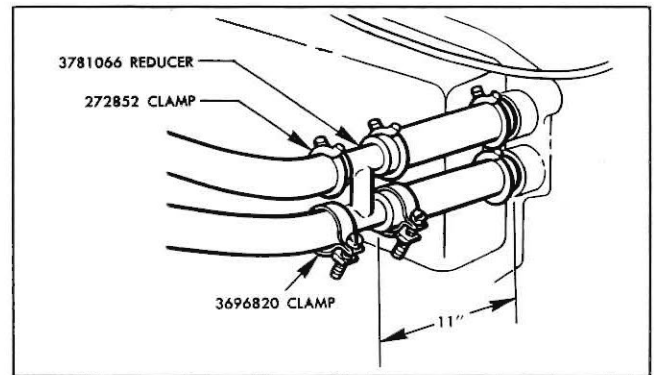
If a gurgling noise, considered objectionable by an owner, is noted in the 1959-60 Passenger Car equipped with 348 cu. in. engine and Air Flow Heater or All Weather Air Conditioning, the noise may be minimized with the installation of a Reducer-Bypass Part No. 3781066, in the heater hoses (fig. 12).

Fig. 12—Installing Reducer in Heater Hoses

This reducer is installed between the inlet and outlet hoses approximately 11 inches from the hose attachment to the heater core.

1. Drain radiator.
2. Cut inlet and outlet heater hoses approximately 11" from ends attached to heater core.
3. Remove and discard restrictor used in the lower or inlet hose at core pipe.

4. Install reducer, using the two 3/4" spring type clamps on the upper hose, and the two 5/8" screw type clamps on the lower hose (fig. 12).
5. Remove lower hose nipple at intake manifold water outlet; remove and discard restrictor.

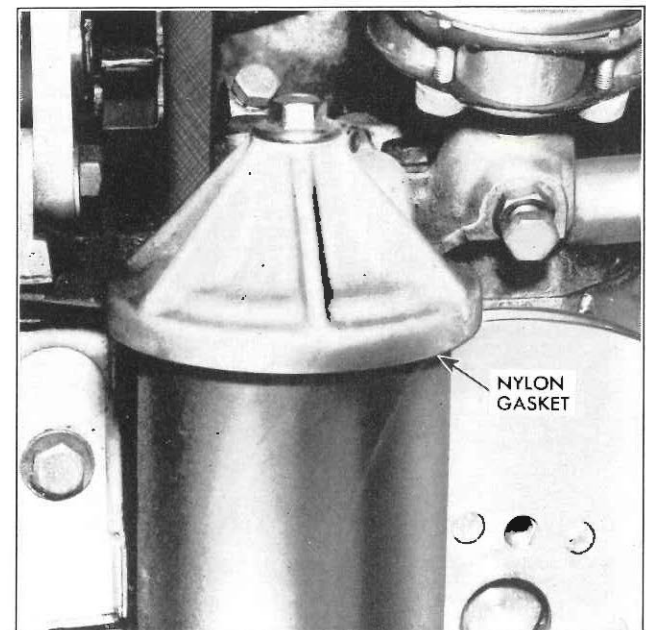
The oil filter center bolt torque specification presented on page 2-6 of the 2nd Edition Corvaire Shop Manual is incorrect. The torque specification should be 9-15 ft. lbs. as stated on pages 6A-51 and 12-6.

The correct amount of torque applied to the oil filter center bolt is very important because if the bolt is tightened to 20-25 ft. lbs. torque as

Fig. 13—Corvaire Oil Filter Gasket

stated on page 2-6 of the Corvair Shop Manual, the nylon gasket may split, causing an oil leak. An oil leak in this area (fig. 13) can result in the rapid exhausting of the engine oil.

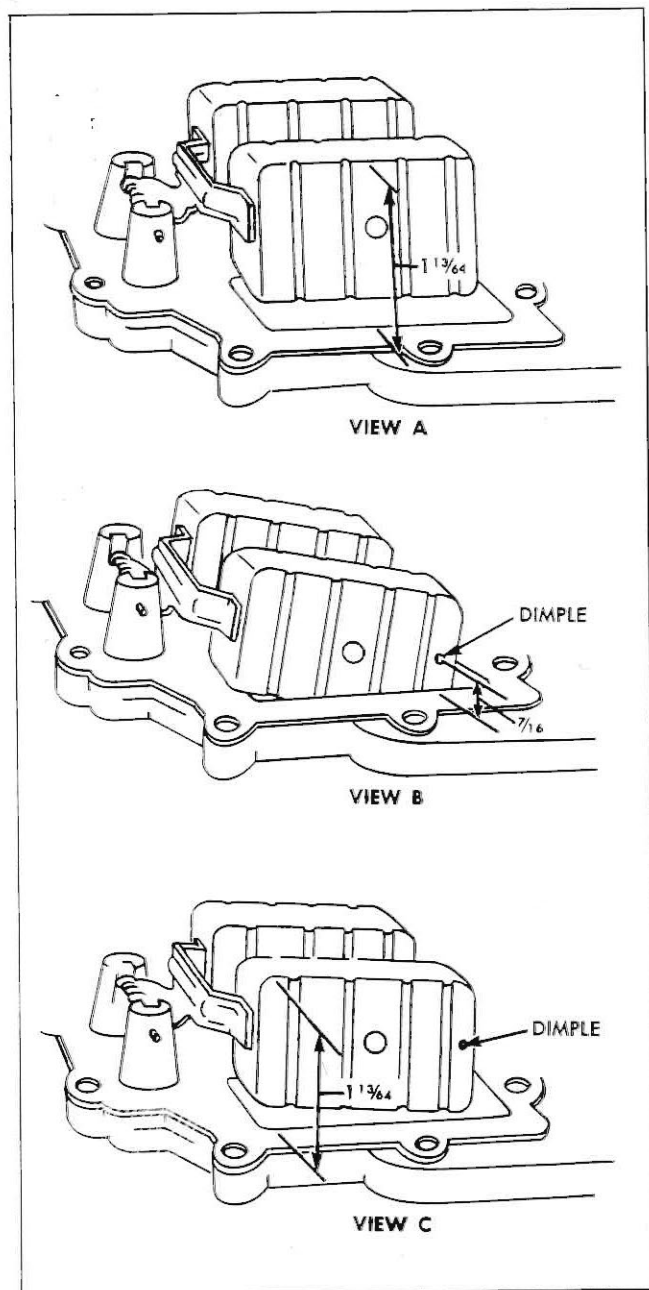
Recent changes in Corvair carburetors make proper carburetor identification necessary to insure correct float setting.

Figure 14 illustrates the float setting according to the type of needle valve used and the float identification marks.

The float setting for Carburetor Part No. 7015310 or 7015311 with solid needle valve and float Part No. 7015241 should be  $1\frac{3}{64}$ " from the gasket surface to the top of the float, View A.

The float setting for carburetor Part No. 7015312 or Part No. 7015313 with spring loaded needle valve and float with a dimple should be  $\frac{7}{16}$ " from the gasket to the dimple, View B.

The float setting for carburetor Part No. 7015310 or Part No. 7015311 with the solid needle valve and the dimpled float should be  $1\frac{3}{64}$ ", View C.

Fig. 14—Corvair Carburetor Float Settings

It is suggested that the solid needle valve and seat Part No. 7015789 be used as service replacement for spring loaded needle valve and seat assembly. It is also suggested that float and lever assembly Part No. 7015241 (without dimple) be used with solid needle valve and seat Part No. 7015789 as service replacement for all dimpled floats. When making this replacement a float setting of  $1\frac{3}{64}$ " should be used.
