SERVICE NEWS

VOLUME 32

AUGUST, 1960

POSITRACTION REAR AXLE

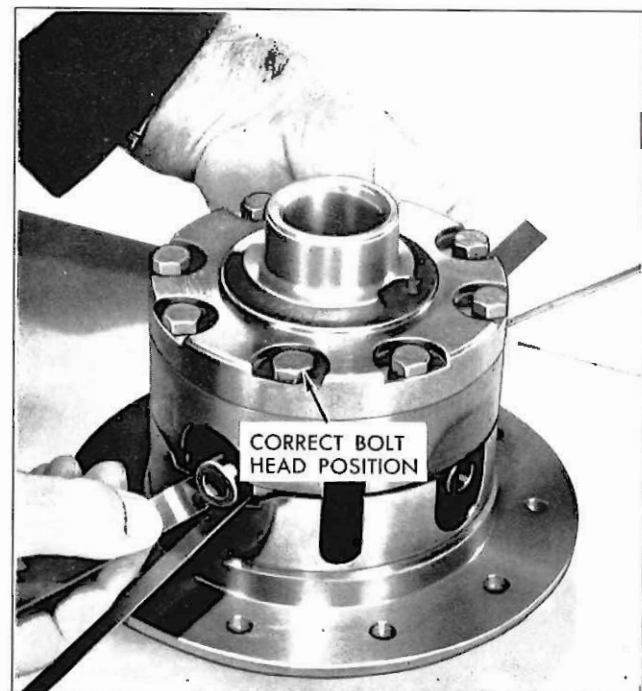
Fig. 1—Checking Mate Shaft Clearance

thickness feeler gage must be used at all four positions. The clearance of the maximum feeler thickness at each of the four positions on original 1957 to 1959 units without Belleville plate should not exceed .015".

NOTE: *On 1957 to 1959 units with Belleville conversion, and on all 1960 units, there should be no clearance (metal to metal).*

If a clearance of more than .015" on 1957, 1958 and 1959 units without Belleville (dished) plate, or more than zero on converted and 1960 units is found, the unit should be disassembled as follows:

NOTE: *If clearance is found to be excessive on the 1957 to 1959 original units, installation of the Belleville plate conversion, Part #3777611, is suggested.*

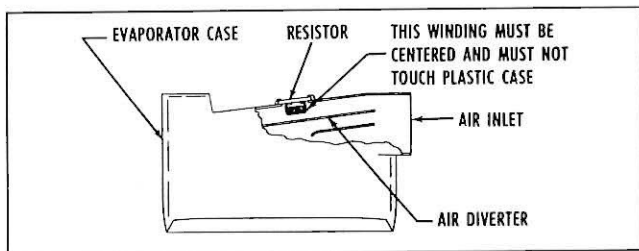
Fig. 10—Cool-Pack Blower Switch Resistor

1. Low blower speed is provided through a resistor located in the evaporator case. (fig. 10). The resistor winding, visible in the evaporator air inlet before the blower ducting is assembled, must not touch any portion of the evaporator case.

Inspect the evaporator prior to installation. If the resistor winding is touching the outside of the case or the air diverter inside the case, use a long screwdriver or other suitable tool to bend the resistor so it is centered in the air stream.

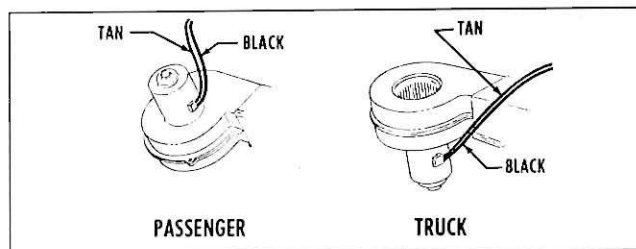
Fig. 11—Cool-Pack Blower Harness Installed

2. When installing Passenger Car blower wiring harness, check to make sure black wire to blower motor is nearer blower case than the tan wire (Fig. 11). This is a correction to Page 6 of the Passenger Car Cool-Pack Instruction Sheets.

Existing Cool-Pack Instruction Sheets for Trucks correctly show the harness tan lead located nearer the blower case, as shown in Figure 11.

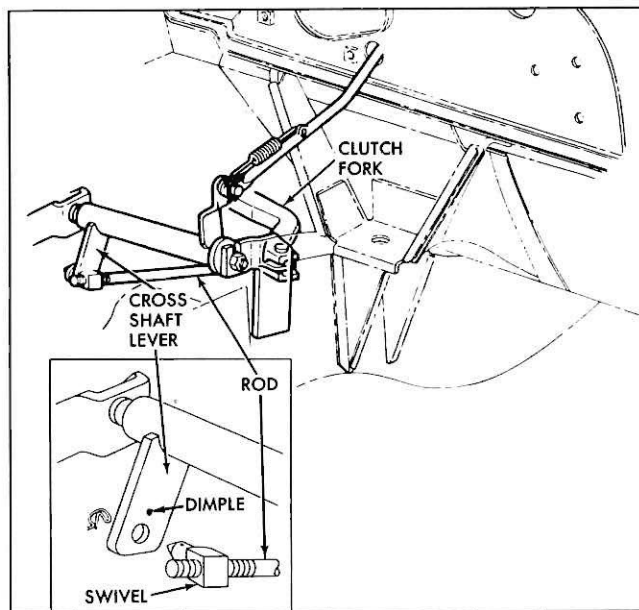
Fig. 14—Adjusting Passenger Clutch Free Travel

In the 1958-60 Passenger Car Shop Manuals, two different methods of adjusting clutch pedal free travel (lash) are described. Experience with these clutch installations has shown that, due to difficulty in determining when the release bearing actually contacts the clutch diaphragm spring, the method of adjustment that requires setting free travel by "feeling" $\frac{3}{4}$ " to 1" lash at the pedal, too

frequently results in an incorrect setting. Therefore, it is recommended that use of that adjustment procedure be discontinued.

The easiest and most accurate means of obtaining specified clutch free travel in 1958-60 passenger cars is by employing the other method outlined in the Shop Manuals. That is, by utilizing the locating dimple in the clutch cross shaft lever (Fig. 14); which will automatically provide the

1. Disconnect the forward end of the clutch fork push rod from the cross shaft lever.
2. Move the fork push rod rearward to remove all lash. With the rod held in that position, adjust the swivel on the push rod so that the conical point of the swivel lines up with the "dimple" in the cross shaft lever.
3. Hold swivel position on rod and reconnect swivel to cross shaft lever.

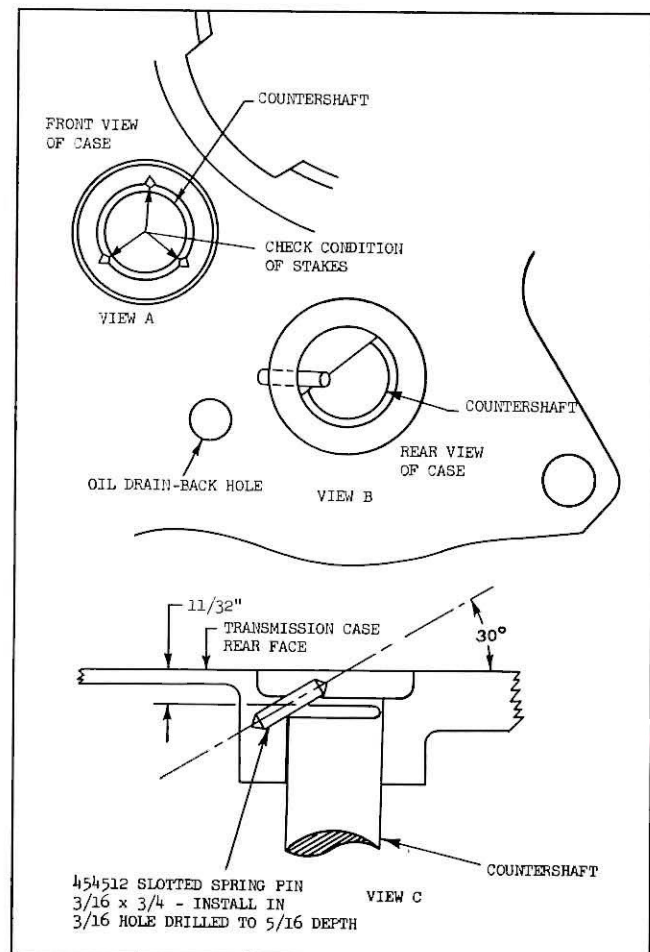
Fig. 15—Three-Speed Transmission Countershaft

Whenever a rear axle pinion bearing failure is encountered on Corvairs equipped with 3-speed transmission, the transmission countershaft should be checked for looseness in the case. Looseness can be detected by movement of the countershaft from its fully seated position against the stakes at the front of the transmission case, or by the wear pattern created by the shaft on the front face of the axle housing.

When shaft movement occurs, lubricant leaks from the shaft bore at the front of the transmission

To prevent possible loss of lubricant and resulting pinion bearing seizure on transmission units built prior to April 28, the countershaft should be pinned when handling either an existing axle failure or whenever transmission is removed from vehicle.

1. Remove transmission cover and check for damage to transmission.
2. If countershaft has moved rearward, tap shaft in position against stakes at front of case bore (View A, Figure 15). Amount of force necessary to seat shaft will indicate whether or not

bore has opened up to point where an effective oil seal cannot be maintained. If press fit has been lost, the transmission case will have to be replaced. Shaft should recess in case approximately 11/32" (View C, Figure 15). Condition of stakes at front of case should be checked and shaft re-staked if necessary.

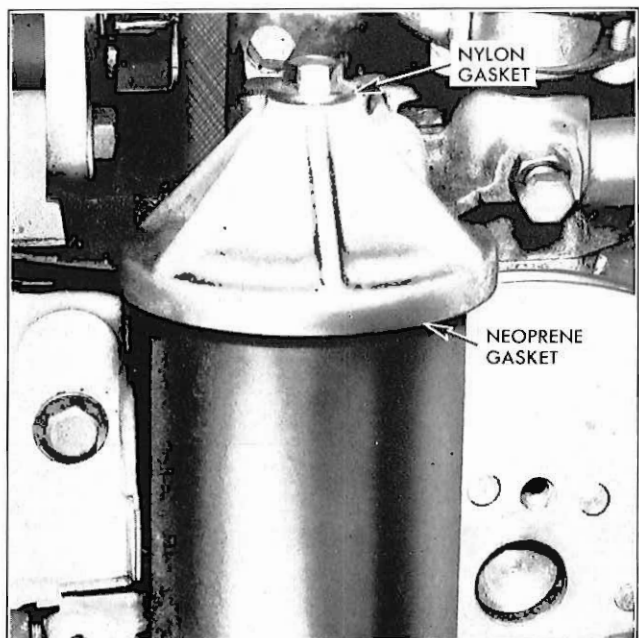
Fig. 16—Corvair Engine Oil Filter

The oil filter center bolt torque specification presented on page 2-6 of the 2nd Edition Corvair Shop Manual is incorrect. The torque specification should be 9-15 ft. lbs. as stated on pages 6A-51 and 12-6.

The correct amount of torque applied to the oil filter center bolt is very important because if the bolt is tightened to 20-25 ft. lbs. torque as stated on page 2-6 of the Corvair Shop Manual, the nylon gasket may split or the neoprene seal may be damaged, causing an oil leak. An oil leak in either of these areas (fig. 16) can result in rapid loss of engine oil.
