CONTENTS

CORVAIR "95" ACCELERATOR LINKAGE

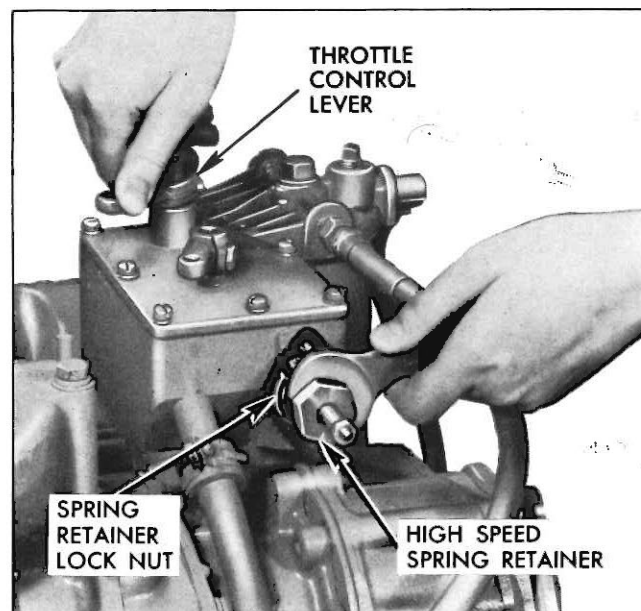
Fig. 3—Adjusting Governor on 6V-53 Diesel

This governor utilizes a screw and lock type of adjustment for setting engine maximum no-load speed (Fig. 3). Engine no-load speed must not exceed 2800 rpm, and should be checked with the engine at operating temperature.

NOTE: In error, a governor in which selective shims are used to adjust engine maximum no-load speed is described on page 22 of the 1962 Chevrolet Truck Diesel Engine Operating and Service Guide. A governor incorporating this type adjustment is not used on the 6V-53 Diesel engine.

2. Using a spanner wrench, back-off the high speed spring retainer lock nut approximately five turns.
3. With engine running (at operating temperature), hold the speed control lever in "full fuel" position. Turn high speed spring retainer in the direction needed to attain a tachometer indicated 2800 rpm no-load speed (turn in to increase—out to decrease).
4. Release speed control lever. Hold high speed spring retainer and tighten lock nut.
5. Install governor spring housing.

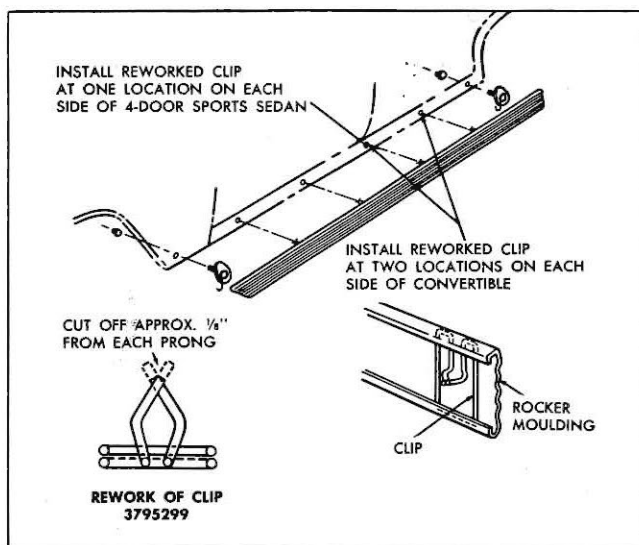
Fig. 4—Impala Rocker Moulding Installation

The clips used to attach the aluminum rocker panel mouldings on 1962 Impala series passenger cars are too long and at some locations hit the reinforcing panel inside the sill. The specific locations where interference is incurred is at the third

clip from the front on 4-door sports sedans and at the third and fourth clips on convertibles. See Figure 4.

If a rocker panel moulding on an early production 4-door sport sedan or convertible is found to have missing or improperly seated clips at the above mentioned locations, correctly install the clips (Part #3795299) after shortening the clip prongs as shown in Figure 4. It is important that the clips be reworked before installation, since use of force in an attempt to seat the long clips can cause the rocker moulding to be dented.

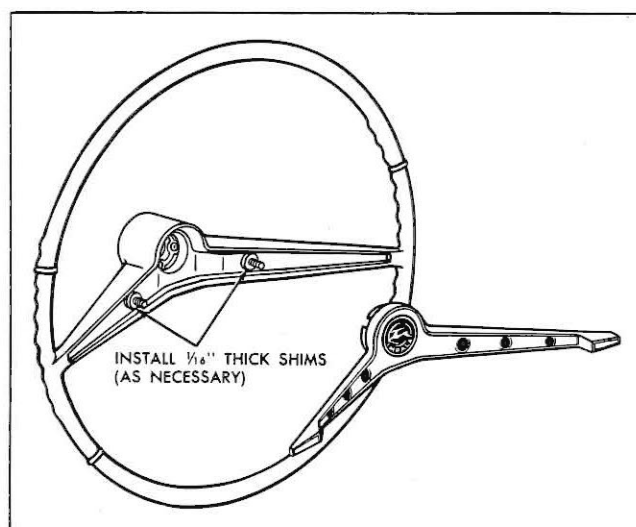
Fig. 5—Shimming Impala Horn Bar

When attempting to sound the horn on some early Impala series passenger cars, the end of the horn bar may bottom out in the steering wheel spoke before the bar has pivoted far enough to complete the horn electrical circuit.

To correct this condition remove the two horn bar attaching screws from the back of the steering wheel and add one or more 1/16" washers to each screw (fig. 5). It is necessary to shim with the same washer thickness at both sides of the horn bar, otherwise the bar would be noticeably misaligned.
