SERVICE NEWS

VOLUME 33

MAY, 1961

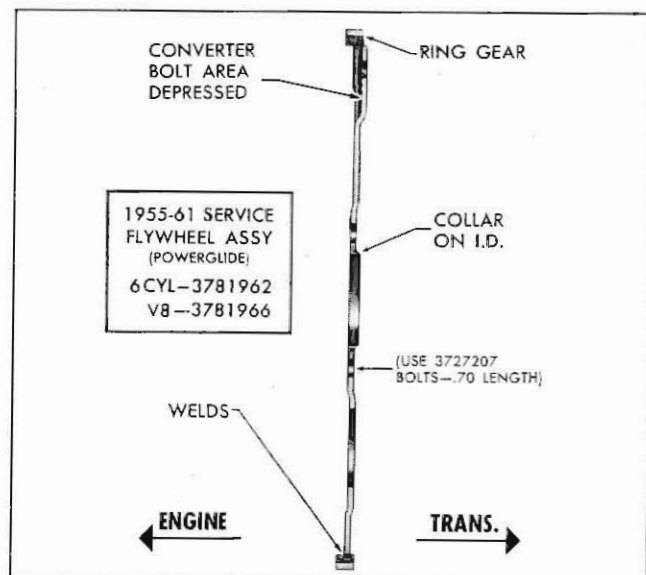
Fig. 1—Powerglide Flywheel

Instances have been reported where parts damage has occurred due to these flywheels being installed backwards. In other cases where flywheels of older design were being replaced, crankshaft flange attaching bolts removed from the old flywheel were used to install a 3781962 or 3781966 flywheel, resulting in an interference condition existing between the flange bolts and the cylinder block.

A decrease in section thickness at the flange bolt circle of the flywheel web, due to elimination of an integral spacer ring effective with introduction of flywheels 3781962 and 3781966, makes it mandatory that flange attaching bolts no longer than .70" be used to install these later flywheels. Currently, bolts of the proper length, Part No. 3727207, are furnished with these replacement flywheels.

Figure 1 clarifies installation of engine flywheels, part number 3781962 and 3781966, which are currently serviced for 1955-61 Powerglide equipped 235-6 cylinder and V-8 engines respectively.

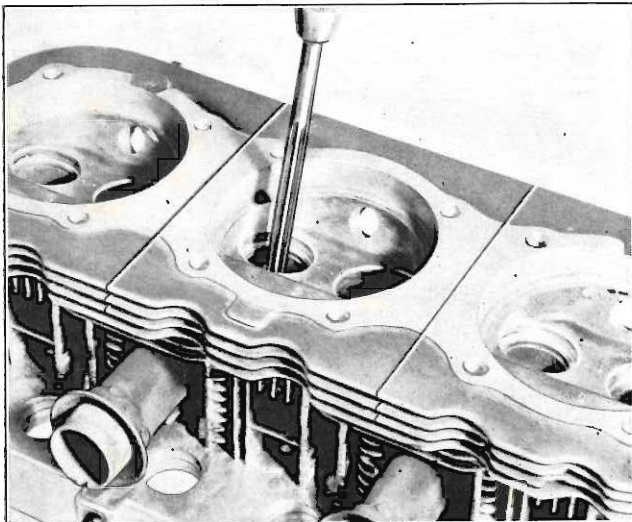
Fig. 3—J-5830-5 Reamer (.020 oversize valves)

Valve Guide Reamer J-5830-5, shown in Figure 3, is designed for use in cases where extreme exhaust valve guide wear requires the installation of valves having a stem diameter .020" oversize. Tool J-5830-5 is now available from Kent-Moore Organization.

It is recommended that valve stem to guide bore clearance now be checked only by means of a dial indicator. Clearance should be within the following revised specifications:

Intake valve stem to bore clearance should be .001" to .0027" (new), and .004" (worn). Exhaust valve stem clearance should be .0014" to .003" (new), and .006" (worn).

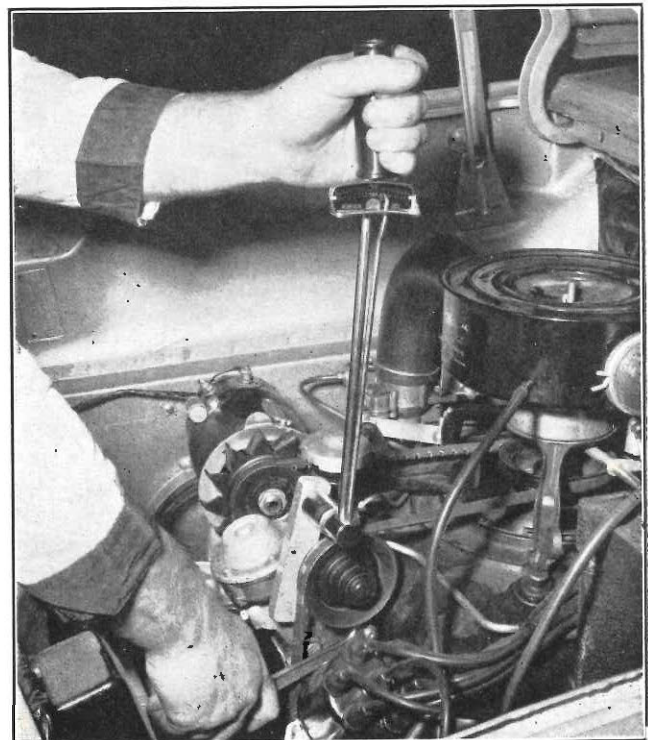
Fig. 4—Tensioning Belt with Torque Tool

Results of field tests show that retensioning of used Corvair engine blower belts to the presently specified 70 lbs. strand tension (equivalent to 3/8 inch belt deflection with 15 lb. load) will materially reduce the life of the belt. It is therefore recommended that used belts be retensioned to a 50 lb. strand tension. A used belt is defined as one that has been installed for more than 1,000 miles.

available strand tension gauge, or by using a torque tool that can be made in the dealership. Belt tension checks performed with a torque tool (fig. 4), assembled as described later in this article, were found to provide very accurate strand tension settings.

If belt is new or has operated less than 1,000 miles, install with 20 ft. lbs. torque applied. If belt is used, install with 15 ft. lbs. torque applied.

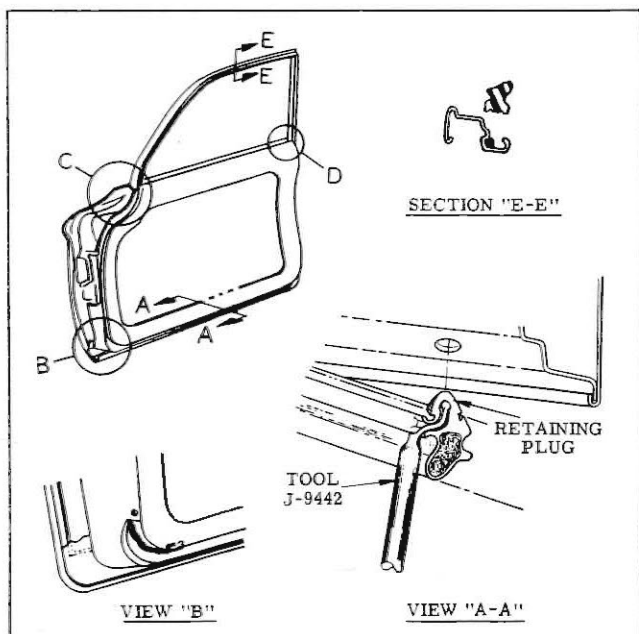
Fig. 6—Vinyl Weatherstrip Installation

Installation of the vinyl weatherstrip requires use of Weatherstrip Installer J-9442, now available from Kent-Moore Organization. J-9442 is designed specifically for installation of this type weatherstrip; see view "A-A" of Figure 6. An attempt to install the weatherstrip without a properly-designed tool will probably result in damage to the retaining plugs.

1. Clean off old cement from door to insure a clean cementing surface. A volatile cleaner is recommended for this operation.
2. Apply a continuous bead of "Vinyl Weatherstrip Adhesive" along entire length of channel in door upper frame. Also apply a bead of cement for a minimum length of eight inches on door hinge pillar (cove area, see area "C" in Figure 6) and a minimum length of one inch on door lock pillar (see area "D" in Figure 6) and between retaining plugs at lower front radius of door (see view "B" of Figure 6).

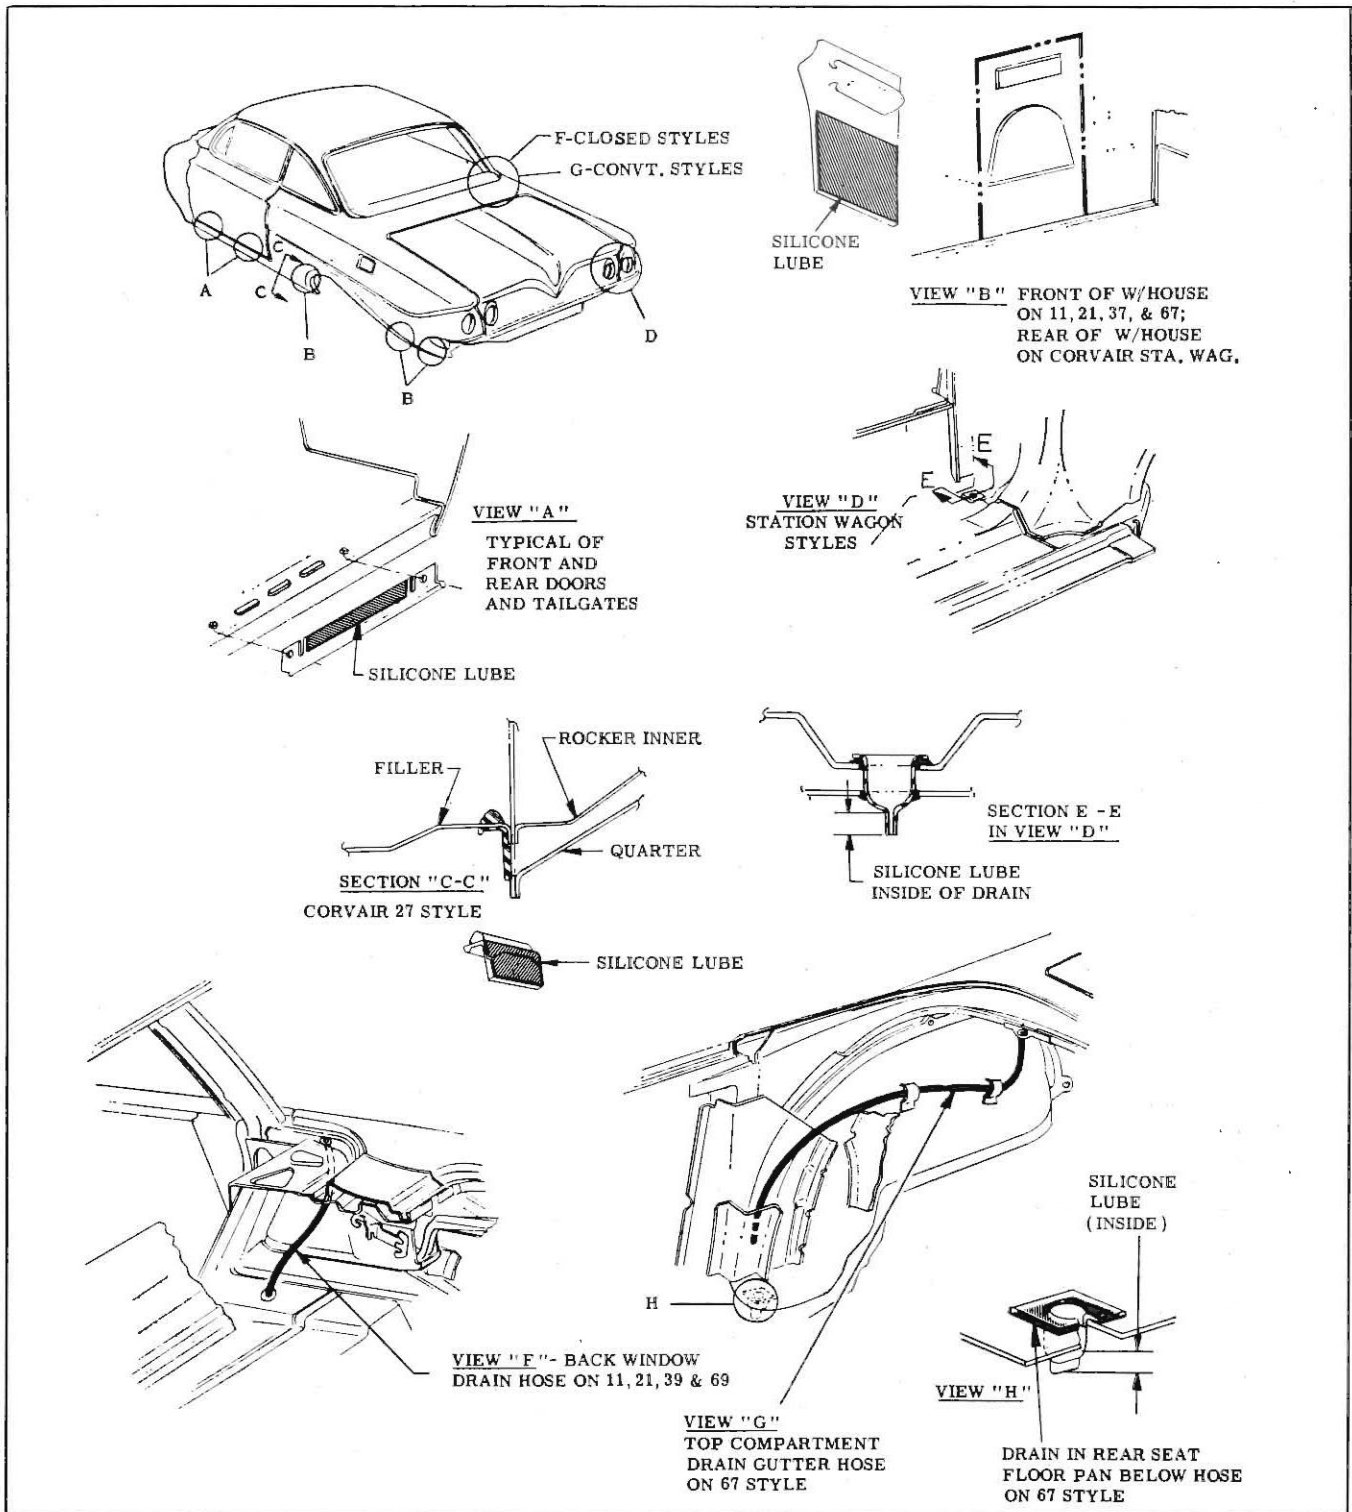
Fig. 7—Location of Body Water Drains

Figure 7 illustrates water drains provided in 1961 Passenger Car and Corvair bodies. In most cases where evidence of water accumulation is detected on inner or unexposed surfaces of body metal, one of the prime suspects should be a clogged body drain. To minimize water damage to the body interior, body drains should be kept free of debris, and drain hoses that show signs of deterioration should be replaced. Periodic application of silicone lubricant in the lips of the body drains will prevent the drains from sticking closed.

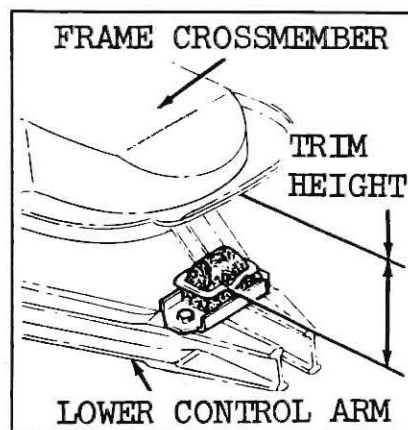
Fig. 8—Measuring Trim Height

As shown in the following chart, "toe" varies in direct relation to trim height, with "toe" and trim height being reduced as weight is added to the vehicle. Figure 1 illustrates the location at which the suspension trim height dimension should be scaled.
