# SERVICE NEWS

VOLUME 33

SEPTEMBER, 1961

NUMBER 9

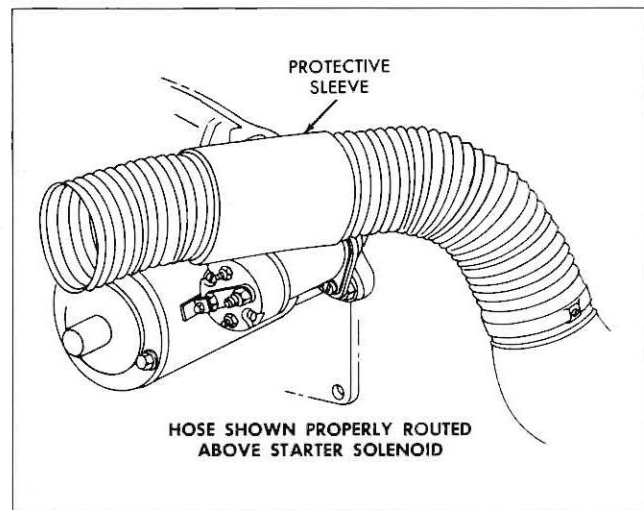
Fig. 1—Corvair Heater Blower Inlet Hose

On some Corvair Direct Air Heater installations the blower hot air inlet hose from the left hand duct on the engine may be in error, routed along

the left side of the starter solenoid. Proper routing for this hose is above the starter solenoid, as shown in Figure 1.

If a car remains in service with the heater hose routed along the side of the solenoid, the hose may chafe on the "hot" terminal of the solenoid causing the terminal to wear through the hose fabric and contact the reinforcing wire in the hose. This would result in short circuiting and battery discharge.

If a hose is found mispositioned it should be routed over the top of the starter solenoid and the protective sponge rubber sleeve on the hose should be centered directly over the solenoid.

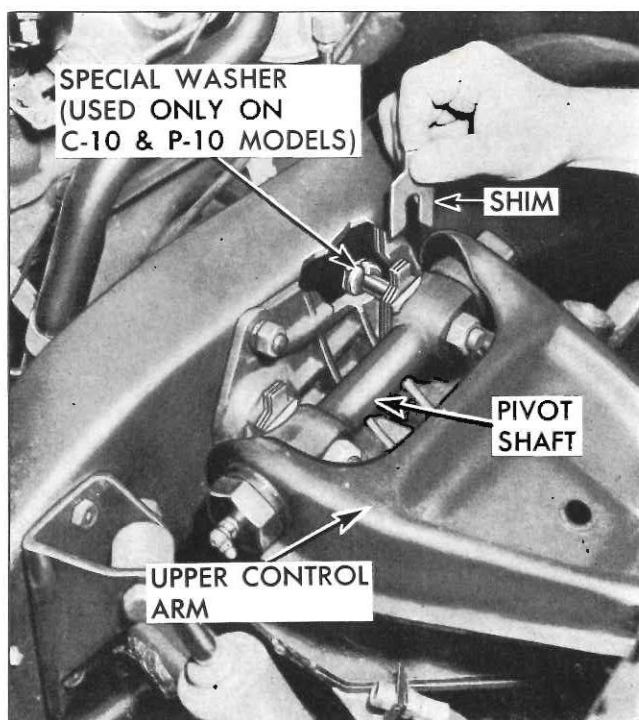
Fig. 2—Pivot Shaft Attachment (Typical)

Reports have been received stating that the caster/camber shims have fallen out shortly after the front end has been aligned on some 1960-61 trucks, Series 10 through 40. If loss of shims is

experienced, it is probably due to the upper control arm pivot shaft attaching bolts not being properly torqued on completion of wheel alignment. A false torque reading will be obtained if the attaching bolt is not properly aligned in its frame bracket hole.

The head of the pivot shaft attaching bolt has a spherical seat that nests into a depressed mating surface on the inner side of the upper control arm frame bracket (Fig. 2). When the pivot shaft nuts are loosened to change the shim pack, the upper control arm moves upward and rearward causing the bolt head to be misaligned. If the bolt is tightened in this position, it will later shift and fall into its seat on the first severe road shock or panic stop. This would result in the loss of the caster/camber shims.

Correct pivot shaft bolt alignment and torque may be achieved using the following procedure. First, raise the front of the vehicle so that the wheels hang free. Torque the nut on the pivot bolts to 30-40 ft. lbs. Rap the front and rear flange of the upper control arm, near the pivot shaft, using a one pound hammer. When the bolts are properly seated, increase nut torque to applicable specification shown in the following chart.

*NOTE: To torque pivot shaft nut it will be necessary to use a socket to hold the head of the bolt from inside the frame.*

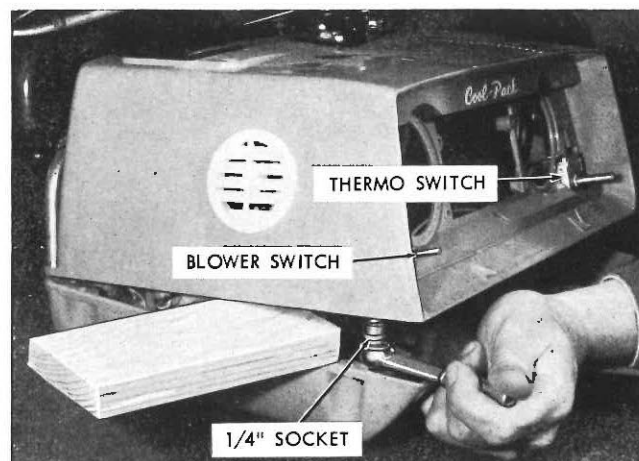
Fig. 3—Cool Pack Control Switch Removal

To replace the blower or the thermostatic switch on a 1961 Passenger Car "Cool Pack" air conditioner, it is not necessary to discharge the system or even loosen the evaporator at its instrument panel mounting. The plastic evaporator drain pan is flexible and can be lowered sufficiently with the evaporator installed, to allow replacement of either control switch assembly. Perform switch replacement as follows:

5. Using a ratchet and  $\frac{1}{4}$ " socket, remove the switch attaching screws, as shown in Figure 3.
6. Working through the evaporator grille opening, and between the lowered drain pan and case, remove any quick-disconnect switch leads that would be too short to permit the switch to be pulled out between the pan and evaporator case.
