SERVICE NEWS

VOLUME 34

JUNE, 1962

NUMBER 6

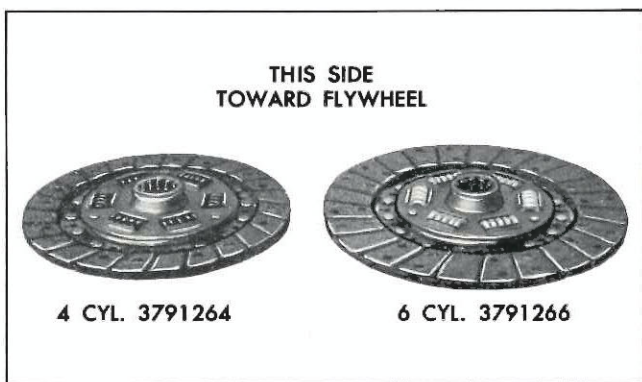
As previously covered in the November 1961 issue of Service News, the clutch driven discs for both the four and six cylinder Chevy II engines should be installed so that the extended end of the hub and the dampener springs are toward the flywheel (Fig. 1). The flywheel is recessed to receive the dampener springs and hub.

Fig. 1—Clutch Discs for Chevy II Engines

Unfortunately, the service replacement clutch driven disc assemblies of early manufacture, in error, had the words "FLYWHEEL SIDE" stamped on the rear face of the disc. If the driven disc assemblies for the four or six cylinder engines

were installed according to this marking, the hub and dampener spring retainer plate would interfere with the clutch pressure plate and prevent full disengagement of the clutch.

The source furnishing the Service clutch disc assemblies is now painting out or deleting the incorrect marking from parts of late manufacture. Chevrolet Parts installations are inserting an instruction sheet in all warehoused units of early manufacture. Installation instructions being enclosed warn that the "FLYWHEEL SIDE" markings should be disregarded, and the service disc assembly installed so that the side with the paint marking on the hub is toward the pressure plate.

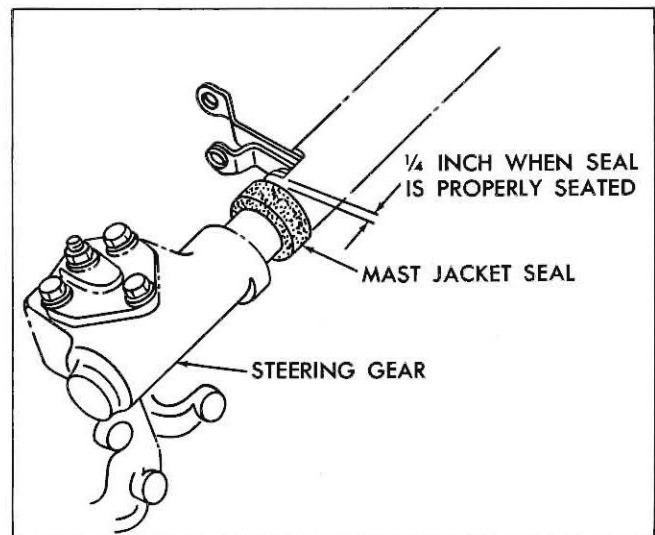
Instances of Chevy II three-speed transmission block-out in first and reverse, or reports of severe shift linkage deflection, can in most cases be attributed to improper positioning of the lower mast jacket seal. The lower seal should fit inside the mast jacket about $\frac{7}{32}$ inch to provide support for the lower end. That part of the seal on the outside of the mast jacket will be within $\frac{1}{4}$ inch of the opening in the outer tube of the mast jacket when properly installed (Fig. 2).

Fig. 2—Chevy II Steering Mast Jacket Lower Seal

Before transmission shift linkage adjustments are made, the seal should be checked and positioned by using the side of a screwdriver or other suitable tool. Shift linkage can then be adjusted according to the 1962 Chevy II Shop Manual, Page 7-4.

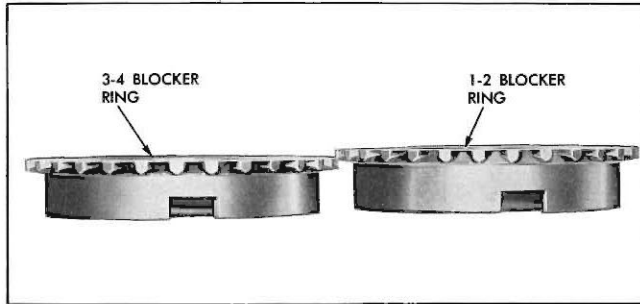
Instances of Corvair 4-speed transmission hard shifting and gear clash in 1st and 2nd can be caused by installation of the wrong synchronizer blocker rings. Some of these transmissions have apparently been assembled with the 3-4 blocker

Fig. 3—Corvair 4-Speed Transmission Synchronizer Blocker Rings

rings installed at either the 1st or 2nd gear location, or at both locations. As shown in Figure 3, the 1-2 synchronizer blockers are wider than the 3-4 blocker rings. If the 3-4 blockers are in error used with the 1st or 2nd speed gears, these narrower blockers will slide off the synchronizer keys and tend to block engagement, or cause gear clashing.

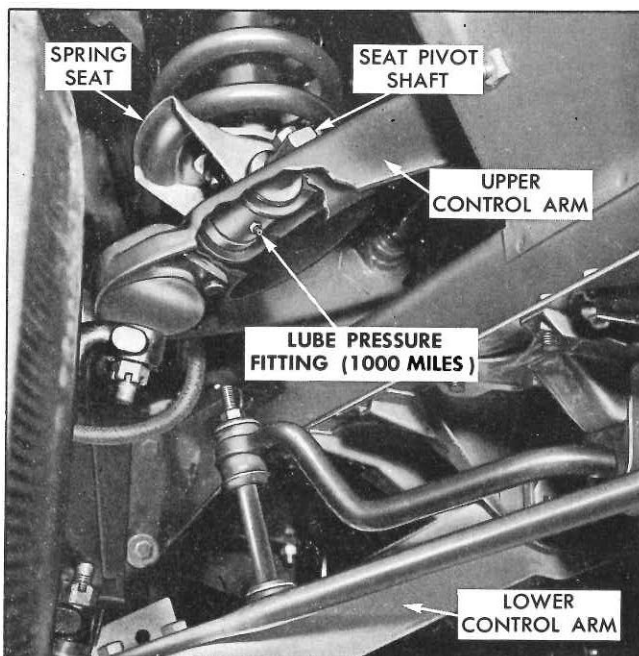
- **CHEVY II FRONT SPRING SEAT**—The pivoting lower seat utilized for each front suspension coil spring is provided with a pressure type fitting to accept chassis lubricant for the seat pivot shaft. In many instances these fittings have been overlooked at regular chassis lubrication due to servicemen being unfamiliar with this type suspension. At each spring lower seat, the grease fitting is located on the underside of the pivot shaft bearing housing (Fig. 4) and can be reached easily through the large opening in the upper control arm. In cases where the pivot

Fig. 4—Chevy II Front Spring Seat Pivot

shaft is not receiving lubricant, a noise similar to that produced by a mispositioned front spring or worn control arm ball joint may emanate from the dry pivot shaft bearing.

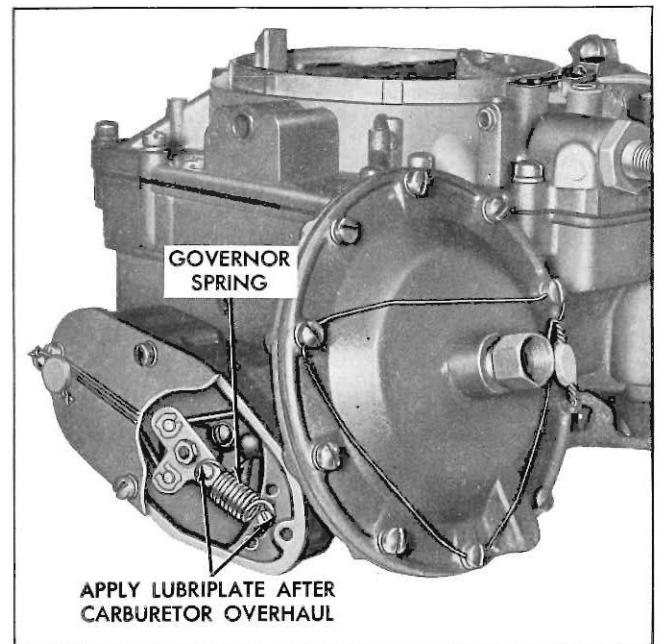
- **FOUR CYLINDER ENGINE DIPSTICK**—When inserting the crankcase dipstick on the Chevy II four cylinder engine, the dipstick must be pushed down firmly to insure that the felt seal on the dipstick washer is placed in solid contact with the top of the dipstick retaining tube. Failure to seat the crankcase dipstick as outlined above can result in severe loss of engine oil through the dipstick retainer tube.
- **TRUCK VACUUM SPINNER GOVERNOR**—Upon completion of carburetor overhaul on a truck equipped with a vacuum spinner type governor, Lubriplate or equivalent should be applied at the hook ends of the governor spring. This spring is utilized in the carburetor-mounted portion of the engine governor (Fig. 5).

Fig. 5—Vacuum Spinner Truck Engine Governor

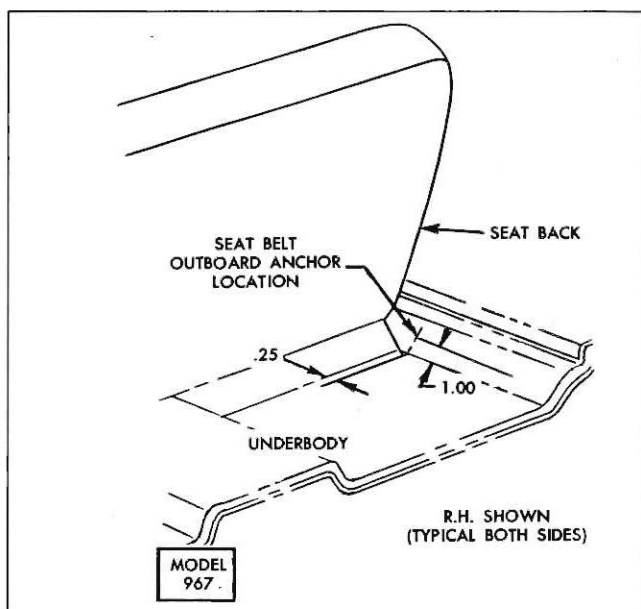
The location of the outboard belt anchors for front seat belts on the Corvair convertible has recently been added to the Seat Belt Instruction Sheet that is included in the Accessory packages. However, numerous Seat Belt Accessory Units already distributed will not contain this information.

The outboard belt anchor on the Corvair convertible is located on the side wall of the rocker inner panel (Fig. 6). The rubber plug at that location can be detected by feeling the surface of the floor carpet. Anchors for the inboard belts on the convertible are provided at the same underbody locations utilized for other 1962 Corvair body styles.

Fig. 6—Seat Belt Anchor Location—Convertibles
