SERVICE NEWS

VOLUME 34

AUGUST-SEPTEMBER, 1962

CORVAIR ENGINE HOT IDLE

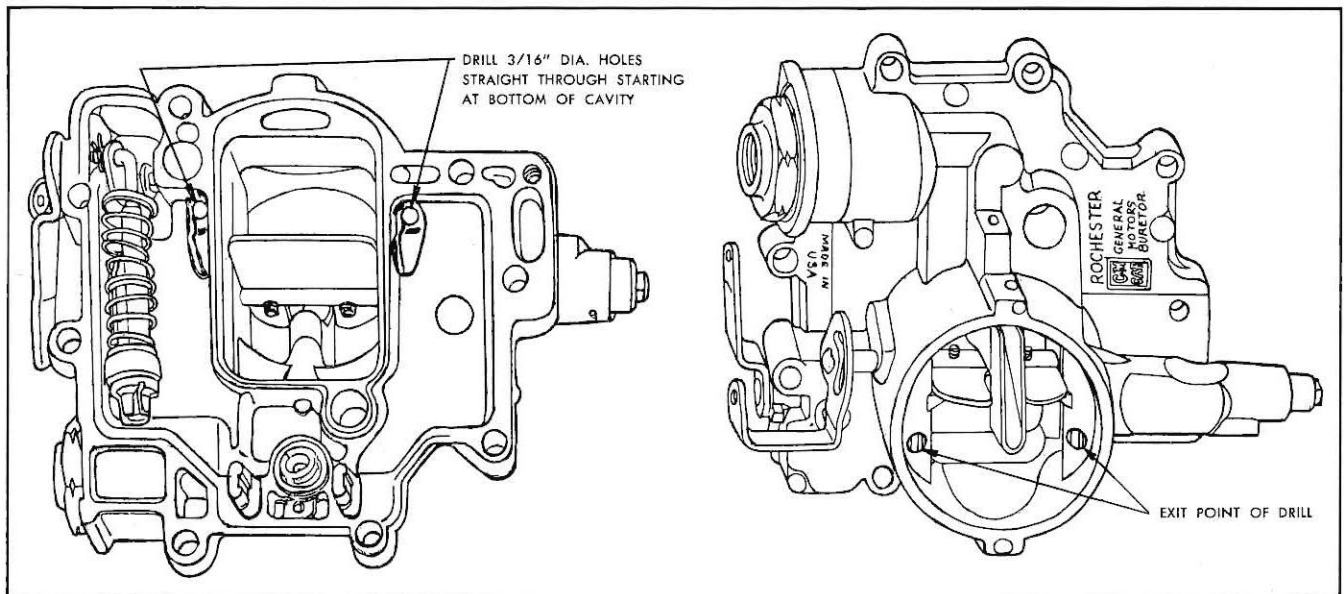
Carburetors on some 1961-62 model Corvair and Corvair "95" vehicles may require additional internal venting to improve engine idle and prevent stalling immediately after a hot start, or when encountering long idle periods in slow traffic.

Fig. 1—1961-62 Corvair Carburetor Modification to Improve Hot Idle

1. Remove bowl covers from both carburetors.
2. Invert bowl covers and remove float, float needle and bowl cover gaskets.
3. Locate and drill two $\frac{3}{16}$ " diameter holes in each bowl cover, as shown in Figure 1. Holes must be drilled straight through to break out inside the air horn as illustrated.
4. Clean out all chips, remove burrs and reassemble the carburetors.

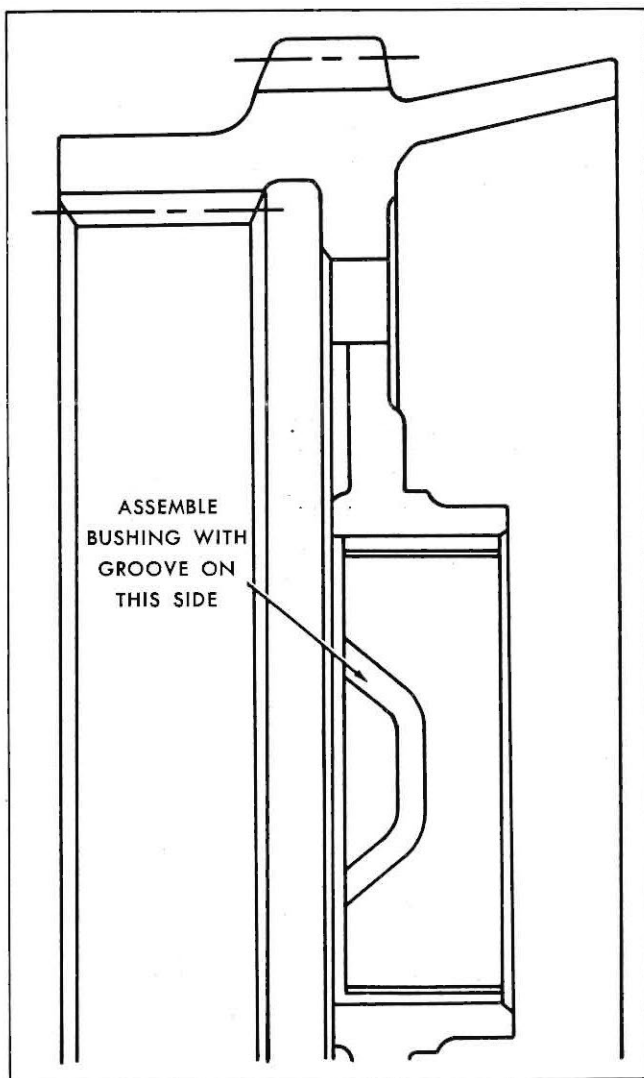
Many instances have been reported wherein a 1954-62 Chevrolet truck Hydra-Matic transmission has encountered reverse cone failure soon after transmission overhaul. In most of these cases the cone failure has proven to be the result of reverse lock-up induced by improper installation of the transmission Reverse Internal Gear Bushing.

Fig. 2—Hydra-Matic Bushing Installation

This bushing should be installed with the oil groove facing forward in the transmission, as shown in Figure 2.

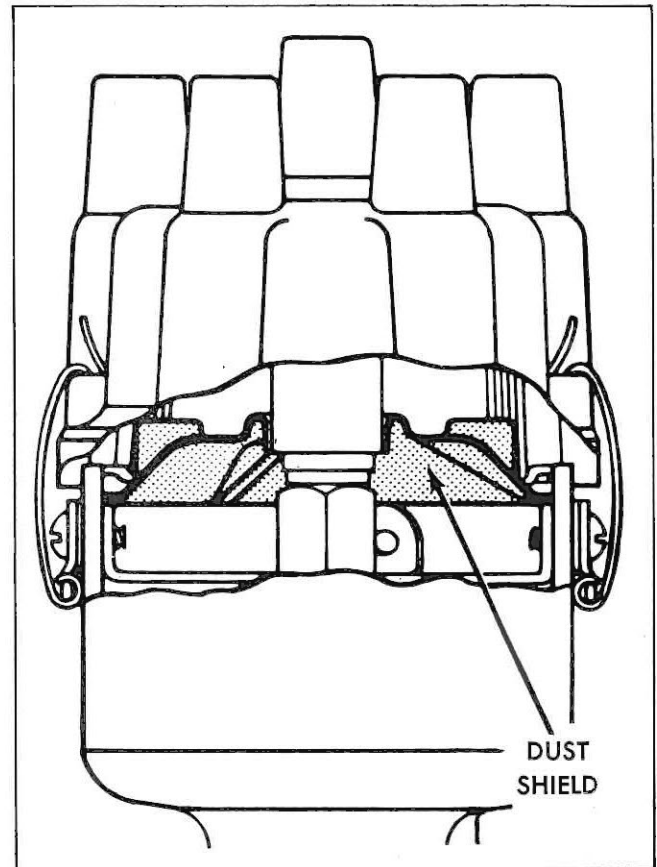
Under extremely dusty operating conditions such as encountered in off-highway driving, it may be necessary to provide additional protection against distributor dust contamination on 6-cylinder engine equipped vehicles. This article lists air vent changes incorporated in distributors of late manufacture, also detailed are recommended service modifications which will extend the service life of distributor contact points, rubbing block and cam, when operating in dusty areas.

Fig. 3—Dust Shield Installed on Six Cylinder Engine Distributors

A Service only, Dust Shield, Part Number 1945388, is available to provide additional protection for all L-6 engines of the 1953 thru 1962 model

years. This shield is easily installed by removing the distributor cap and placing shield over the contact points, as shown in Figure 3.
