Corvette Body Rework For Larger Tires

Truck Brake Master Cylinder Cover Leakage

Truck V-8 Engine Exhaust Valve Sticking

Chevy Van Heater Water Shut-Off

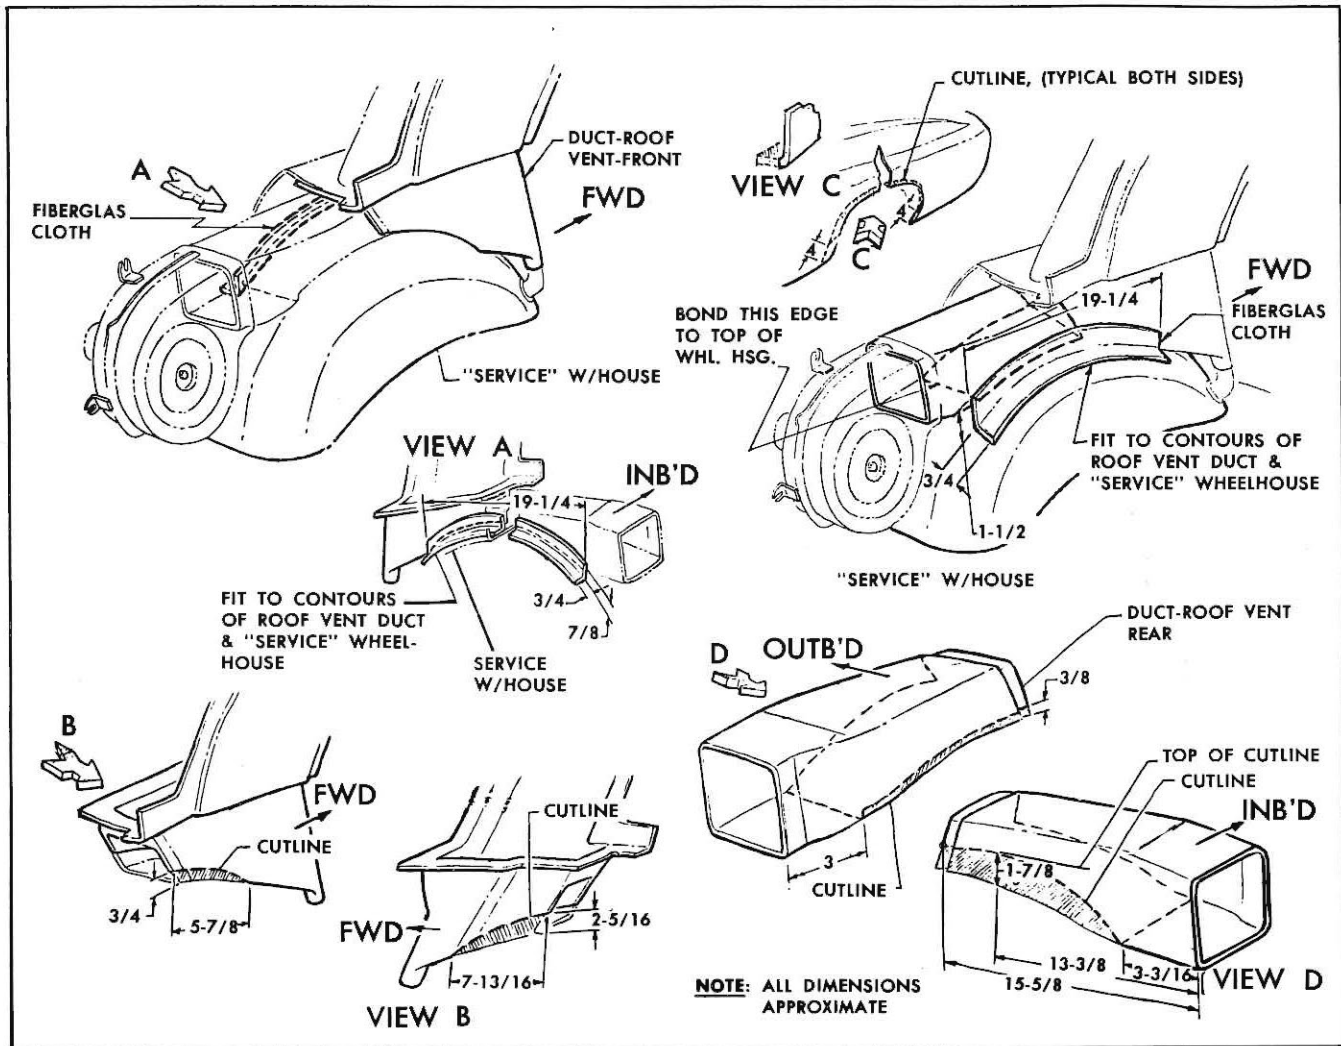
Fig. 2—Rework of 1963-64 Corvette Model 837 for Installation of Larger Tires

Some owners of 1963-64 Corvettes (model 837) may wish to equip their cars with the wide racing type tires without destroying the appearance of the rear quarter panels. Due to body clearances, this is possible on closed models only after rework, and not at all on convertibles, because of interferences which occur with the folding top mechanism.

rework is required to make the larger wheel housing fit under the body rear compartment air exhaust duct. Individual owners may elect to have the exhaust duct system removed instead of going to the expense of the rework. If the rework is undertaken, the efficiency of the rear compartment air exhaust system will be decreased because of the reduced duct area just over the wheel housing.

On closed models, adequate wheel travel clearances may be obtained for 7.10-7.60 x 15 tires mounted on RPO P48 Aluminum Knock-off Wheels (6" rim width) by installing the inner wheel housings which are used in Production with the RPO N03 fuel tank of 35 gallon capacity, and by cutting material away in the wheel openings. These wheel housings are serviced under P/N's 3794441 and 3794442 for the right and left sides respectively. On the left side, considerable

Refer to Figure 2 for details of the installation of the larger wheel housings, the provision of extra clearance between the tire and the wheel openings, and the modification of the body rear compartment air exhaust duct. In those areas where cutting and rebonding of fiberglass is involved, regular shop practices and materials should be used. The use of the materials shown in Group 12.800 of the Chevrolet Parts Catalog is suggested.

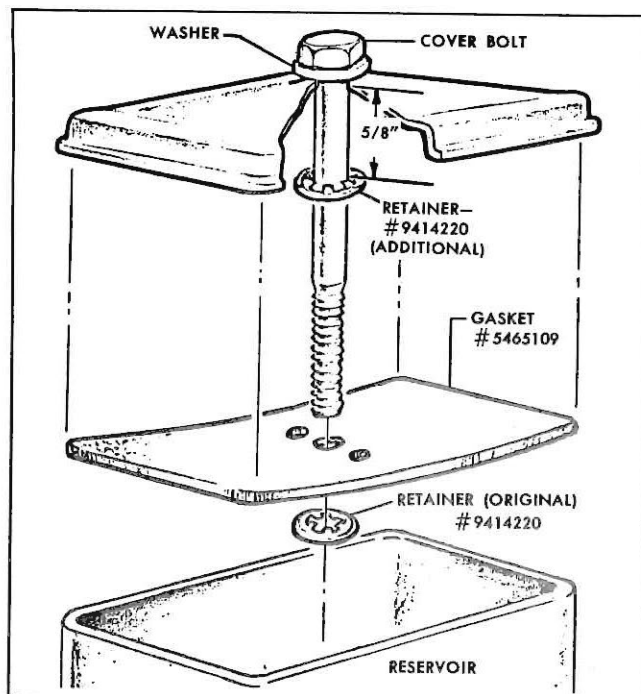
This article provides instructions for a modification that is recommended to avert brake fluid leakage from the rectangular cover used on the brake master cylinder of many 1960-64 trucks. Repeated checking of the brake fluid level has been found to pull the center of the cover gasket upward due to attachment of the gasket retainer to the cover bolt, at the underside of the gasket. Upward movement of the retainer reduces the gasket sealing at the edge and also forms a fluid trap above the gasket, which can result in considerable leakage of fluid out the air vent.

Fig. 3—Rework of Brake Master Cylinder Cover Assembly

To insure proper gasket positioning is maintained so that brake fluid will not be trapped above the gasket, an additional retainer should be installed on the cover bolt; as described below and illustrated in Figure 3.

The original retainer and gasket can be removed by sliding the cover down and off the bolt. Procure an additional Retainer #9414220 and install on the bolt, positioned $\frac{5}{8}$ inch from the underside of the cover. Install Cover Gasket #5465109 (rubber) against the added retainer and use the original retainer underneath to hold the gasket in place. This will position the center of the gasket about $\frac{1}{8}$ inch below the clamping edge of the cover. Assemble the cover to the master cylinder and torque the cover bolt to approximately 45 in. lb. Do not over-torque as it could cause deflection of the cover and result in fluid leakage.

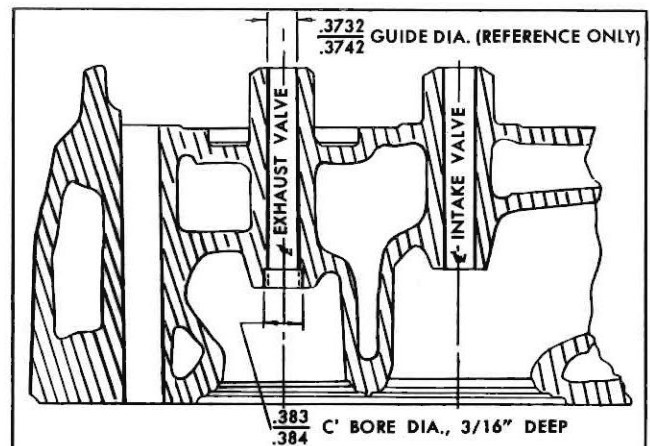
On 348 and 409 cu. in. V-8 truck engines, occurrences of bent or broken push rods can be due to sticking exhaust valves. In those cases where a push rod failure can not be attributed to engine over-speed or other obvious causes, exhaust valve sticking should be suspected.

In many instances when the exhaust valve is removed from the cylinder head in the cold condition, no indication of sticking will be evident. However, valve sticking can be suspected if inspection indicates a carbon build-up in the lower end of the valve guide and the corresponding surface of the valve stem shows carbon streaks or evidence of galling.

Fig. 4—Exhaust Valve Guide Rework

If the above exhaust valve problem is experienced on these engines it can be eliminated by counterboring the lower end of the exhaust valve guides .010" oversize, $\frac{3}{16}$ " deep; as shown in Figure 4. The cylinder heads should be cleaned thoroughly after machining.

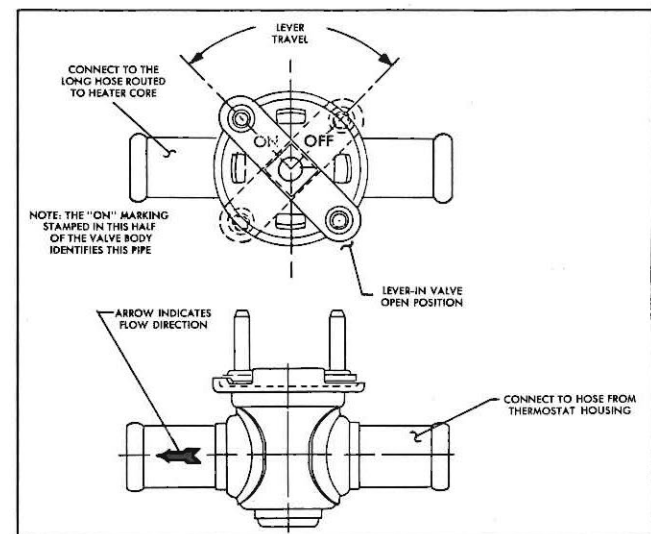
Reports indicate that in many early production Chevy Vans the heater water shut-off valve assembly is incorrectly installed. It is important that this shut-off valve be connected into the heater water inlet hoses with the "ON" marking on the valve body located toward the downstream or heater side of the installation; as shown in Figure 5. If in error,

Figure 5—Heater Water Shut-Off Valve

the valve is connected into the hoses in the reverse direction, it cannot be shut off completely, which would permit hot water flow thru the heater core during warm weather. Check for proper installation of this valve if an owner reports receiving heated air when the valve has been turned off.

NOTE: An arrow stamped into the valve pipe to indicate proper direction of water flow thru the valve, unfortunately is so light on the valves of early manufacture that it will not be detectable on many of these parts.
