Chevrolet SERVICE NEWS

MARCH, 1971

CORVAIR MAINTENANCE—ENGINE FUME ODOR DIAGNOSIS

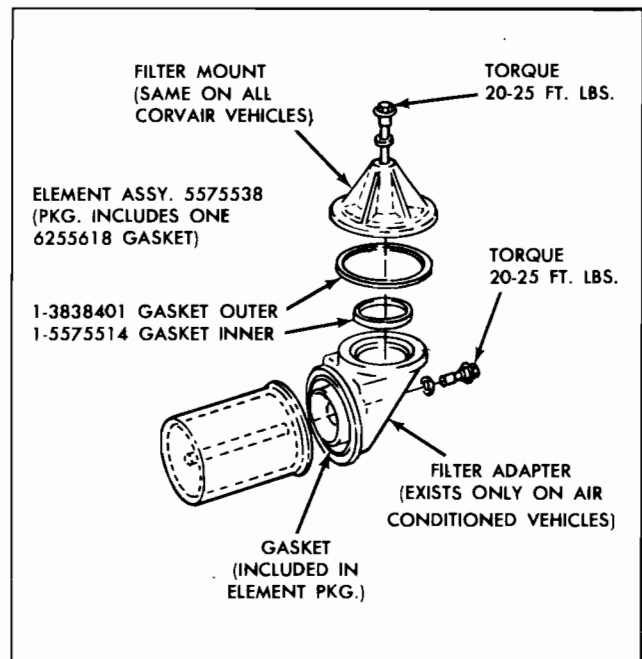
Fig. 3—Corvair Oil Filter

The oil filter on Corvairs equipped with air conditioning and all 1968 Corvairs is mounted horizontally rather than vertically. If the oil filter on these units is removed by itself, excessive oil spillage into the engine shroud will result. Oil in this area is hard to wipe up and leads to an undesirable

Figure 3 shows the engine oil filter installation used on 1961 Corvair passenger cars equipped with air conditioning. To avoid spillage of oil in the engine compartment when replacing the oil filter element; as a unit, remove the element and filter adapter from the filter mount. At the bench, disassemble the element from the adapter casting. When installing the new element assembly use new gaskets at all three locations.

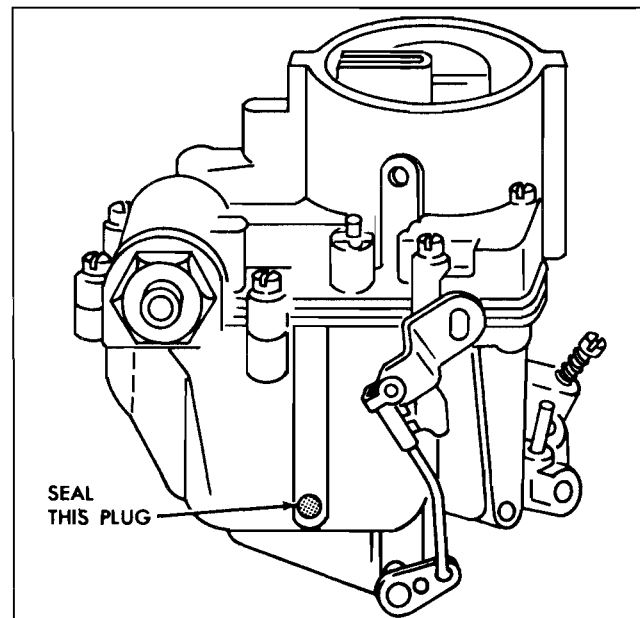
Fig. 4—Aluminum Plug Location

1. Gasoline overflow during filling of tank may flow into the left rocker tunnel causing prolonged fumes to enter the passenger compartment through the fresh air venting system.
2. Leakage at aluminum plug in carburetor bowl (either carburetor on base engine or primary carburetors on 4 x 1 engine) will result in fumes entering through the heater system.

The second condition was corrected at the plants by sealing the aluminum plug (Fig. 4) on

vehicles built after approximate Serial No. 5L-102489 and 5W120745. Early production vehicles can be corrected as follows:

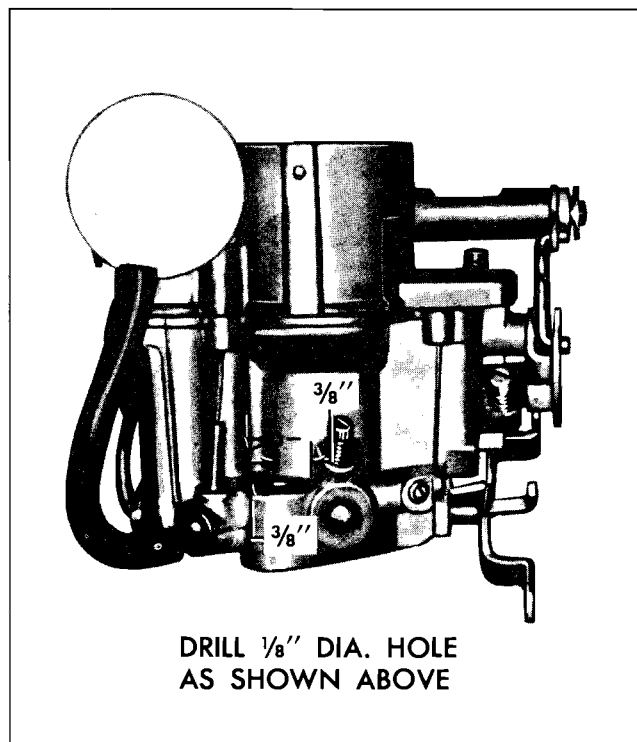
Fig. 5—Drilling Carburetor Vent Hole

Corvair and Corvair "95" engines may be subject to difficult re-starting after the engine has been shut off when hot, for a short period of time. This condition is the result of fuel vapors accumulating in the induction system of the engine.

Hot starting time may be reduced considerably by drilling a $\frac{1}{8}$ " diameter hole through the body of each carburetor as illustrated in Figure 5 to provide a vent.

DRILL $\frac{1}{8}$ " DIA. HOLE AS SHOWN ABOVE

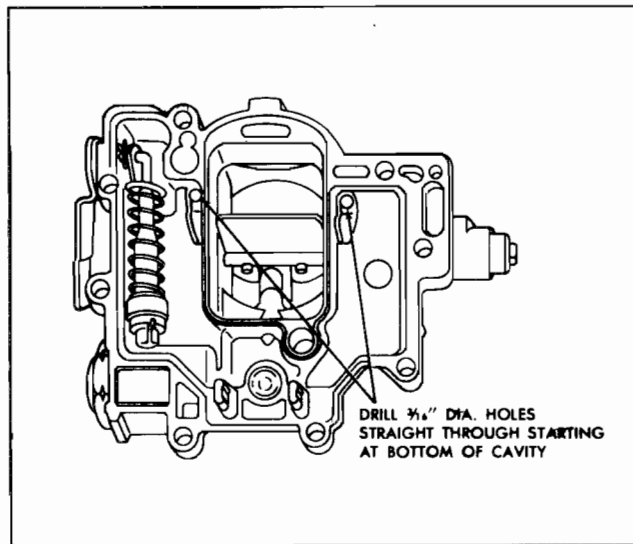
Fig. 6—Vent Hole Location (Inside View)

Corvair or Corvair "95" carburetors may require additional internal venting to improve engine idle and prevent stalling immediately after hot weather and for under the above conditions, additional internal venting may be provided as follows:

1. Remove bowl covers from both carburetors.
2. Invert bowl covers and remove float, float needle and bowl cover gaskets.
3. Drill two (2) $\frac{3}{16}$ " diameter holes in each bowl cover located as shown in Figure 6 on the reverse side. Holes must be drilled straight

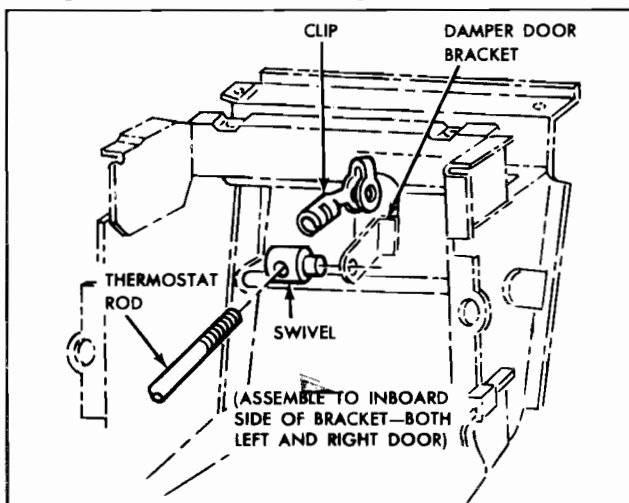
Fig. 8—Thermostat Damper Door—(L.H. Shown)

If the swivel is, in error, assembled to the opposite side of the door bracket, thermostat expansion on vehicle operation would cause a bind at the thermostat stem, resulting in leakage and failure of the thermostat.

NOTE: Operation of the damper doors should be checked whenever a vehicle is in for service, since a damaged lower shroud can cause the door to bind and result in abnormally high engine operating temperatures. The door can easily be checked for binding by manually pulling the door to the full open position.

If damper door adjustment is required, refer to the appropriate Corvair Shop Manual.
