CHEVROLET—CENTRAL OFFICE

TECHNICAL SERVICE BULLETIN

SUBJECT: INTERMEDIATE DOOR HANDLE RUBBER BUMPER
RETENTION - GREENBRIER AND CORVAN MODELS

BULLETIN NO. DR #455

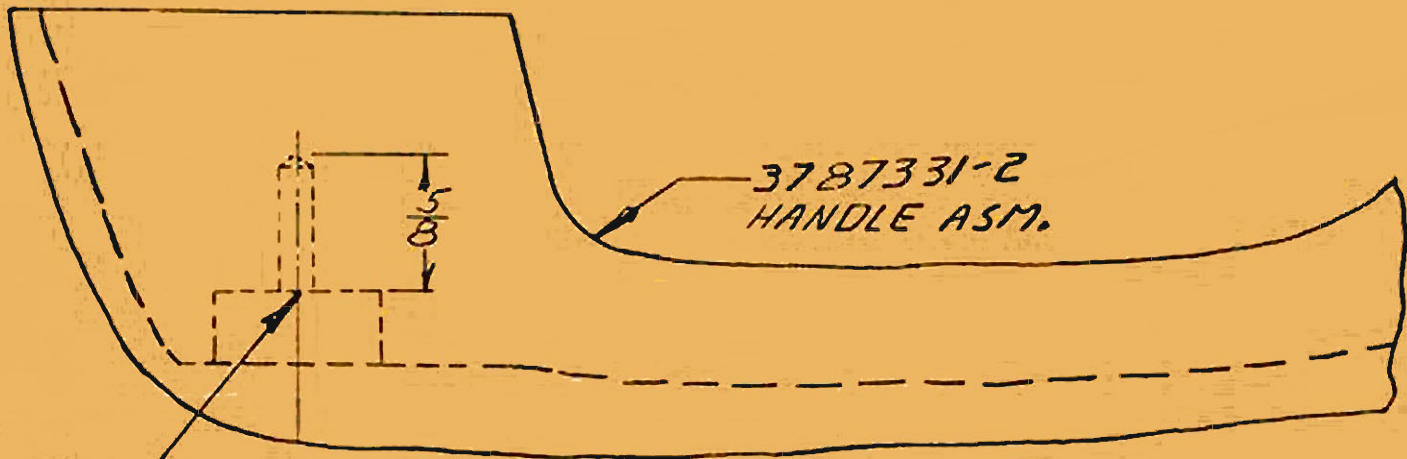
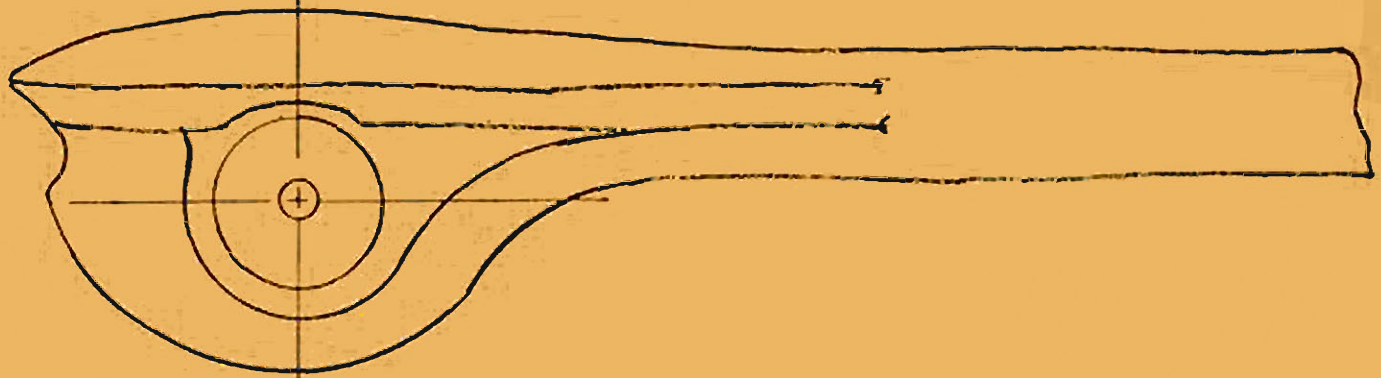
On early production Greenbrier Sportswagons and Corvans, the intermediate Door Handle Rubber Bumper was retained in the handle with cement. In some instances, this retention was unsatisfactory.

USE
1/4 DRILL

1. Rework bumper by drilling a hole through the center with a 1/4" drill. See sketch on Pg. 2.
2. With a #20 drill (5/32" if #20 not available) make a hole 5/8" deep in the center of the door handle. See sketch.
3. Attach the bumper to the intermediate door handle with #178849 screw, making sure that screw is bottomed in hole.
