CHEVROLET—CENTRAL OFFICE

TECHNICAL SERVICE BULLETIN

SUBJECT: TRANSMISSION LINKAGE DEFLECTION AND
EXCESSIVE REVERSE ENGAGEMENT EFFORT
CORVAIR "95" MODELS WITH 4-SPEED
TRANSMISSION

BULLETIN NO. DR # 460

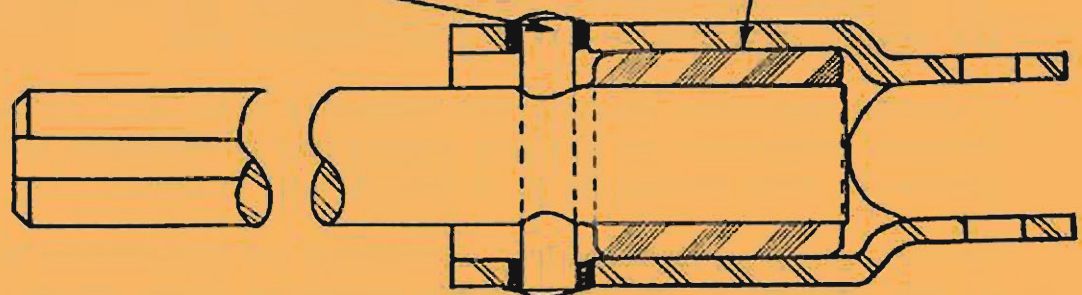
COUPLING REWORKED BY WELDING

Should excessive deflection, resulting in indefinite or poor detent feel exist on early units with the first design coupling, the coupling pin should be arc welded to the coupling bell as shown on Page 2.

NOTE: It is important that the part be quenched in water immediately after arc welding to prevent deterioration of the rubber bushing.

ARC WELD ALL AROUND
BOTH SIDES AS SHOWN

IMPORTANT: WATER QUENCH IMMEDIATELY AFTER
WELDING TO PREVENT DETERIORATION
OF RUBBER
