# CHEVROLET—CENTRAL OFFICE

## TECHNICAL SERVICE BULLETIN

SUBJECT: ACCELERATOR CABLE FREEZE-UP  
CORVAIR "95" MODELS

BULLETIN NO. DR #469

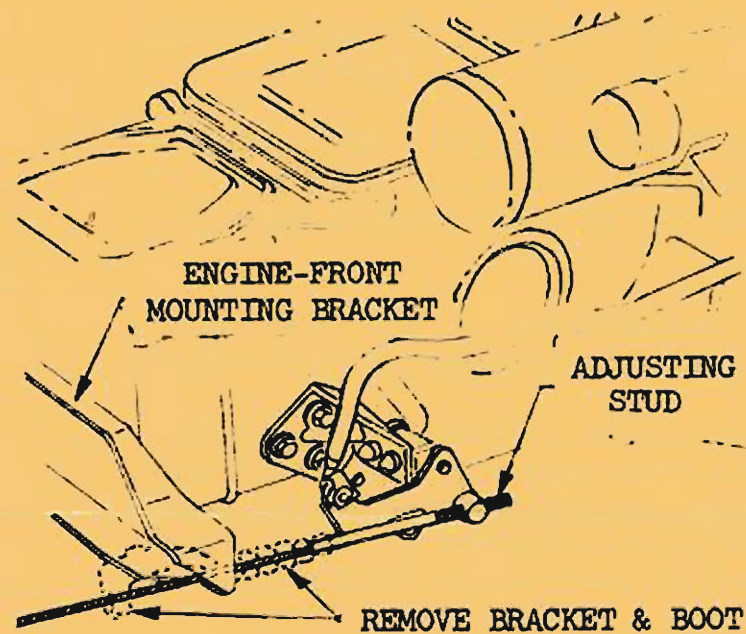
FIGURE 1

In the event accelerator cable freeze-up is encountered on Corvaire "95" Models, the following correction may be performed. It involves removal of the rear half of the cable housing, boot and attaching bracket and thus prevents the accumulation of water and slush around the boot and cable housing at the rear.

5. Lubricate cable with automatic transmission oil and feed cable back through housing. Connect cable to accelerator pedal lever.
6. Drill a  $9/32$ " hole in the flange of the crossmember at the rear of the gas tank 6" from the left hand side rail and  $11/16$ " forward. Remove the cable retaining bracket from the engine front mounting bracket (Figure 1) and install bracket on crossmember flange using the original attaching parts. See Figure 2.

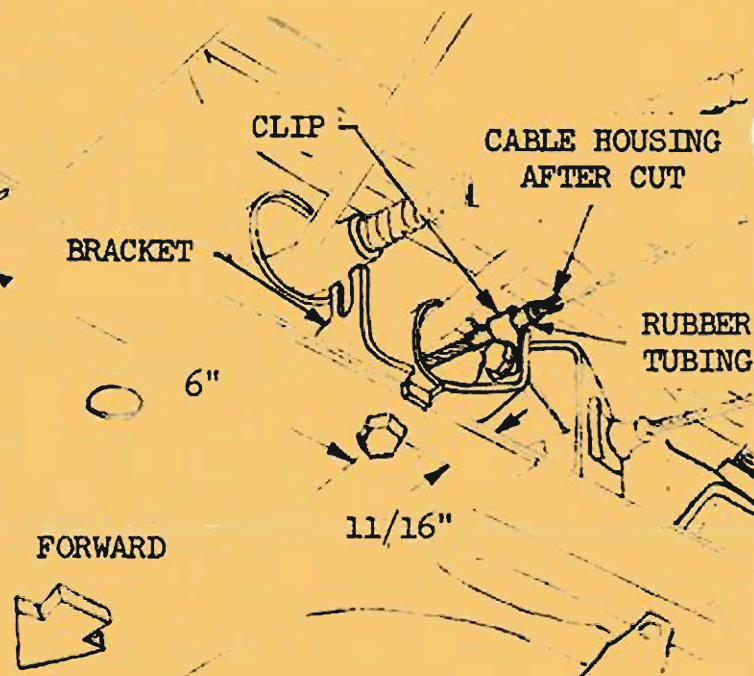
FIGURE 2

**NOTE:** It is important that the cable be retained at this location to prevent a snap or whip to cable that may disengage it from clips over fuel tank. This would subsequently change cable over-all length and adjustment.

3. Using a fine tooth hack saw, cut cable housing off approximately 1" to rear of crossmember behind gas tank. See Figure 2.
4. Discard the rear portion of the cable housing off after first removing the rubber tubing from the housing. Cut a 1" piece of the tubing and slip onto rear end of cable housing back of gas tank.

7. Install Part #3778369 Clip or suitable substitute around the rubber tubing on the cable housing and fasten to the right hand slot of the bracket with a  $1/4$ " - 20 x  $1/2$ " bolt, nut and external tooth star lock washer. Make sure that the housing is retained securely but not crimped when the clip bolt is tightened. See Figure 2.
