CHEVROLET—CENTRAL OFFICE

TECHNICAL SERVICE BULLETIN

SUBJECT: TRANSMISSION GEAR DISENGAGEMENT -
CORVAIR "95" AND GREENBRIER MODELS

BULLETIN NO. DR # 480

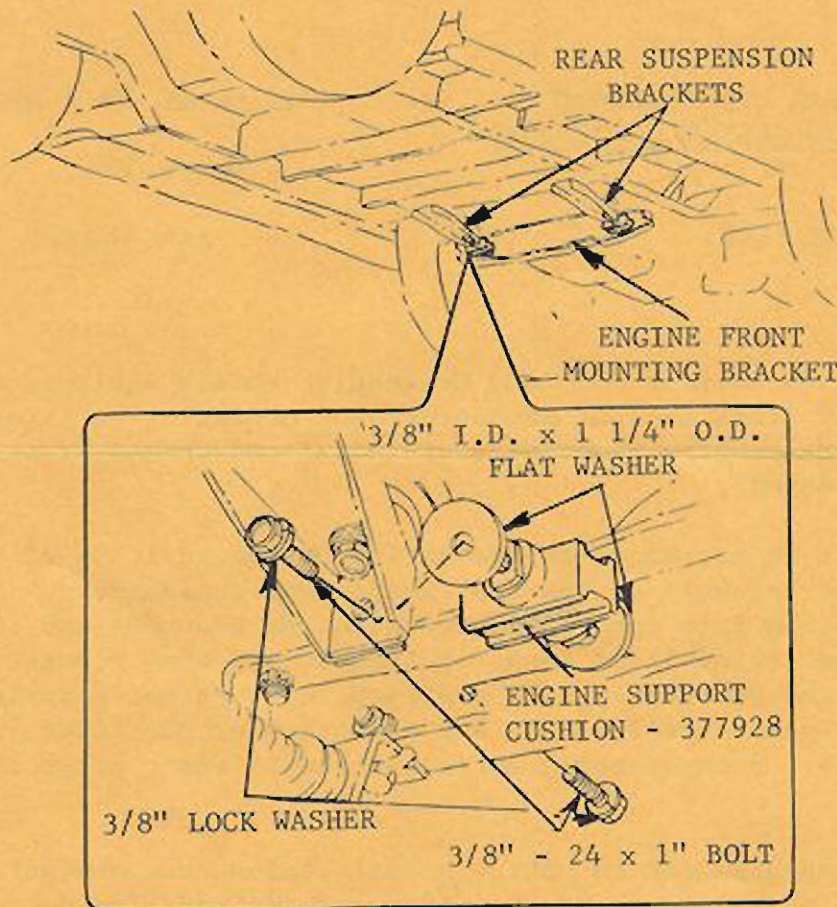
FIGURE 1

Gear disengagement on Corvaire "95" and Greenbrier models equipped with either 3 or 4-speed transmissions may occur when operating on irregular roads or other terrain which produces fore and aft movements of the powertrain in its mounts.

On 4-speed transmission models, install an engine support cushion 377928 with a 3/8" I.D. x 1 1/4" O.D. flat washer at each end between the rear suspension crossmember supports and engine front mounting bracket (Fig. 1). Secure the cushion with a 3/8" - 24 x 1" bolt and 3/8" lockwasher at each end tightened to approximately 20 ft.-lbs.

On 3-speed jobs, the same procedure applies except it will be necessary to add sufficient additional 3/8" flat washers between the ends of the cushion to completely fill the area between the support bracket and engine front mount. Extra washers should be added equally at each end of cushion. It is essential that the space be completely filled in order to effectively eliminate any forward movement of the powertrain.
