CHEVROLET-CENTRAL OFFICE

TECHNICAL SERVICE BULLETIN

SUBJECT: DIFFICULT COLD WEATHER STARTING -
1961-62 CORVAIR "95" MODELS

BULLETIN NO. DR #528

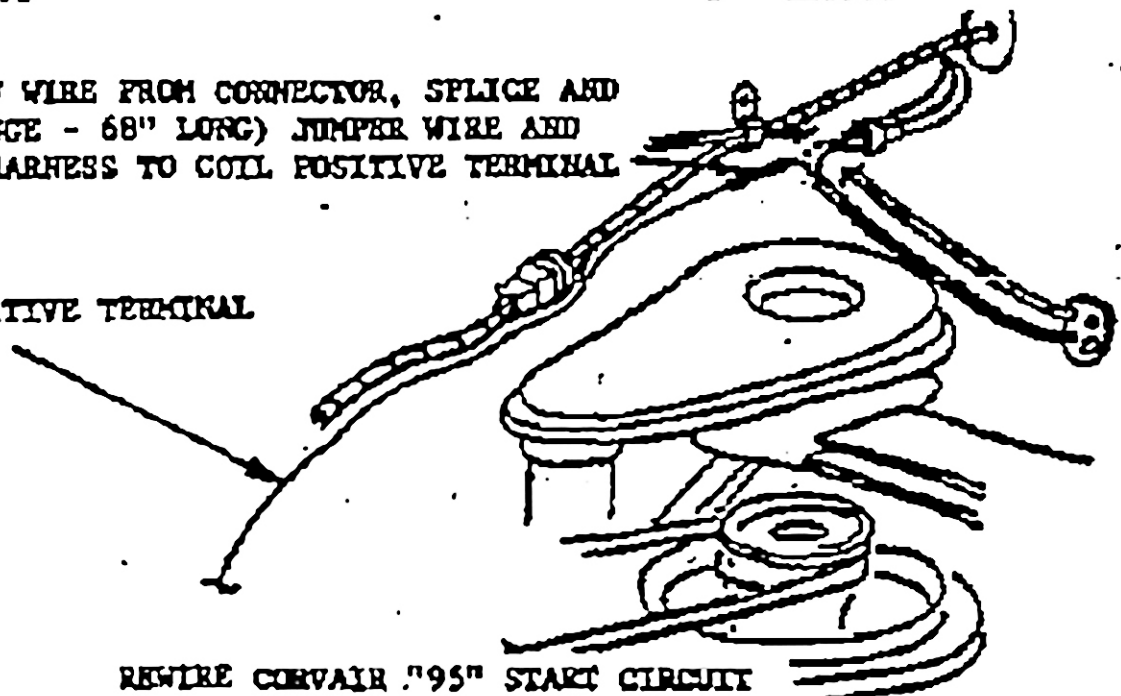
REWIRE CORVAIRE "95" START CIRCUIT

Difficult starting during cold weather on 1961-62 Corvaire "95" models, even though the engine cranks readily, may be due to only partial voltage being delivered to the engine ignition system. The normal ignition circuit includes a resistance wire, while the starting circuit should by-pass this resistance and furnish full voltage for starting. On Corvaire "95" models, this resistance was not being by-passed for starting and consequently, only the normal 6 to 7 volts was being supplied.

In the event this condition is experienced on 1961 and early 1962 vehicles, attach one end of a jumper wire (16 gauge - 68" long) to the yellow lead from the starter solenoid and the other end to the coil positive terminal as shown in the following sketch. This provides a by-pass of the resistance wire while on the starting circuit. Both wires (resistance and jumper) should be attached to the coil positive terminal.

DISCONNECT YELLOW WIRE FROM CONNECTOR, SPLICE AND
SOLDER TO (16 GAUGE - 68" LONG) JUMPER WIRE AND
ROUTE WITH MAIN HARNESS TO COIL POSITIVE TERMINAL

TO COIL POSITIVE TERMINAL
