CHEVROLET—CENTRAL OFFICE

TECHNICAL SERVICE BULLETIN

RELOCATION AND REVISED OIL PRESSURE
SUBJECT: SENDING SWITCH - 1961-62 CORVAIR
AND CORVAIR "95" MODELS

BULLETIN NO. DR #538

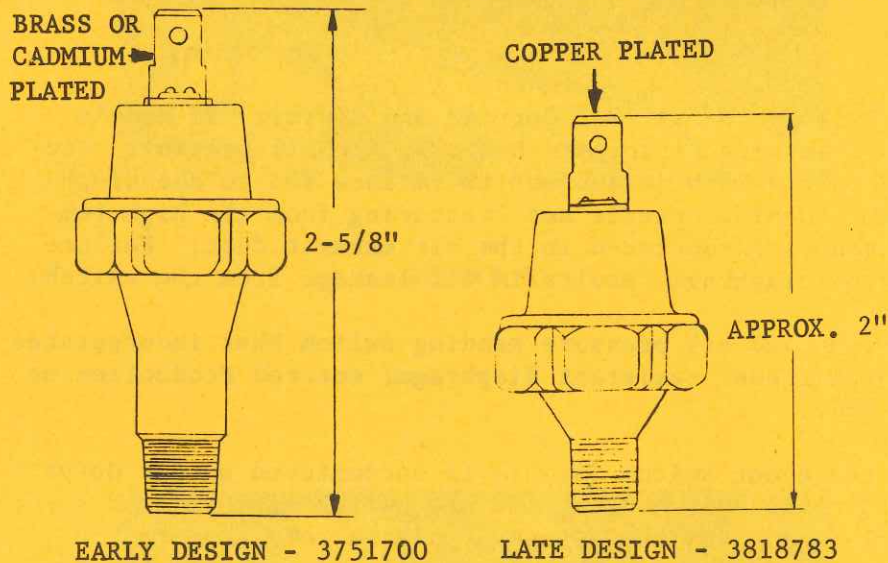
FIGURE I

The new switch Part No. 3818783, has an overall length of approximately 2" from connector tip to the end of the threads as shown in Figure 1. The connector terminal is copper plated as an additional means of identification.

An early design oil pressure switch as shown in Figure 1, with an overall length of 2 5/8", was used on all Corvair and Corvair "95" engines built prior to 8/31/61, except vehicles equipped with air conditioning. Vehicles equipped with air conditioning used an interim switch which has the same overall length as the late design switch, except the connector terminal is brass or cadmium plated. This switch was also used on all Corvair and Corvair "95" engines built from 8/31/61 to 11/8/61.
