CHEVROLET—CENTRAL OFFICE

TECHNICAL SERVICE BULLETIN

SUBJECT: HOT WEATHER IDLE - 1961-62 CORVAIR
AND CORVAIR "95"

BULLETIN NO. DR #546

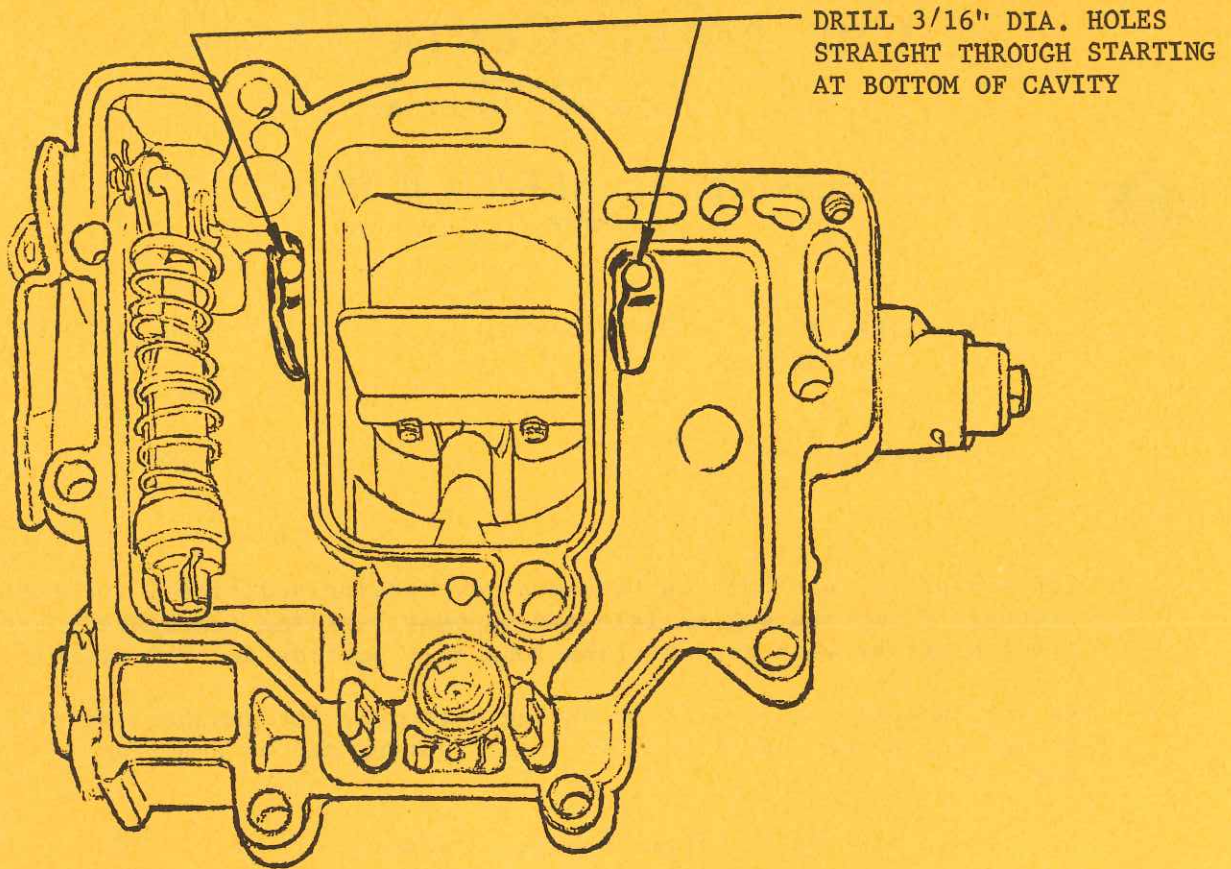
FIGURE 1

Corvair or Corvair "95" carburetors may require additional internal venting to improve engine idle and prevent stalling immediately after a hot start or when encountering long idle periods in slow traffic.

1. Remove bowl covers from both carburetors.
2. Invert bowl covers and remove float, float needle and bowl cover gaskets.
3. Drill two (2) 3/16" diameter holes in each bowl cover located as shown in Figure 1 on the reverse side. Holes must be drilled straight through to break out inside the air horn as shown in Figure 2.
4. Clean out all chips, remove burrs and reassemble the carburetors.
