TECHNICAL INFORMATION

SUBJECT	INFORMATION				
<p>POSITRACTION CHATTERING NOISE - 1963 C AND P-10 SERIES VEHICLES</p>	<p>1963 C and P-10 Series vehicles equipped with RPO G80, positraction rear axle may be subject to a severe rear axle chattering noise when turning a corner.</p> <p>Effective in production approximately March 1, 1963, the above positraction equipped vehicles will use a special hypoid rear axle lubricant.</p> <p>The chattering noise complaint may be eliminated on vehicles built prior to the above date by draining the factory fill rear axle lube and refilling with G. M. Positraction Grease, Part No. 3758791.</p> <p style="text-align: right;">4/8/63</p>				
<p>CHEVROLET 2-SPEED REAR AXLE VACUUM SELECTOR CONTROL COMPONENTS</p>	<p>The following component parts of the vacuum-operated Chevrolet 2-speed rear axle control assembly are available for Service, thereby eliminating the necessity of replacing the entire assembly in the event difficulty is experienced with the speedometer switch, switch housing or vacuum selector cables.</p> <p>PART NUMBER</p> <table border="0"> <tr> <td style="padding-right: 20px;">3846490</td> <td>Switch Assembly - Electric Speedometer Adaptor</t

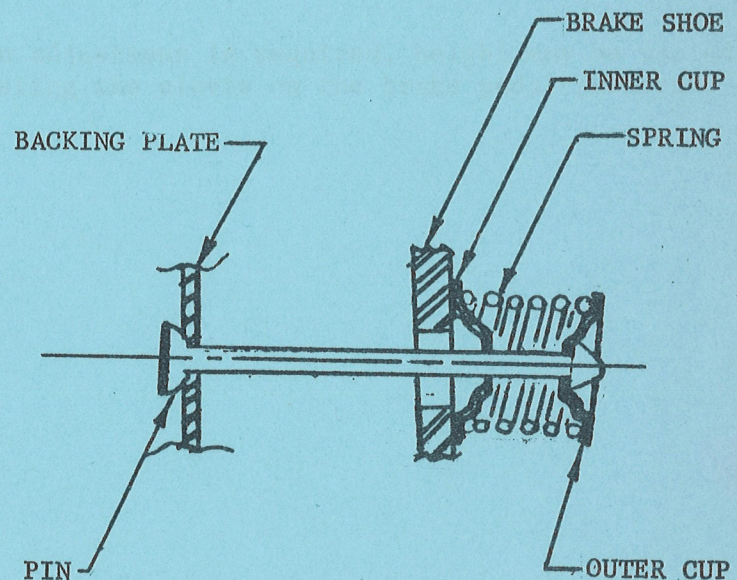
A loud metal to metal grinding noise at low speeds may be heard on a few 1962-63 Corvair and Chevy II models equipped with metallic brakes.

If this condition is encountered, check the brake shoe for proper retension (as shown below). Omission of the brake shoe hold down inner cup will result in excessive looseness of the brake shoes to backing plate.

This cup is available as part of Service Kit #3792385 which includes the hold down show pin and spring.
