TECHNICAL SERVICE BULLETIN

SUBJECT: FRONT PINION SHAFT OIL SEAL LEAKAGE -
1960-63 CORVAIR W/POWERGLIDE

BULLETIN NO. TSB #886
DR #590
SECTION IV

DATE May 1, 1963

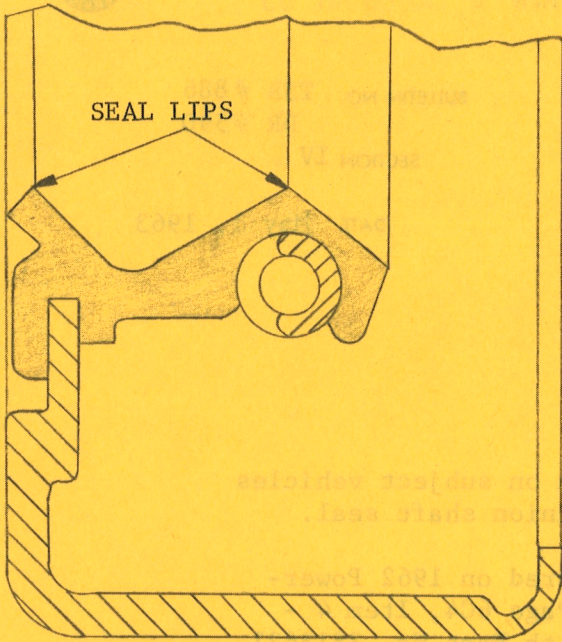
1962-63 3813621

Axle lubricant leakage into the transmission on subject vehicles may be due to a faulty or worn axle front pinion shaft seal.

In cases where a leakage problem is encountered on 1962 Powerglide axles, the existing single lip seal (Page 6C4, Item 4 - 1961 Corvaire Shop Manual) may be replaced with Part No. 3813621 double lip seal. On 1960-61 Powerglide axles, the existing Part No. 6256074 single lip seal should be installed with the lip pointed toward the axle as shown on Page 2 of this Bulletin.

Sealing lip with garter spring must be installed toward axle -
 Both type seals. Care should be taken when installing the seal
 not to distort the metal seal housing.
