FC Fire Company Greenbrier Restoration August 06, 2016

This remarkable story begins with someone sending to me on May 12, 2016, scans of several Corvair 95 window stickers and car shippers for my ECL decoding project (the originals have gone to Dave Newell). Among these was the car shipper for a 1963 8-door Greenbrier sold to the Malden West Camp Fire Company in Saugerties, NY. It was a very interesting FC, with an optional (but non-RPO) engine. Twelve days later, my good friend Ed Bittman emailed that he has spied several Corvair cars and FCs on Craigslist in a neighboring Florida city, which he soon visited and dutifully reported back the FC VINS and data plate codes. Incredibly, one of them is the Malden West Camp Fire Company van! After some tough haggling with the owner, we decided to buy it. Ed made the initial purchase, and then sold it to me. I just had the van flat-bedded to Marietta, OH.

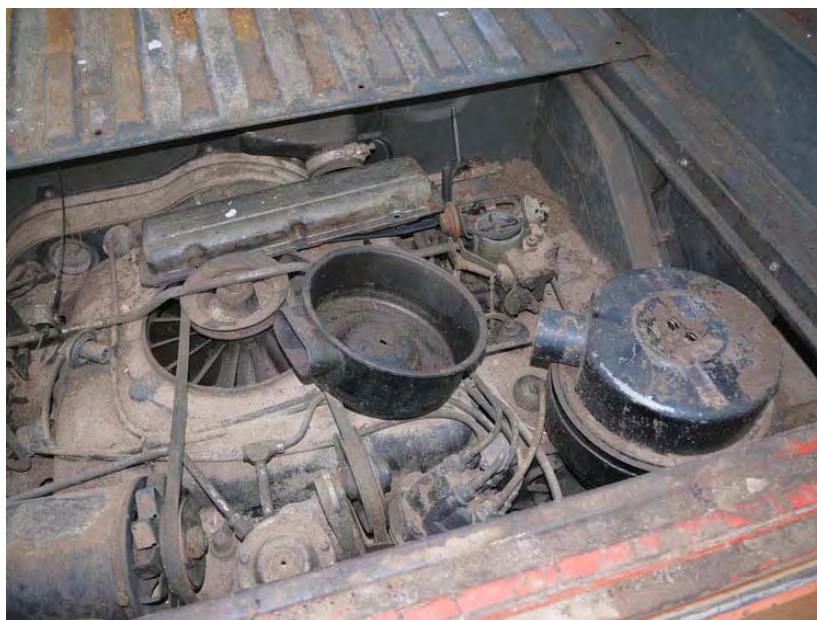
Visually, the engine is in very rough shape, it is caked in silt and debris, and may have been inundated in a flood. Disassembly will show the actual state of affairs, but a cursory inspection shows dirt but little rust. The pre oil bath cleaner, listed in the car shipper, is still present.

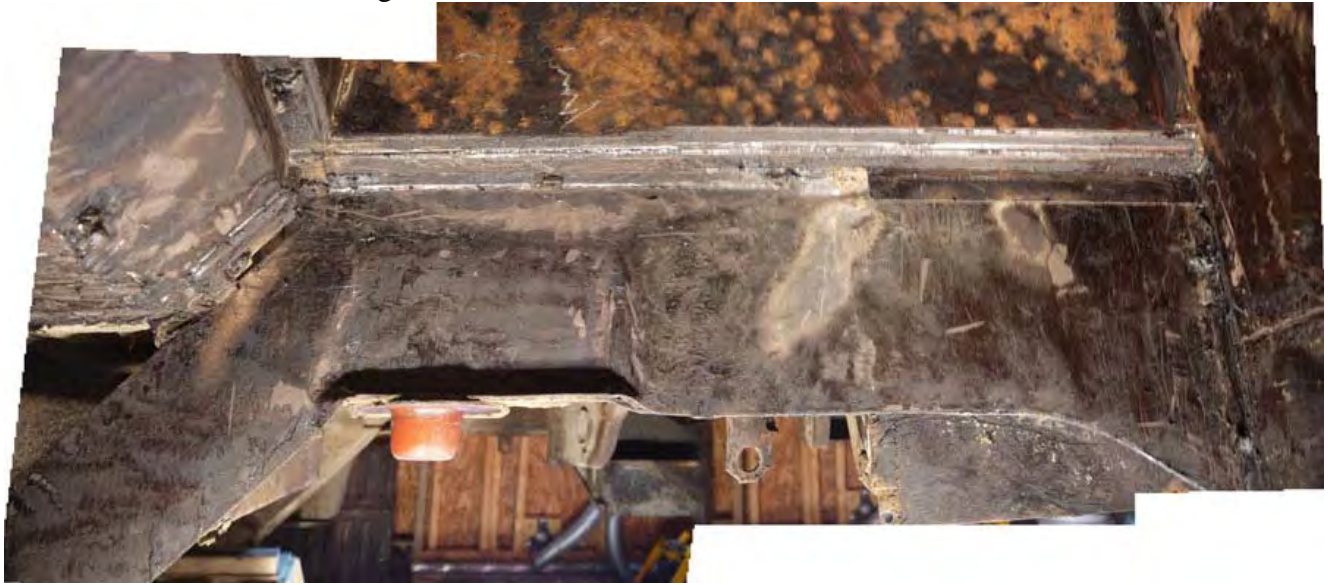
Here the same area after being multitooled:

The multitool does not remove all the undercoating, but certainly the bulk of it. And there are areas that cannot be reached with the tool, and these required brute force heating and scrapping with a stiff putty knife. Any remaining undercoating needs to be removed with stripper and solvent. I start with aircraft stripper - wear a respirator and arm-length rubber gloves (available at HF) when using this stuff. I found the "odor-free" type actually worked better than the regular formula. Aircraft stripper works slower on undercarriage paint. The paint softens and dissolves, but does not bubble up. Give it 5 - 10 minutes to work. If you're going to do this right, going to bare metal in most areas is important to assess where and how much rust is present, and dealing with it before repainting.

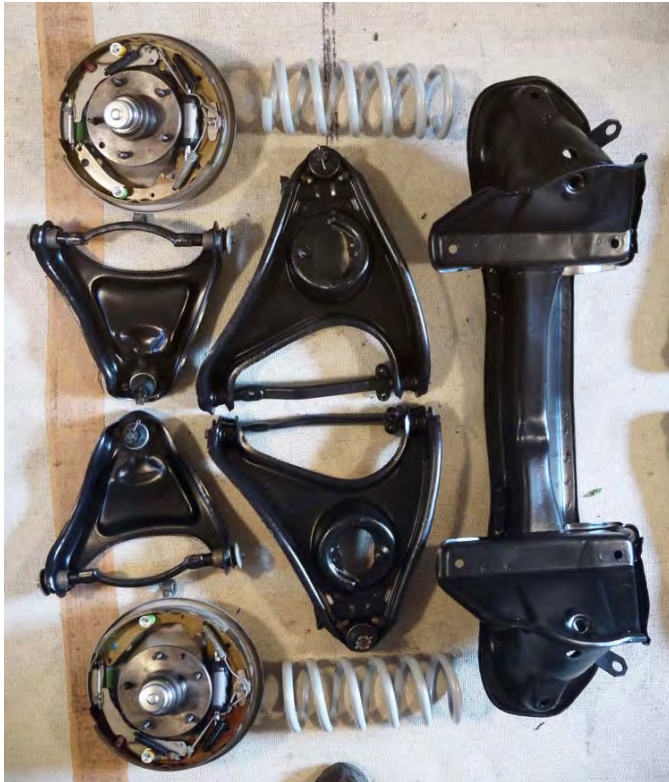
So other projects... The suspension is almost ready for reassembly. Had a real bugger of a time pressing in the bushings on one of the front lower control arms; all the rest went in fine, but for whatever reason, the two sleeves were slightly out of alignment and the bushings would not go in. Ended up warping the sleeve rims beyond repair and gave up; got a replacement from the Corvair Ranch (bushing went right in). Here's the front suspension

Still deciding whether the springs will be black or metallic, but I think they'll be metallic with appropriate color stripes. As you can see, brakes also have been rebuilt. Flanges and were blasted, primed, and painted. As previously mentioned I'm using Eastwood "Detail Gray" on the stamped steel parts (such as the flange) and "Spray Gray" on the cast parts (such as the steering knuckle control arms).

Complete rebuild of the brakes themselves; and new front wheel bearings. Found exact match for the cylinder to brake pad rods at the local NAPA (the car rods are different). The only parts reused were the emergency brake components and the automatic adjuster screws, two of these needed thorough derusting and cleaning.
