FC Fire Company Greenbrier Restoration August 06, 2016

This remarkable story begins with someone sending to me on May 12, 2016, scans of several Corvair 95 window stickers and car shippers for my ECL decoding project (the originals have gone to Dave Newell). Among these was the car shipper for a 1963 8-door Greenbrier sold to the Malden West Camp Fire Company in Saugerties, NY. It was a very interesting FC, with an optional (but non-RPO) engine. Twelve days later, my good friend Ed Bittman emailed that he has spied several Corvair cars and FCs on Craigslist in a neighboring Florida city, which he soon visited and dutifully reported back the FC VINS and data plate codes. Incredibly, one of them is the Malden West Camp Fire Company van! After some tough haggling with the owner, we decided to buy it. Ed made the initial purchase, and then sold it to me. I just had the van flat-bedded to Marietta, OH.

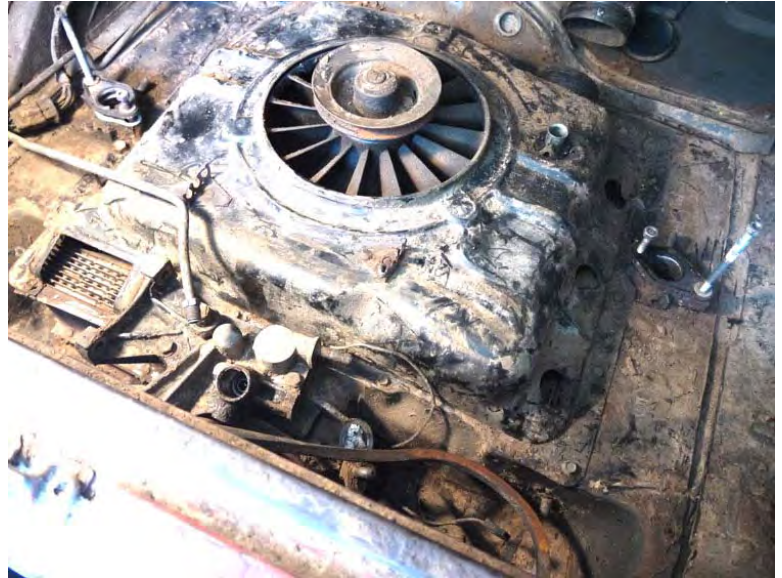
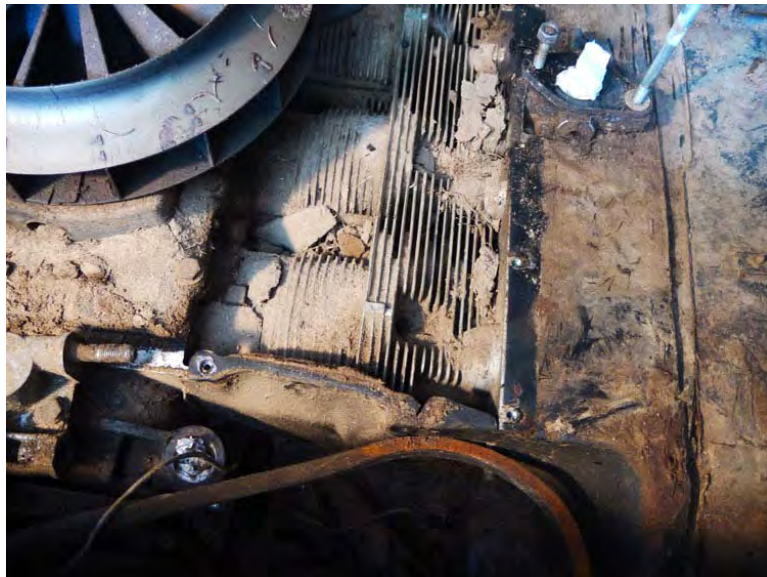
With the top shroud removed, sediment underneath was revealed

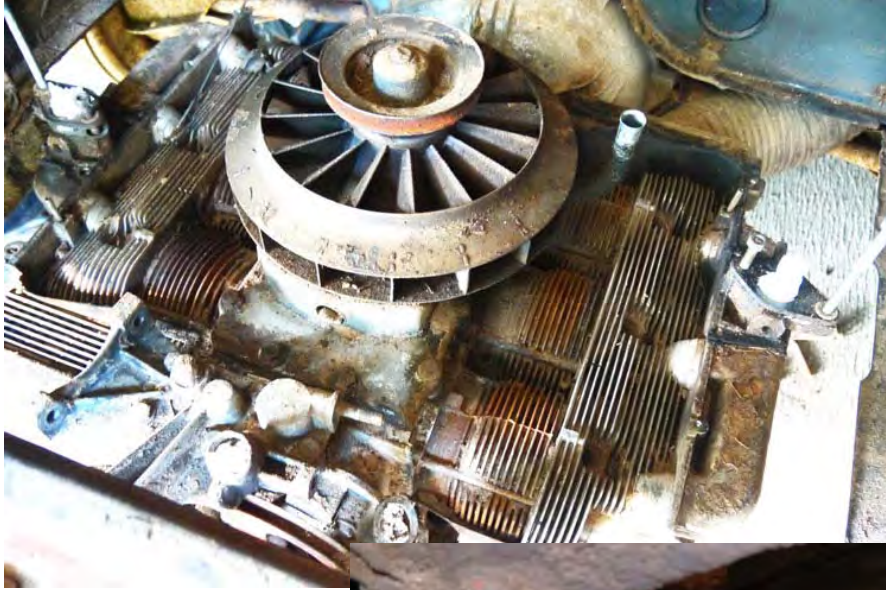
Here's the engine exposed and vacuumed clean (more or less).

Next steps will be to remove the oil pan and crankcase cover, examine the condition of the connecting rods, and then drop the powertrain. There is only a layer of greasy scum in the oil pan. The engine arrived with the spark plugs and the valve covers removed, and this has left the rocker arms, push rods, etc. well oxidized. I've been researching past Forum threads on removing rusted head nuts.

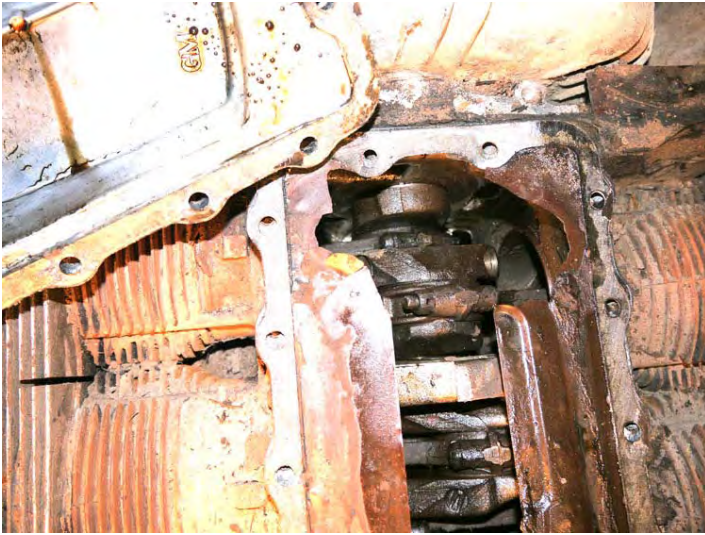
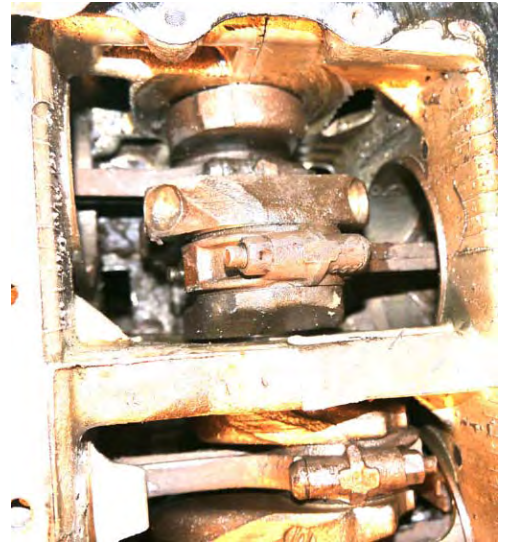
- 1) Damage to the crankcase vent assembly over rods 5 & 6
- 2) But no visible damage to rods 5 & 6

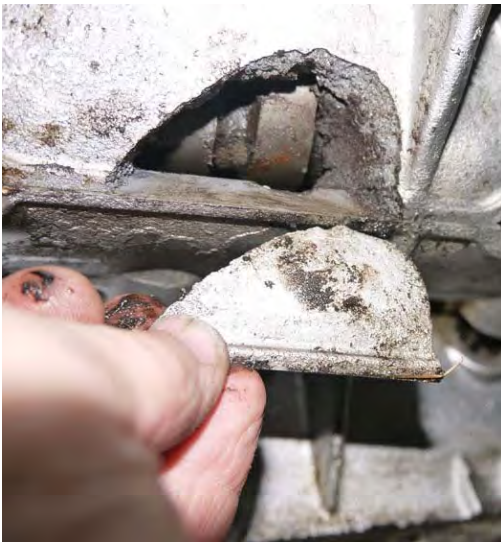
- 3) A hole punched through the bottom of the crankcase left side below rods 5 & 6
Oh, and by the way, can this be repaired through aluminum welding?

It seems that a foreign object shredded the sheet metal of the crankcase vent assembly. The metal pieces were battered about violently enough to punch a hole through the crankcase. I hope to soon know if there has been any other damage.

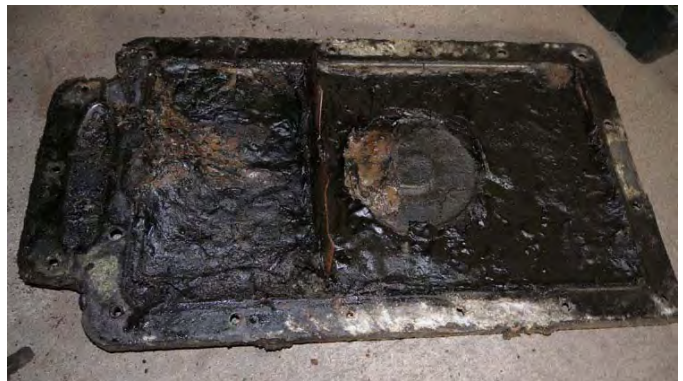
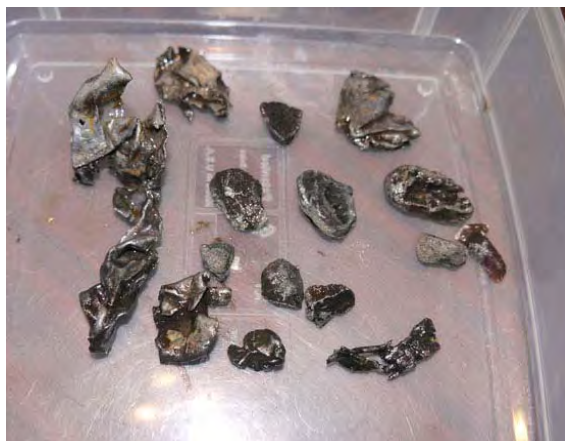
The oil pan seems to have taken a trip through the LeBrea Tar Pits -- it was packed with sludge over an inch thick in some places.

A careful excavation found no extinct mammals but did yield a multitude of foreign objects. These include small pebbles and a variety of metal pieces, mostly contorted sheet metal

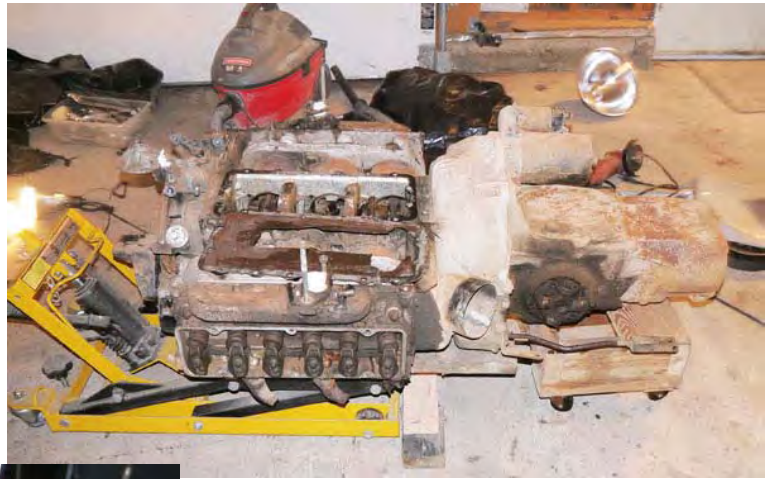
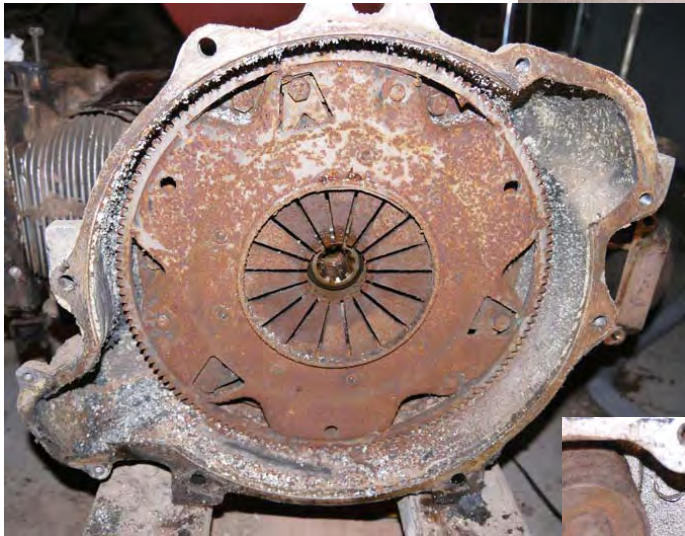
Separating the front end shows the clutch is in bad shape. Seems to me to be rusted beyond reprieve? Ditto for the starter

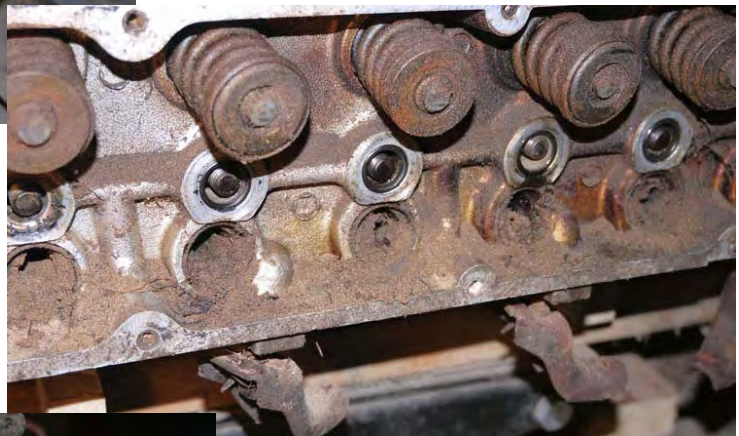
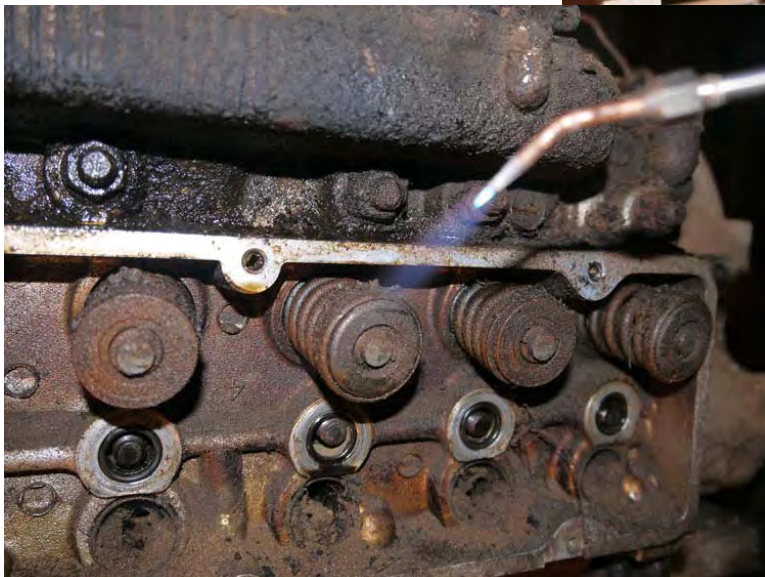
The rocker arms/lower cylinder head nuts came off very easily, and revealed push rod tubes containing more (much more) than just push rods.

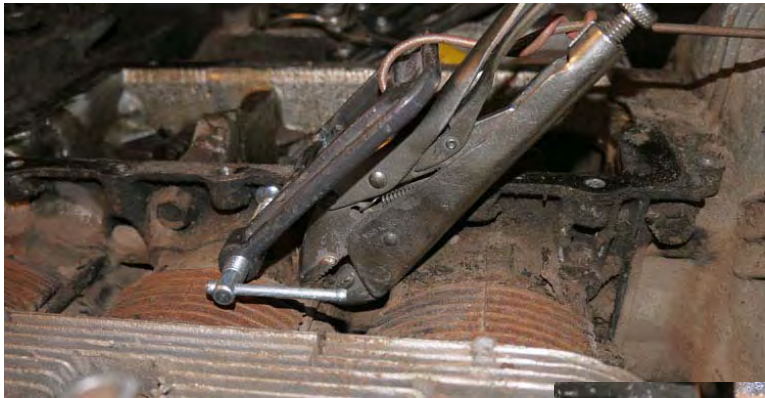
The upper cylinder head nuts and the ends of the bolts were seriously rusted. I tackled these with serious heat, and lube. I used my Smith mini-torch, which used map gas and O₂ (I've got it connected to a large O₂ cylinder).

The head bolts were locked in place as best possible with a vice grip and other apparatus to prevent rotation. After torching the nut for 1-2 minutes, it was sprayed with a penetrating lubricant and then ratcheted off. Sometimes the nut had to be reheated 2 - 3 times.

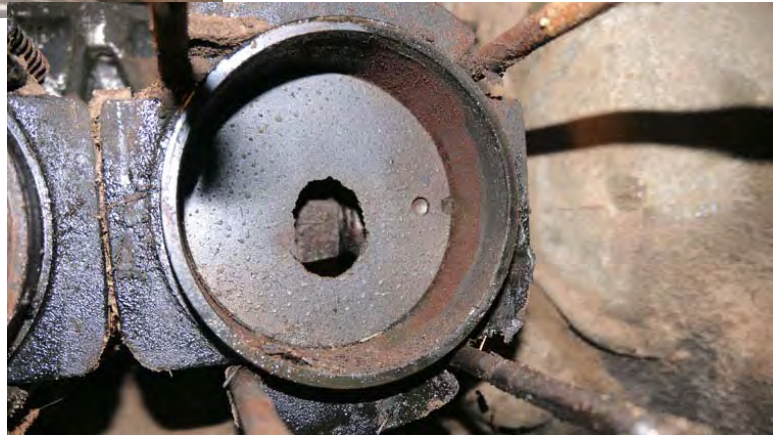
11 -12 nuts were removed successfully, one bolt unscrewed from block (I'll replace with over-sized one). And what did I find when the heads were pulled...? Three of the pistons have holes in them, like this

So what would cause holes in half the pistons? I've heard that detonation will do this, but in three? I'm pretty sure that it was metal from the pistons that damaged the crankcase vent assembly and the block. Fortunately, I see no other damage to the crankcase. The pistons were seized in the cylinders, but after I removed the cylinders the crankshaft could be rotated with a ratchet on the pulley nut.

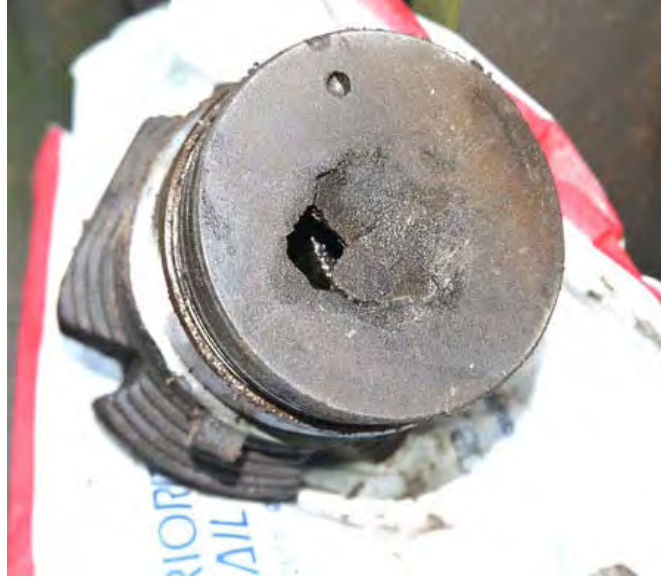
Here's some other pictures of the damaged pistons. For all three damaged pistons, the crown has been blown downward, which is clearly shown here

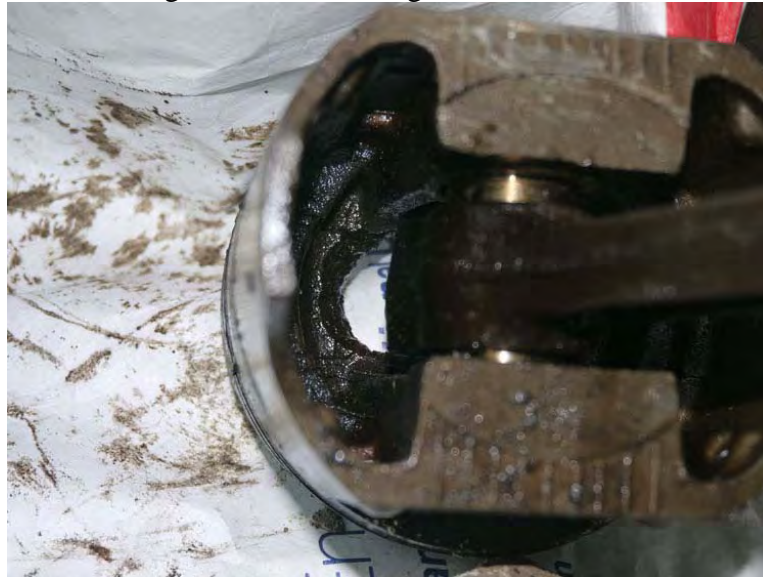
This is the rear; again, punched down from the combustion chamber. I see no damage to the connecting rods

So what would cause this type of piston damage but leave the heads undamaged??

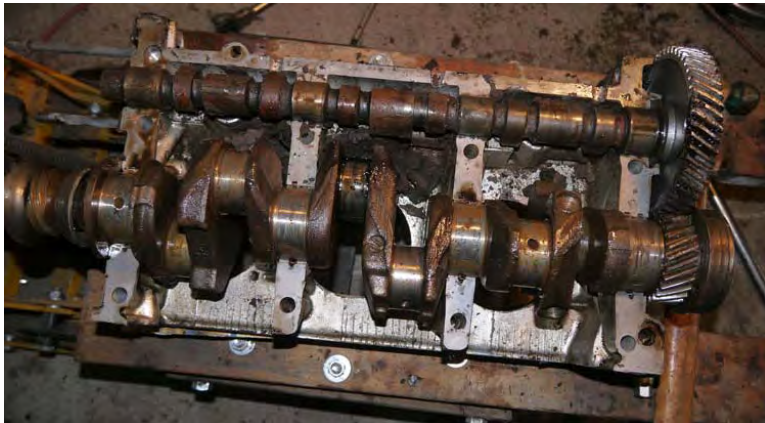
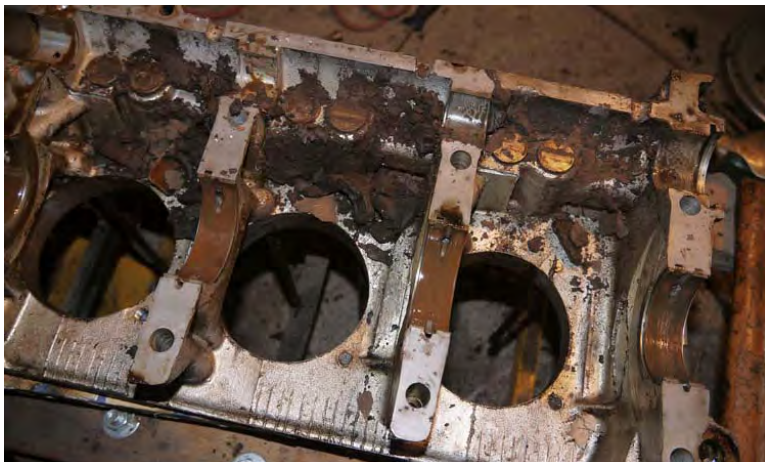
Split the crankcase; crankshaft looks good; still covered with oil, but camshaft is dry and some cams show surface rust - I'm assuming this will need to be replaced

Lots of dried muck around camshaft and lifters, which were seized. I had to tap, sometimes firmly, to get lifters out.

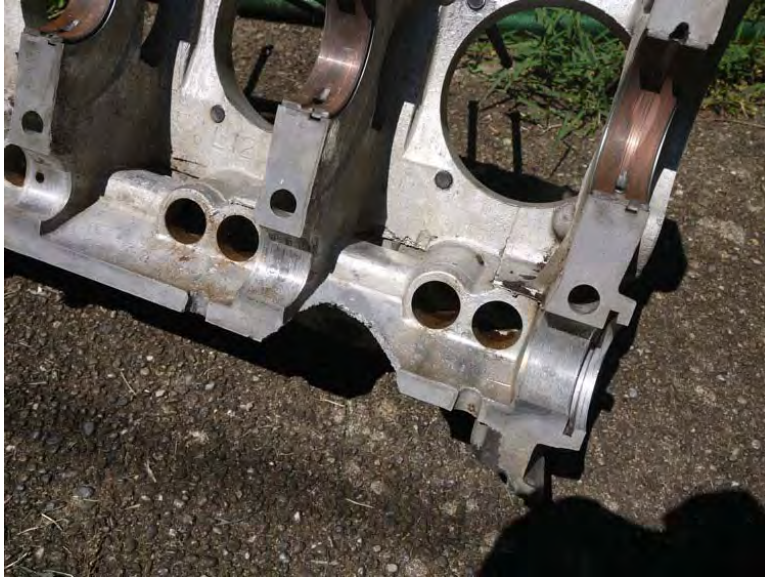
Here's the damaged crankcase half cleaned up. I saw no other significant damage.

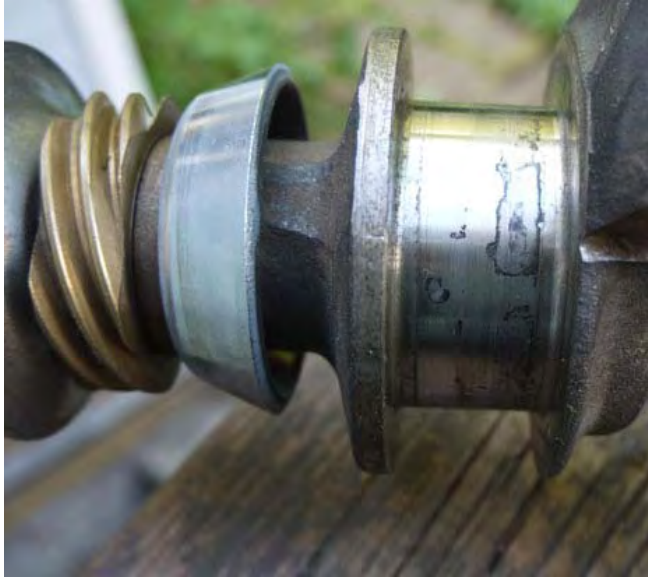
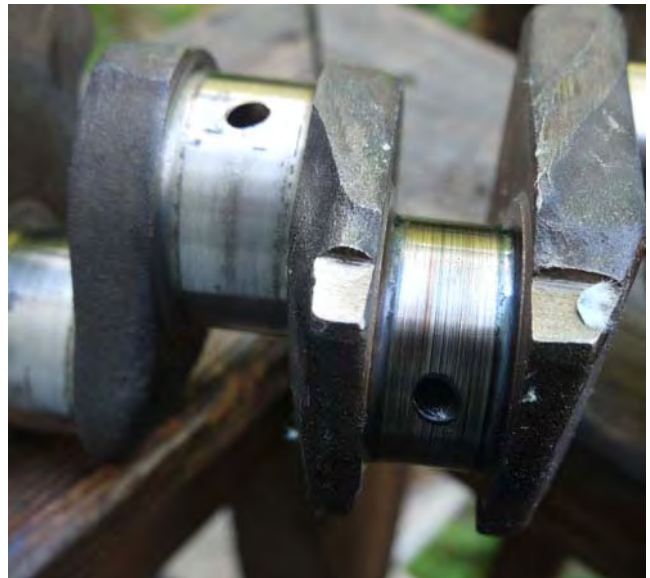
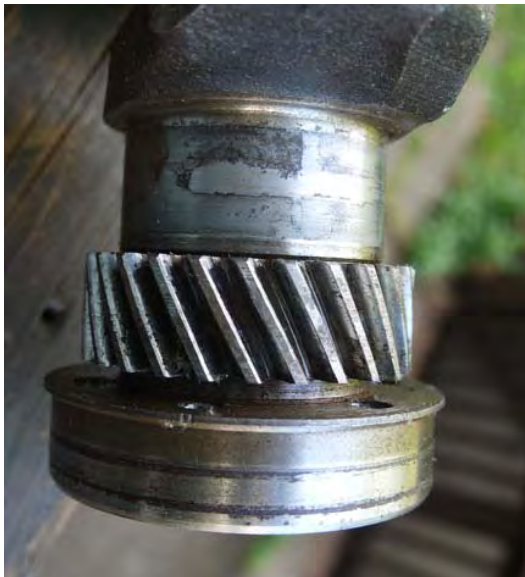
Closer inspection shows that the crankshaft has some scoring, and as per the discussion on the Engine Bearing thread, it needs to be turned or replaced.

I've decided to have it turned. My machine shop guy says the staining of the main journals is evidence of moisture (I never mentioned likely engine flooding), which he said also necessitates a regrind. Plan is for a 0.01 or 0.02.

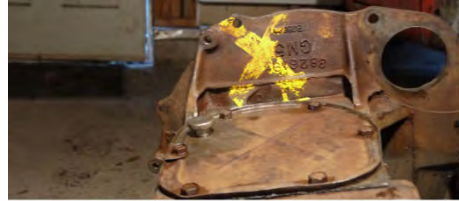
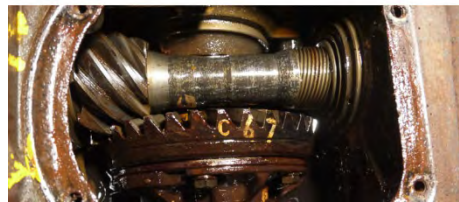
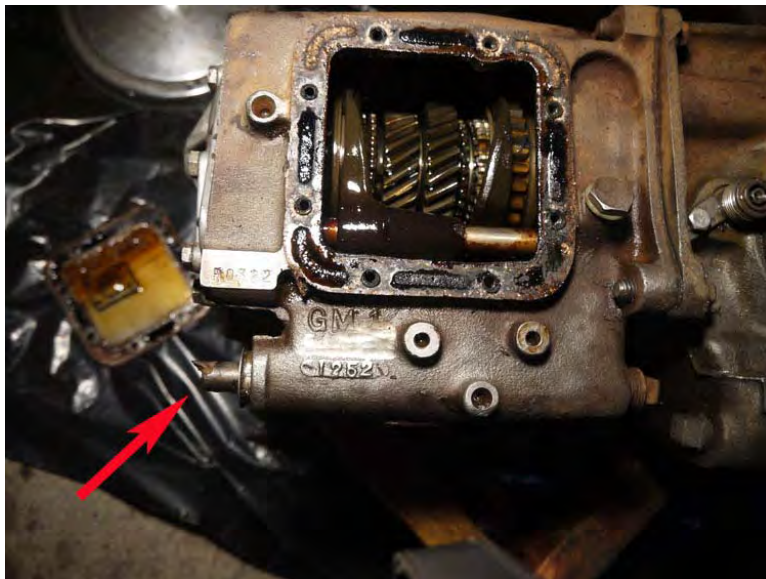
Can anyone identify in the following pictures the big yellow 'X' on the differential carrier case, the metal tang on one of the differential cover bolts, and the letters "C67" painted on the differential ring gear?

There was plenty of oil in the differential but little fluid in the transmission. But overall, both look OK, and can be turned by hand. The end of the selector shaft is broken, and this will need to be replaced.

My plan is to have both disassembled as necessary to clean and inspect.

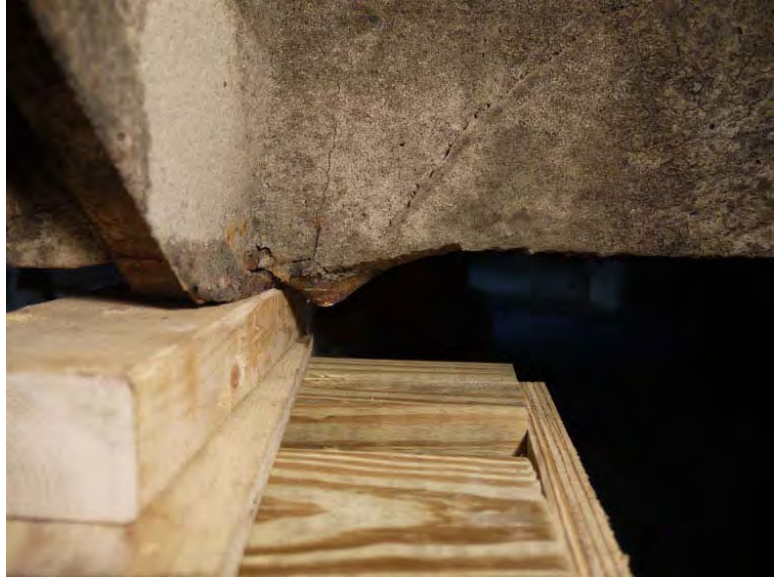
With the suspension removed I've looked more closely at an unusual feature of the rear undercarriage. What I thought was jacking damage seems to be something more insidious.

I had noticed earlier this bend to the rear cross support near the right side jacking position, viewed here from the rear:

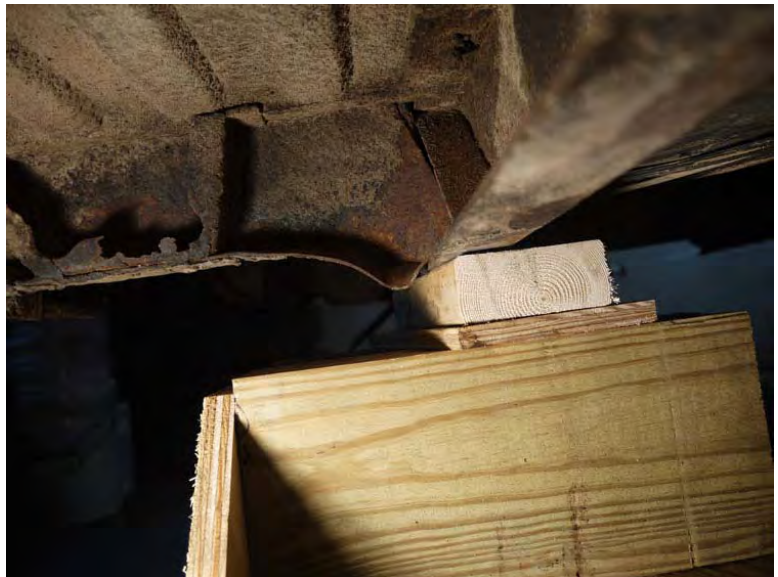
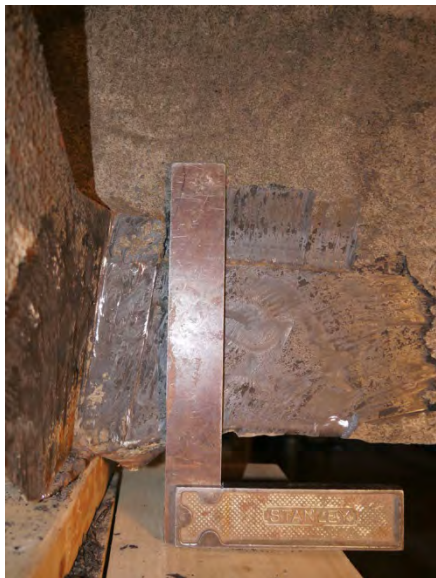
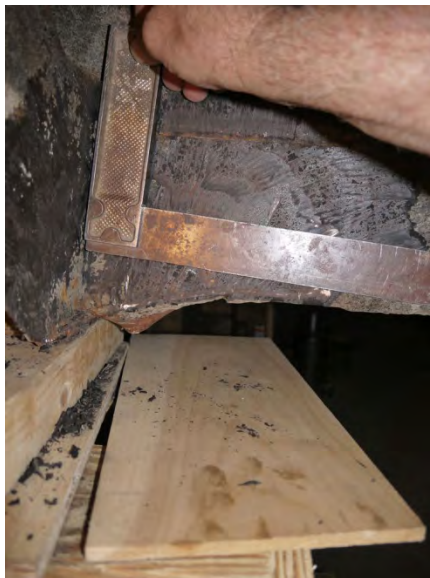
and here from the front:

With the under coating removed, I can see there is some significant distortion of the undercarriage:

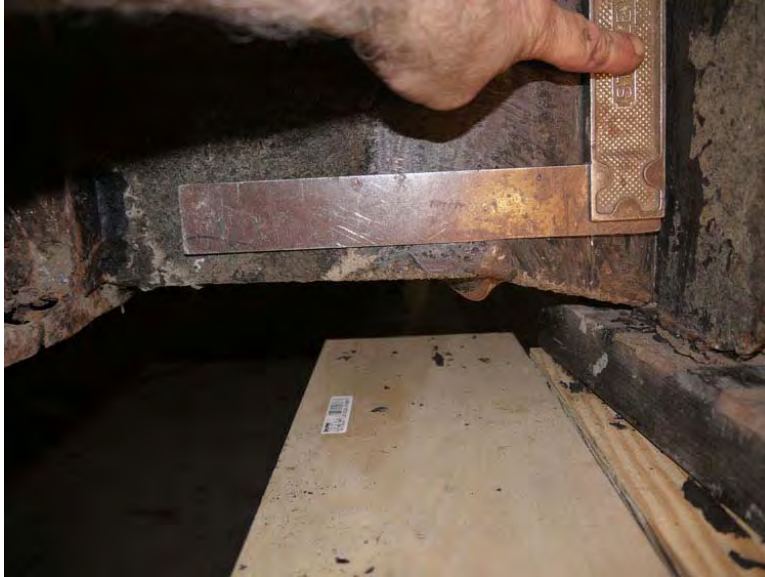
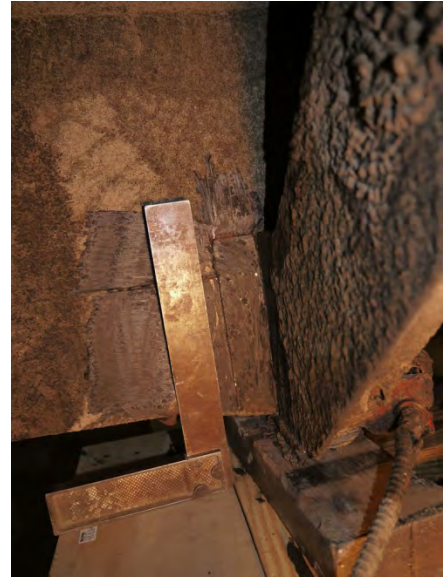
There is something similar on left side, though without as significant change to the surrounding undercarriage.

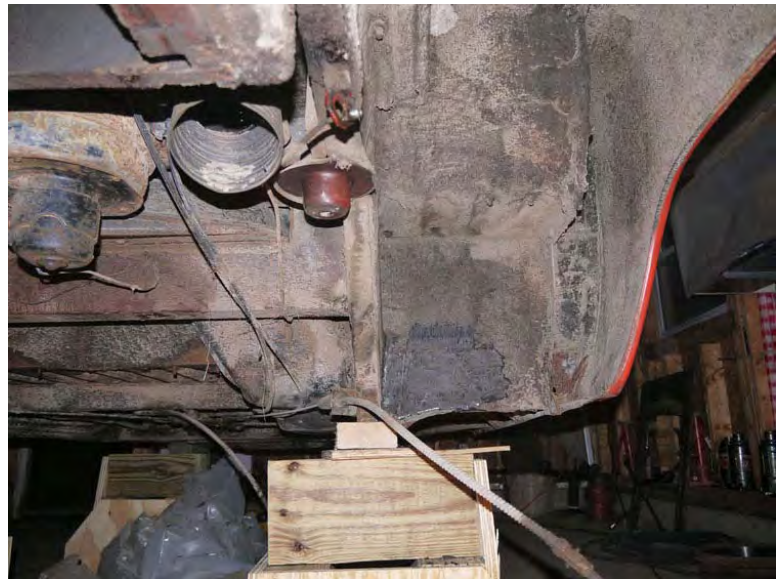
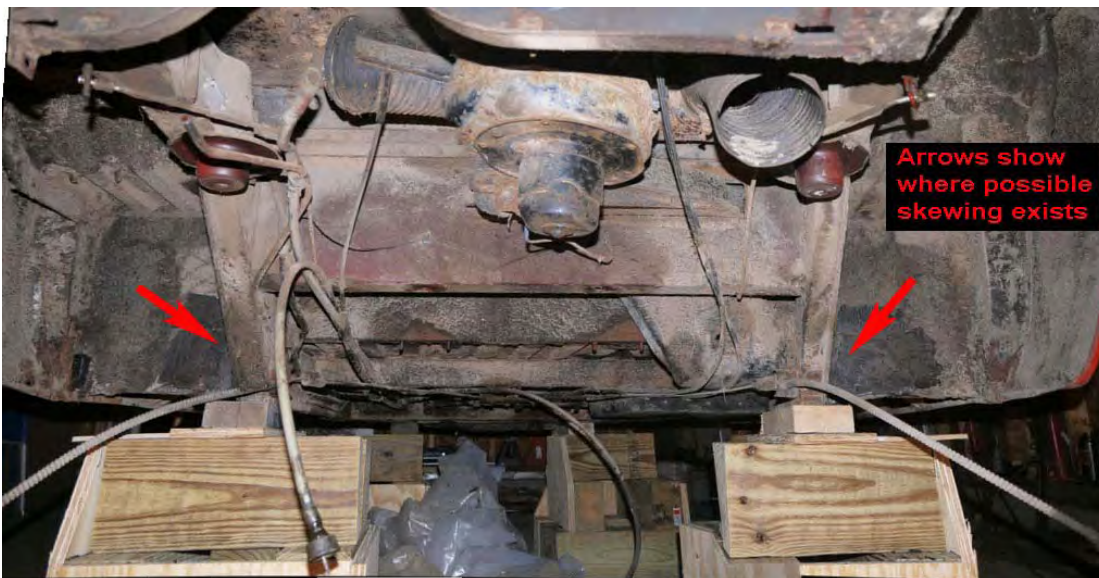
Here's two more images.

I'm trying top envision how/if this would impact wheel alignment? I'm not seeing that there is a significant change to the positioning of the rear crossmember and the transmission mounts, and any minor change should be corrected with alignment shims, no?

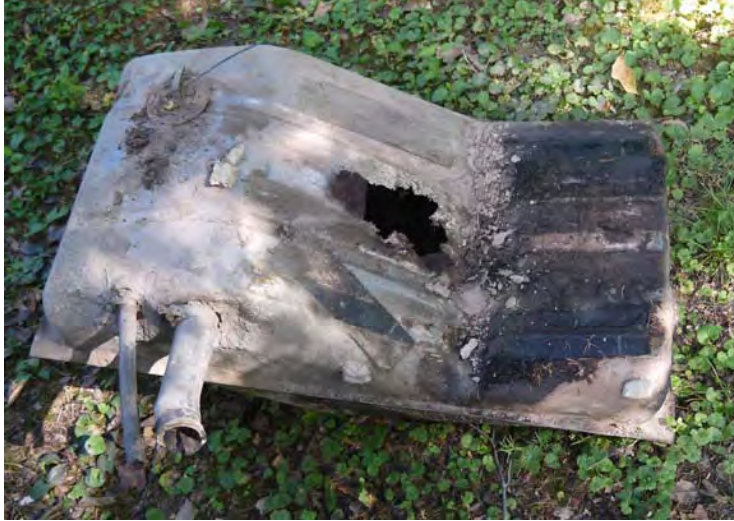
The absence of fuel in the gas tank was explained by the huge hole in the top.

Both are junk.

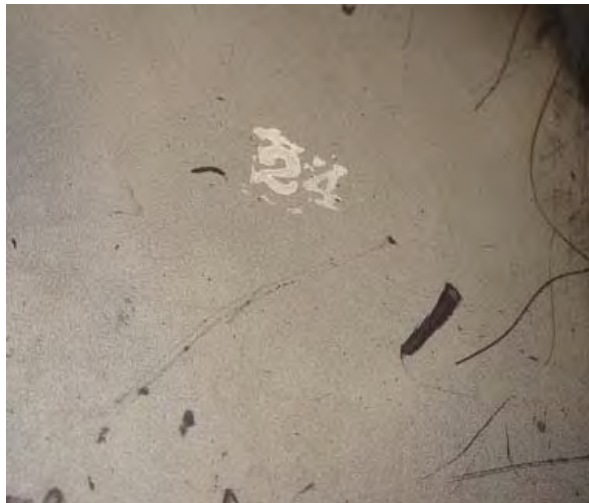
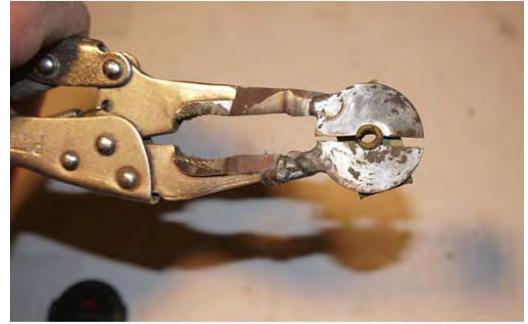
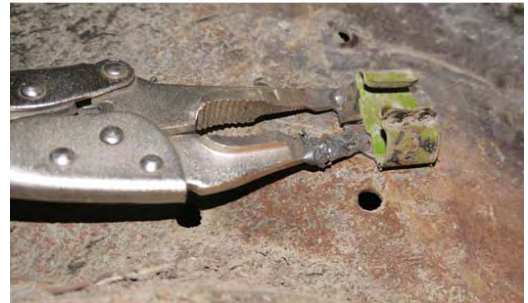
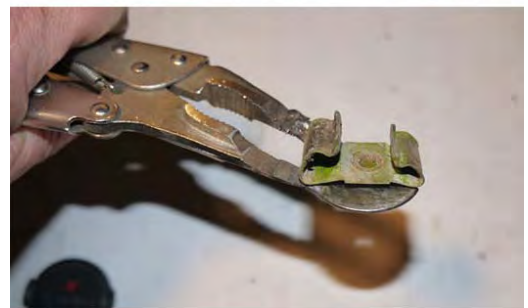
btw: Does anyone know why the number "24" would be printed on the inside of the left rear quarter panel, inside the wheel well?

This was found beneath the undercoating. It is painted quite resiliently.

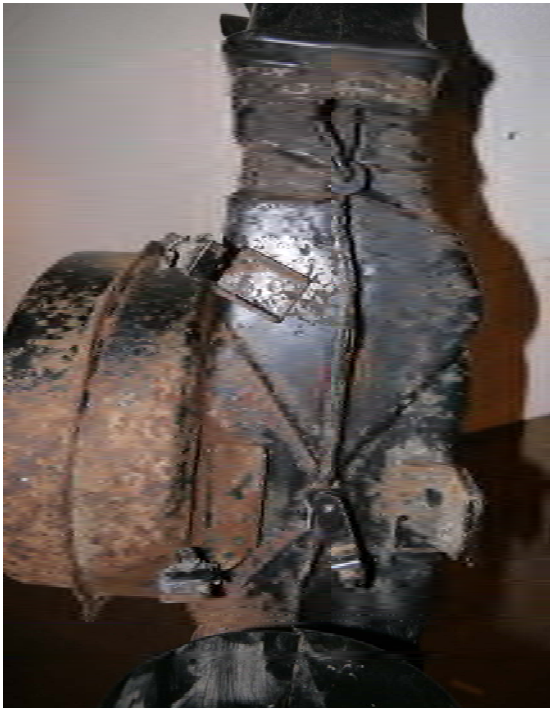
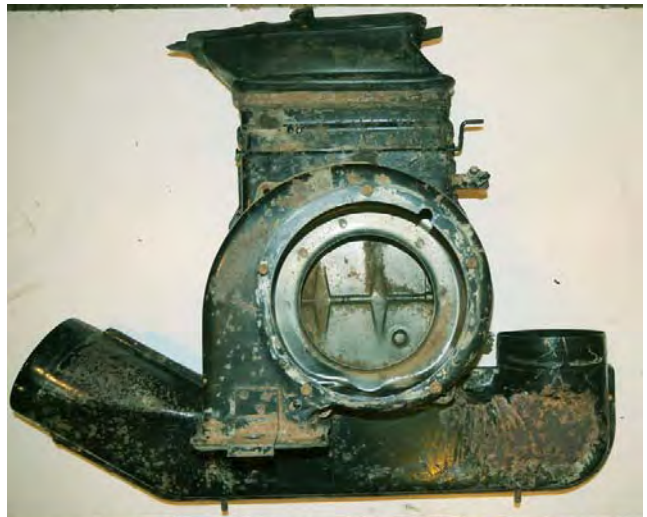
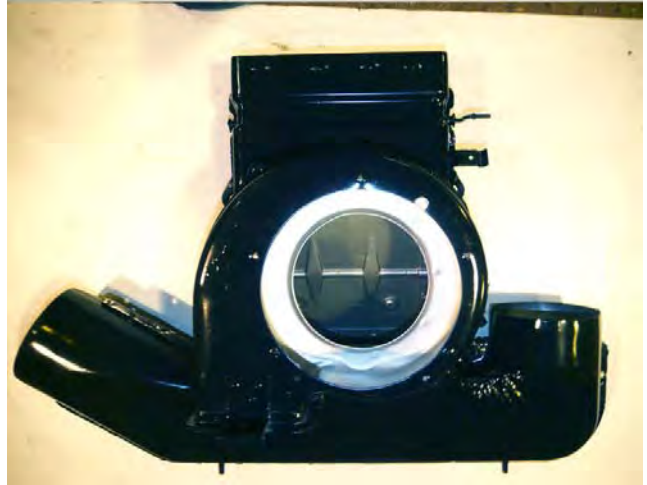
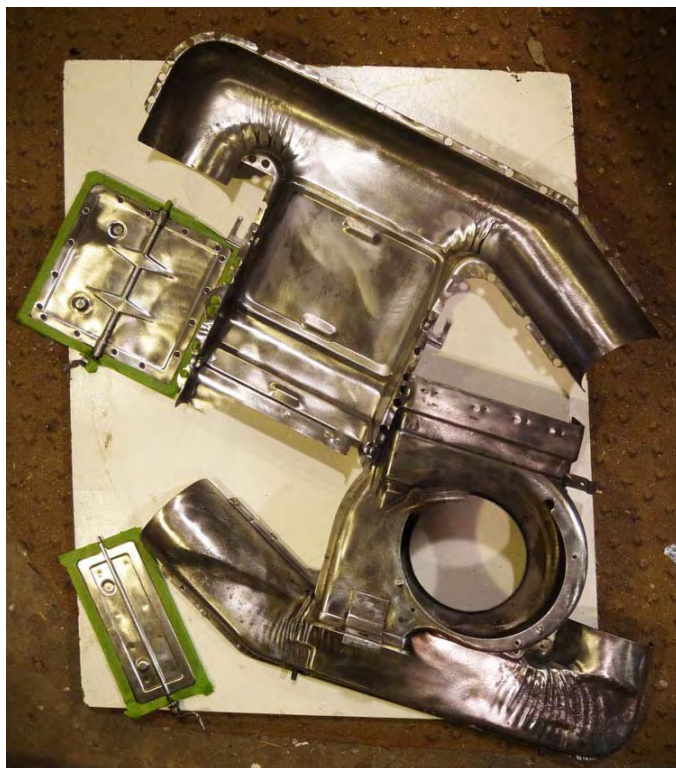
The unit was in really rough shape. The large baffle would barely move.

The two halves of the heater were separated using a 5/16" spot-weld drill bit, cutting the weld on the top side of the assembly. Inside: no wonder the baffle wouldn't move. Everything was derusted in my electrolytic deruster, power wire-brushed clean, and bead blasted where necessary. Fortunately, the rubber seals around the baffles were in excellent shape, and were carefully protected during cleaning.

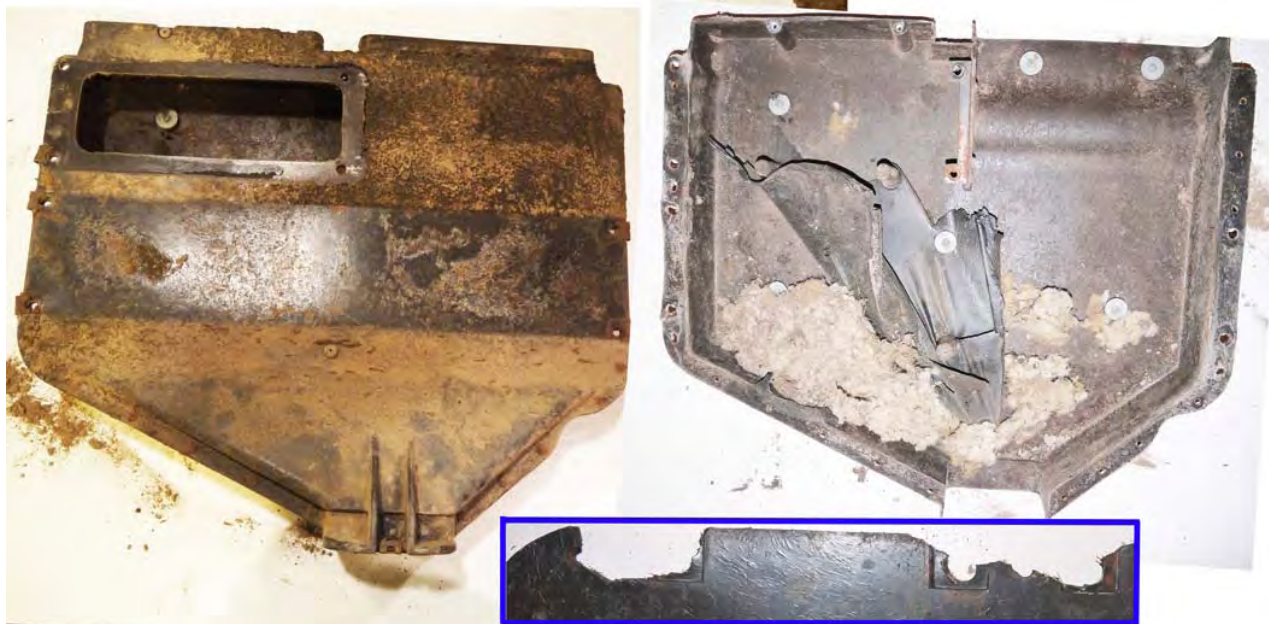
Most of the heater ducts were made of a resin fiberglass, which fifty years later has become brittle, with edges broken or cracked. Overall the Firebrier ducting is in good shape, though dirty, showing evidence of rodent nesting, and, of course, covered with undercoating. The rear upper duct needed some work, and after everything was thoroughly cleaned restoration was done.

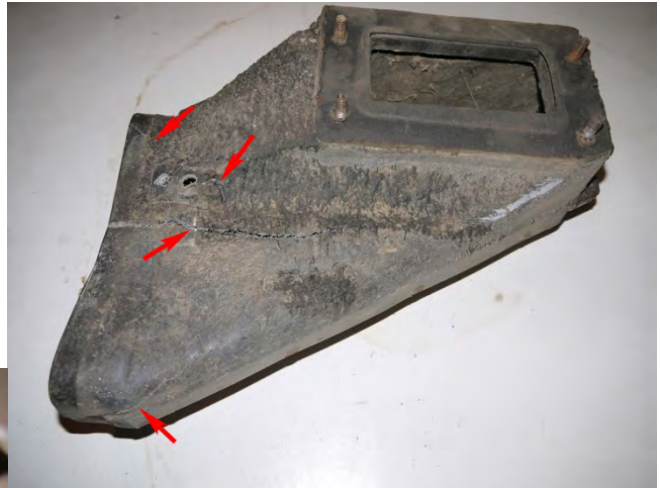
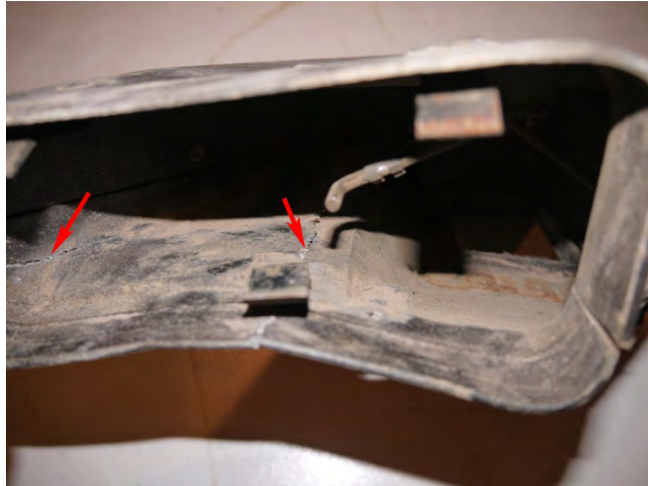
Further repairs on the heater ducts was necessary. After cleaning the dirt, grease and mud wasp nests off the front heater duct, it was found to be seriously cracked

I suspect these are stress fractures due to warping with age of the air entry opening.

After drilling out the rivets the repairs were made using epoxy impregnated Kerdi membrane as described above.

The repairs were made leaving the opening warped, which was necessary so that it will nest with the preceding duct, which is also warped (but not cracked).

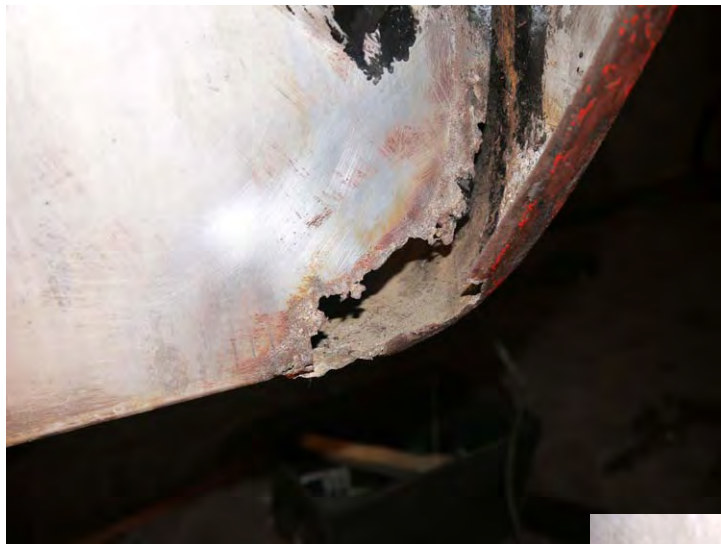
Both areas were partially coated with undercoating; these are annoyingly tight spaces to work in! After stripping it to metal, the battery compartment had more rust than expected (and when isn't this space rusty?), and patches were needed in several areas. Here's some of the metal removed, other areas needed to go as well.

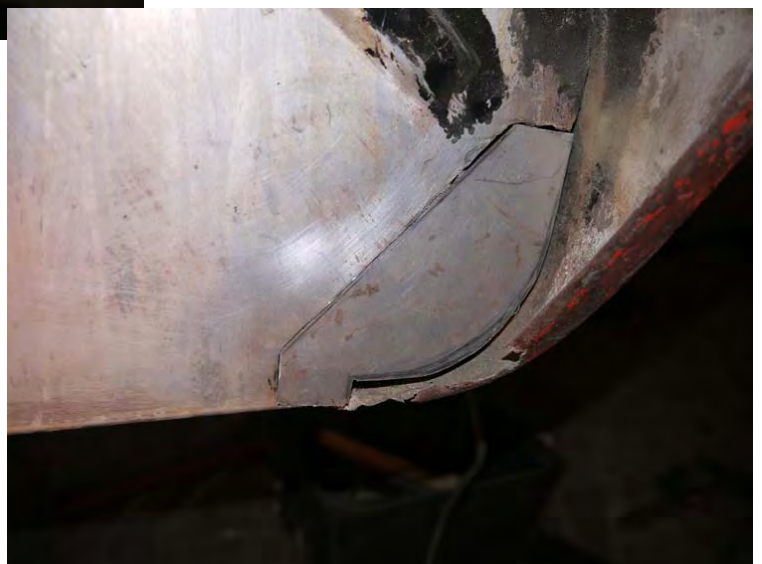
Rot found on the fender splash guard, and the lower edge of the wheel opening molding.

Patches were cut from 20 Ga steel, which are always edge (butt) welded. Cutting patches to fit correctly takes careful work,

and fabricating curved areas, like the bottom of the wheel well opening, more so.

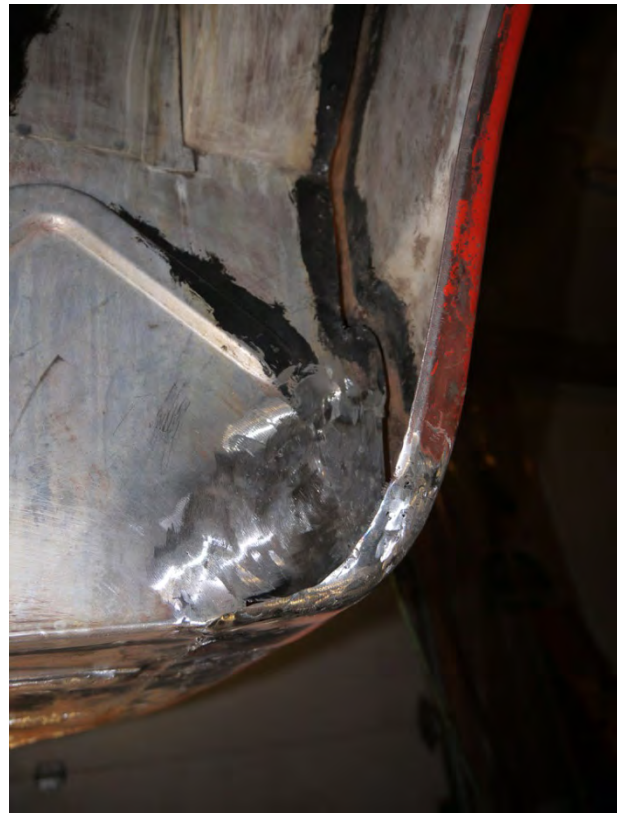
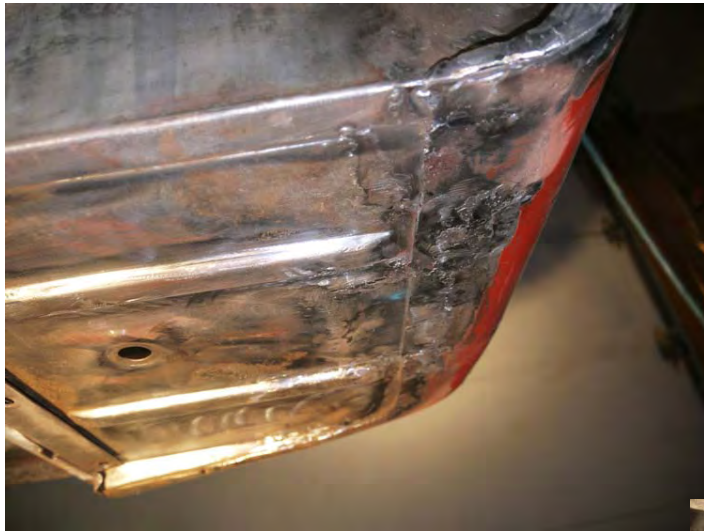
Most of the rust was on the inside lower surface. Some pitting, but most of the metal was solid, except where I placed the patches. I decided to treat with POR-15 rather than replace the whole panel.

And more challenging yet is welding these to old metal without blowing holes. But with lots of time all can be done.

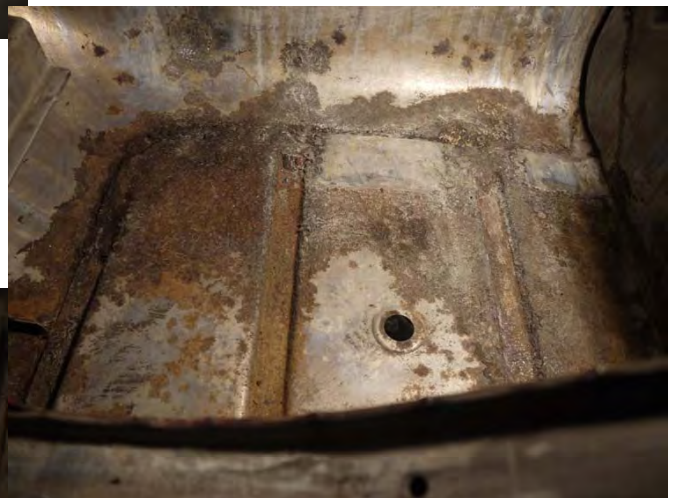
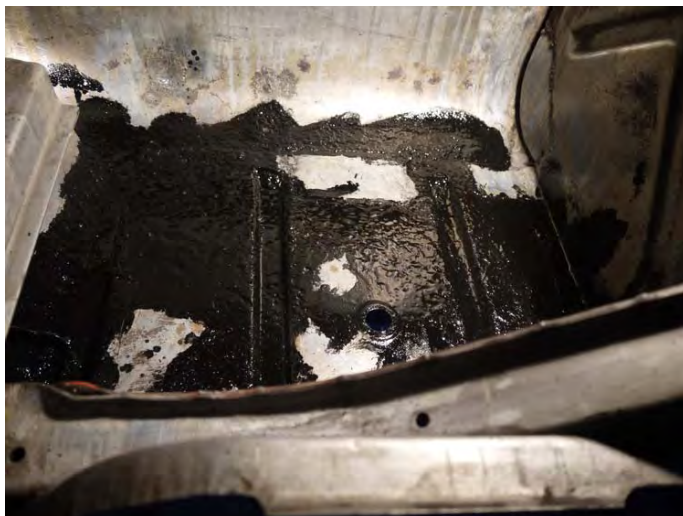
Most of the rust was on the inside lower surface. Some pitting, but most of the metal was solid, except where I placed the patches. I decided to treat with POR-15 rather than replace the whole panel.

All loose rust was power wire brushed off, and the surface was scrubbed clean with POR-15 degreaser and then treated with Metal Prep, before applying two coats of POR-15.

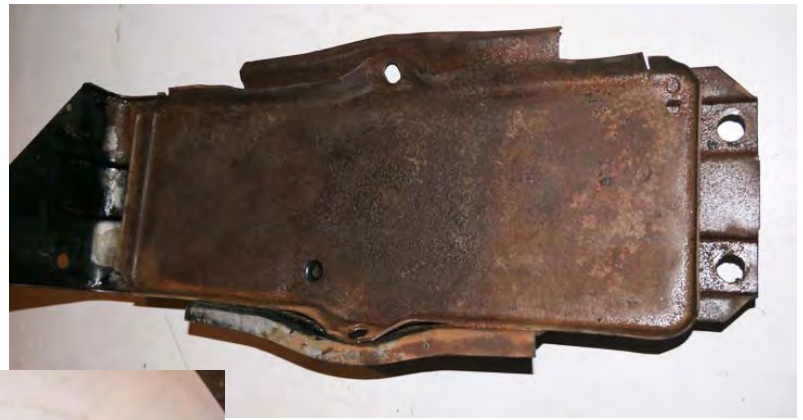
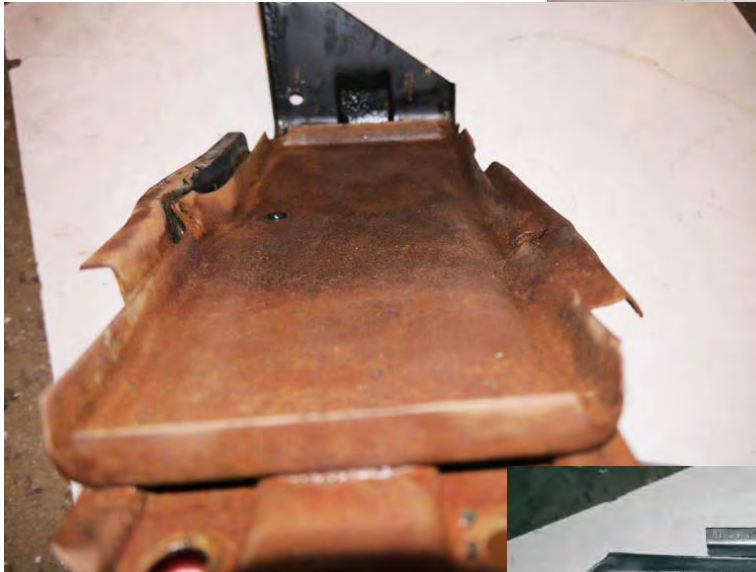
The battery tray needed some work. One of the sides had been pulled outward, undoubtedly to accommodate a bigger battery.

To facilitate straightening, I decided to remove one of the sides ... no, that's untrue... one of the sides loosened up and was easily removed, which made the repair easier. Here's the tray stripped and ready for finishing

Holes are drilled in the sidepiece to allow rewelding to the tray.

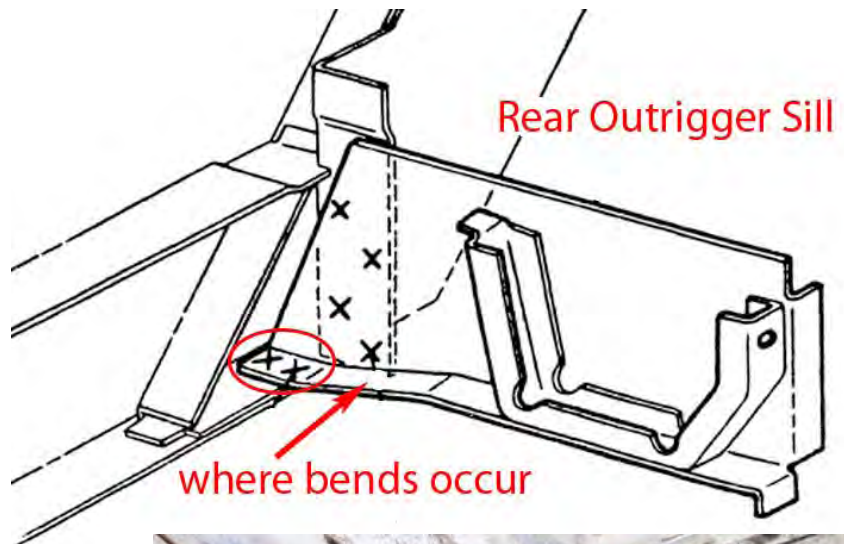
Back on August 21 I reported concerns about the bent undercarriage. The bends were found in the right and left side rear outrigger sills, that extend in front of the rear wheel wells. It's likely that the bends were the result of careless towing.

Here's the original condition of the left and right sides.
