FC Fire Company Greenbrier Restoration August 06, 2016

This remarkable story begins with someone sending to me on May 12, 2016, scans of several Corvair 95 window stickers and car shippers for my ECL decoding project (the originals have gone to Dave Newell). Among these was the car shipper for a 1963 8-door Greenbrier sold to the Malden West Camp Fire Company in Saugerties, NY. It was a very interesting FC, with an optional (but non-RPO) engine. Twelve days later, my good friend Ed Bittman emailed that he has spied several Corvair cars and FCs on Craigslist in a neighboring Florida city, which he soon visited and dutifully reported back the FC VINS and data plate codes. Incredibly, one of them is the Malden West Camp Fire Company van! After some tough haggling with the owner, we decided to buy it. Ed made the initial purchase, and then sold it to me. I just had the van flat-bedded to Marietta, OH.

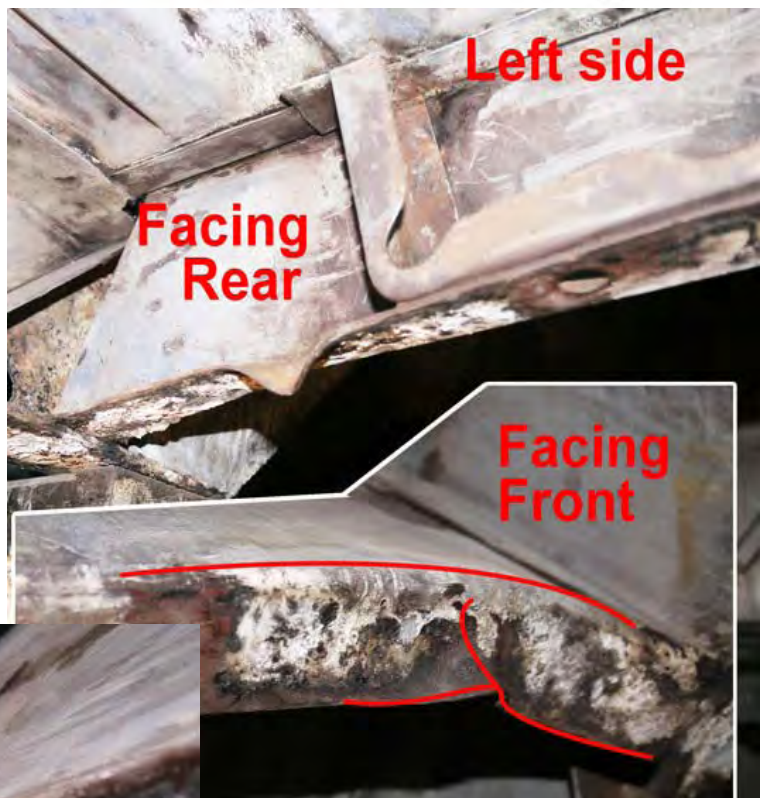
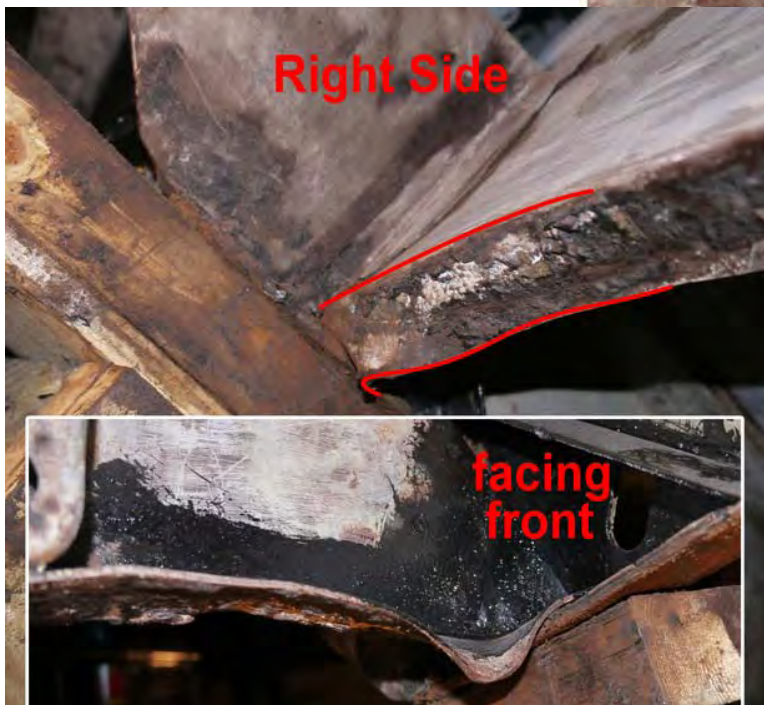
Here's the original condition of the left and right sides.

Consensus appeared to suggest that this wasn't a big problem, But I asked my body shop guy to visit and take a look. He also felt it was not serious and thought it could be fixed. And so, with torch, mallets, metal working hammers and dollies I went at it.

It took about an hour for each side, aligning the edges to a straight edge, and carefully working the 'dimples' flat again.

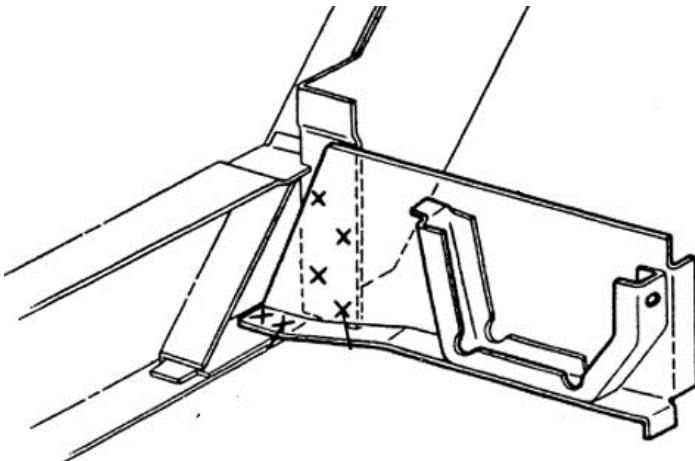
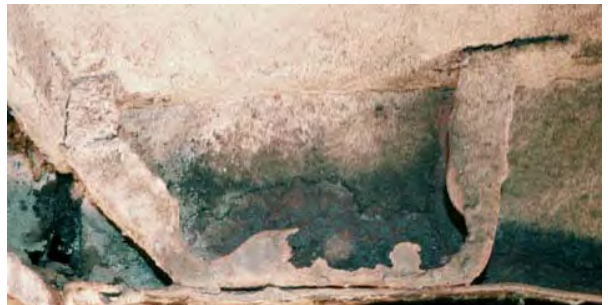
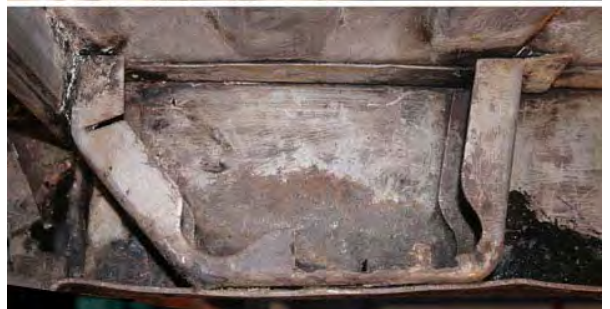
I've begun to receive some replacement body parts, so decided to go ahead and repair a rotted outrigger sill brace. Here's what it looked like before and after removing the undercoating. The bottom of the brace was pretty well rotted away.

The outrigger sills are the undercarriage supports that extend out to the side rocker panels. This diagram from the assembly manual shows the brace on the left side, although I was working on the mirror image brace on right side.

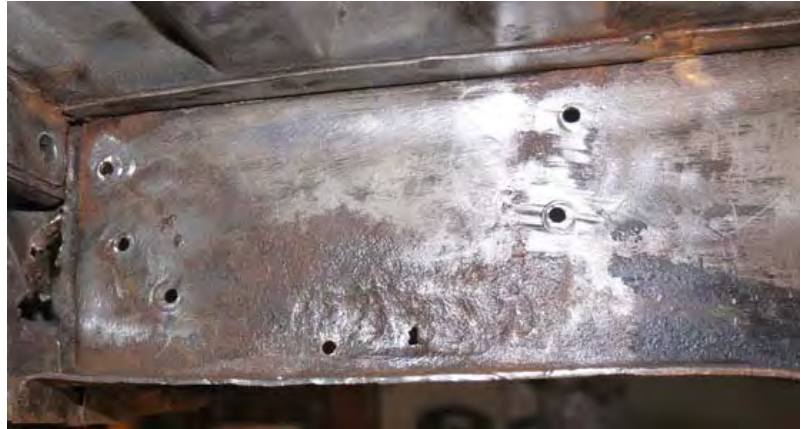
It was helpful that I could cut the original brace into pieces as I worked to better access spot weld and rip it out. The outrigger sill itself shows some rust, but was pretty solid.

The rotted brace was removed by drilling pilot holes from the back side through the center of each spot weld, and then using a spot weld drill on the front side. There were plenty of spot welds, including four on the bottom.

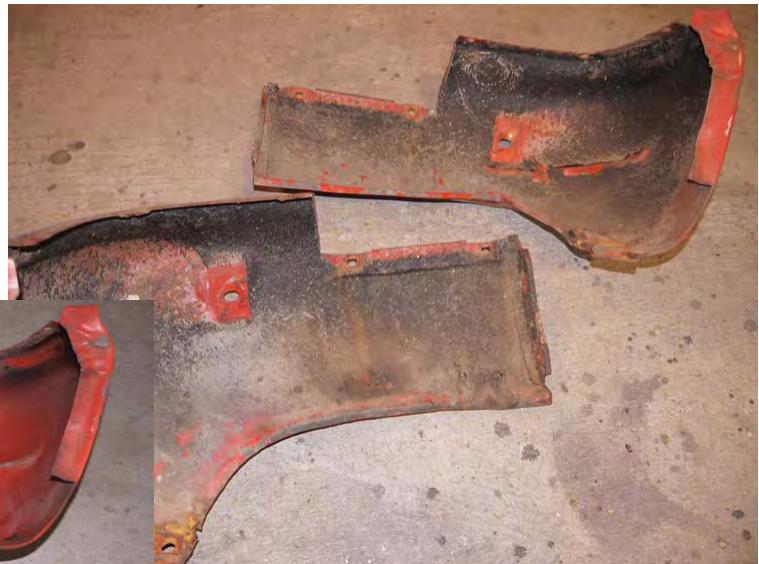
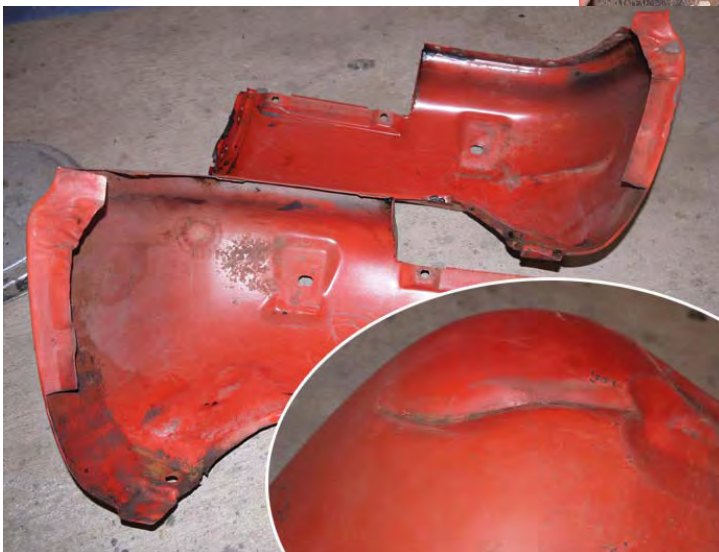
I removed the front bumper and lower body corner pieces to gain access below the cowl. Those corner pieces were well undercoated.

They look good, no serious rust, but will need metal work to restore shape.

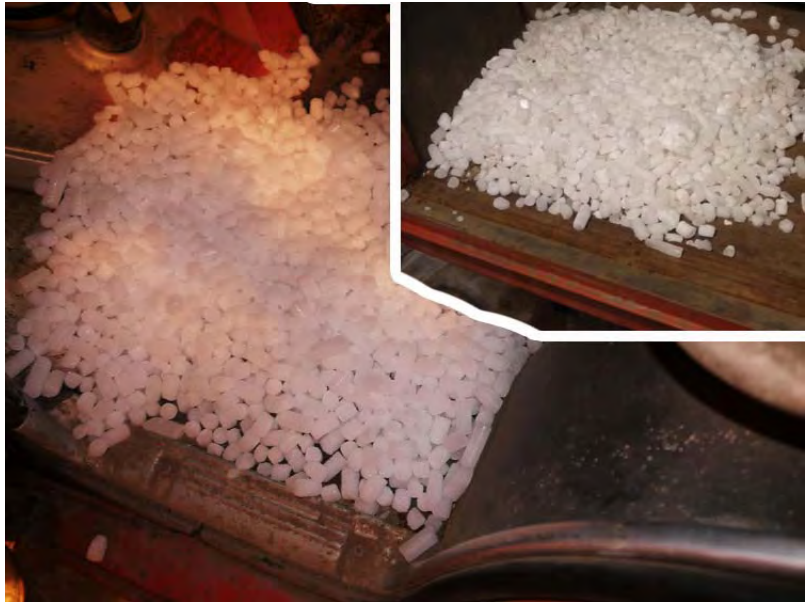
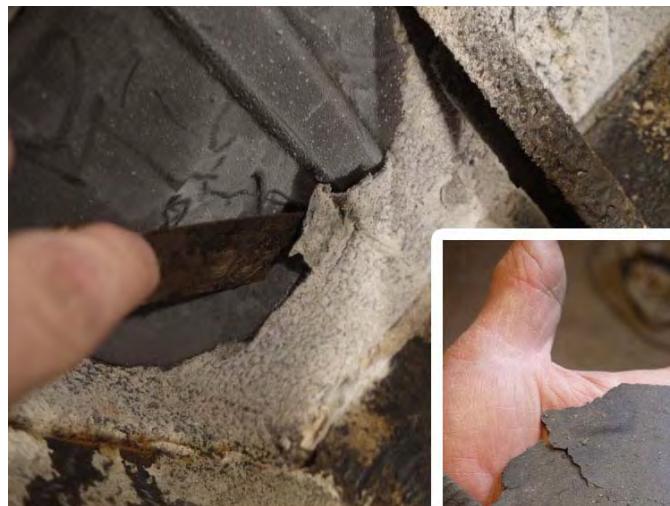
I had read online about using dry ice to remove undercoating, but didn't try it until now. I purchased 30 pounds of dry ice pellets, and spread piles on flat surfaces above areas with undercoating (the piles were also covered with blankets for insulation). When the metal reached deep freeze in about 10 minutes, extending about half way down the sills, the undercoating chipped off rather easily, often in large flakes using just a small putty knife.

I found the pellets held up for several hours, long enough to remove the undercoating from several locations, before subliming away. Not only was this far easier than using the torch and vibratory multitool, but the undercoating came off much cleaner, leaving the paint with almost no residual undercoating.

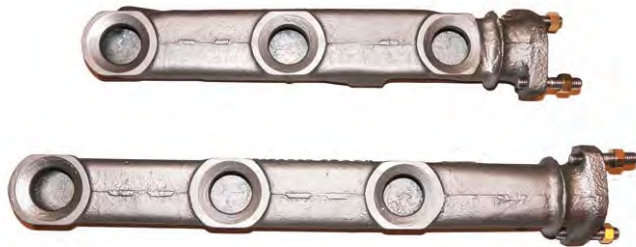
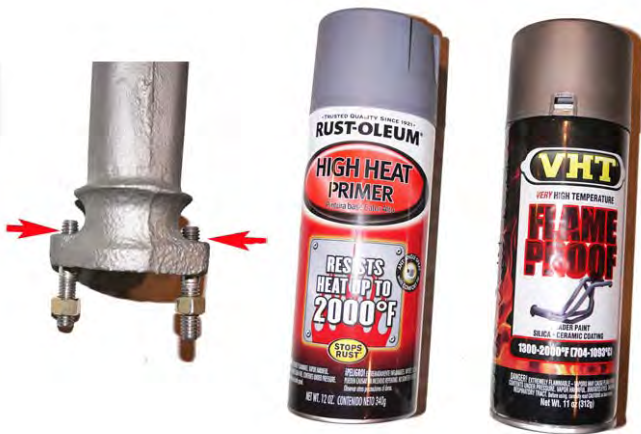
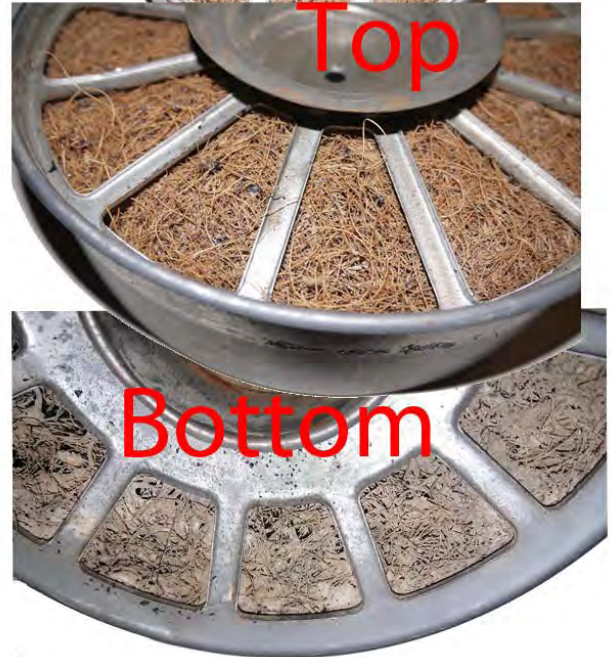
The studs were pretty rusted and were upgraded with stainless steel replacements from Clarks. With some serious heat and torque, two studs were extracted intact, but two snapped off. These had to be drilled out up to 5/16 dia and then retapped.

The exhaust manifolds have been cleaned and painted.

I noticed that the exhaust system was not included among the applications listed for standard VHT High temp paint, so I used their extreme high temp "Flame Proof" paint. Both the primer and paint were heat cured as directed. Overkill? I rest comforted knowing that, should the engine ever catch on fire, at least the exhaust manifolds will still look good!

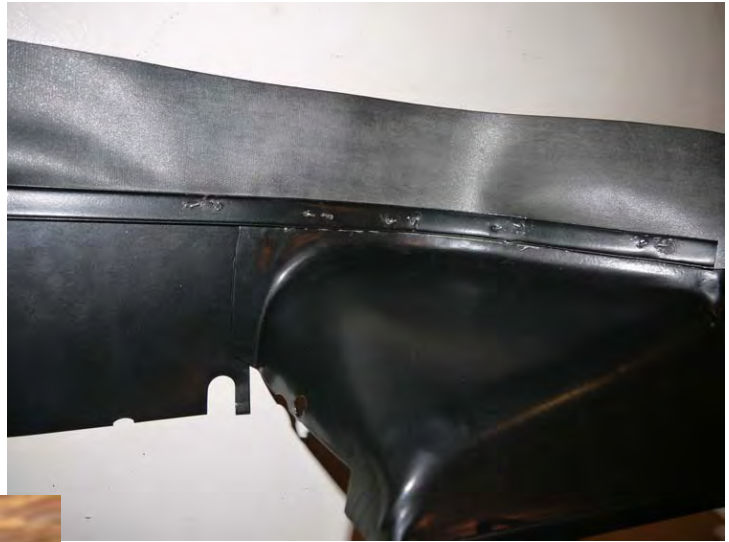
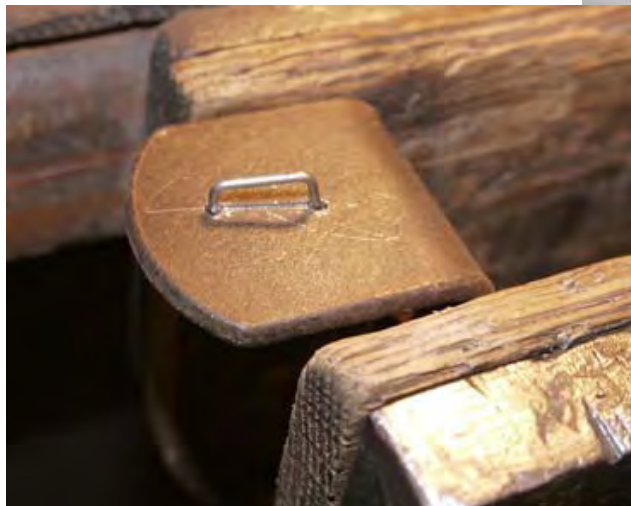
Installing the fabric correctly was one of the most exasperating projects so far. The task is particularly arduous because the replacement staples need to go through the original holes of the shroud and retainer while passing through the tough fabric seal in between. Keeping everything aligned is not easy.

Furthermore, the staples that Clark's sells were too narrow, and each one had to be expanded. I used this little jig, into which each staple was hammered to spread the legs.

I don't think this was Clarks' fault, rather just variation in GM's assembly tools. The staples are also made from a slightly larger gauge wire than the originals, necessitating expanding all of the holes (I used a #51 drill bit).

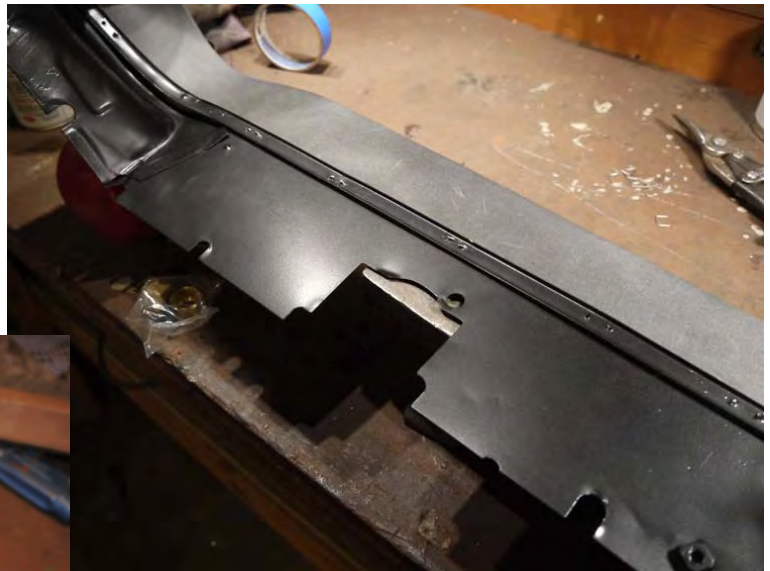
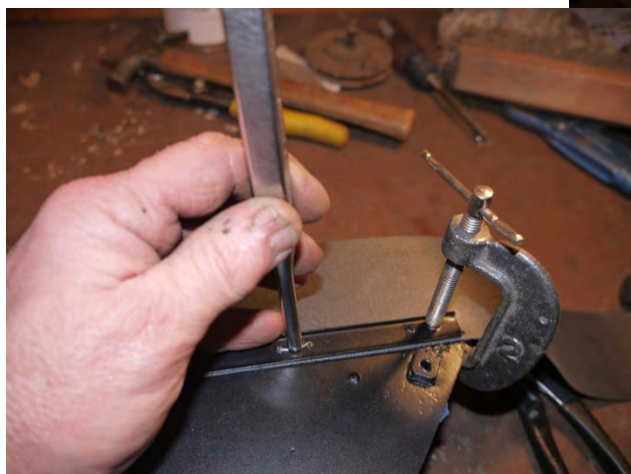
The best way to install the fabric was to start with the staples in the center of the shroud and then work outward, doing approximately every other staple. I found this is the best way to assure that the staples holes would line up. It was, none-the-less, a challenge to get each staple through the holes on both sides.

The staples came with a few suggestions on how to crimp them. One suggestion is to use needle nose pliers, but I found the staple wire is too strong to bend by hand. I used a metal punch.

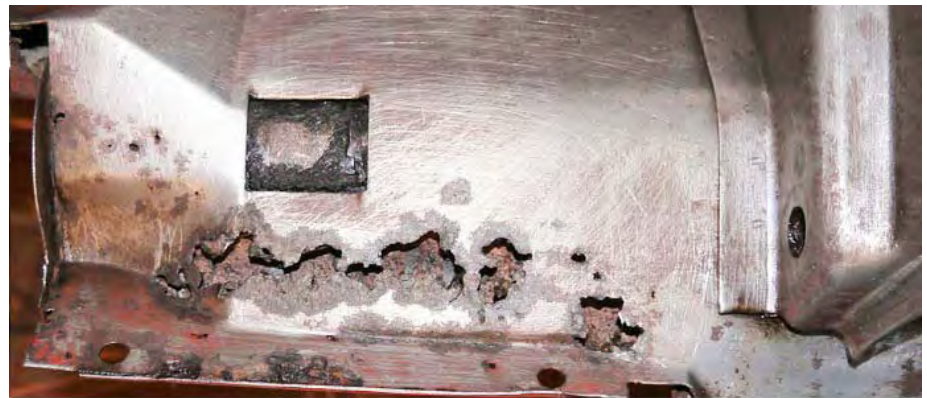
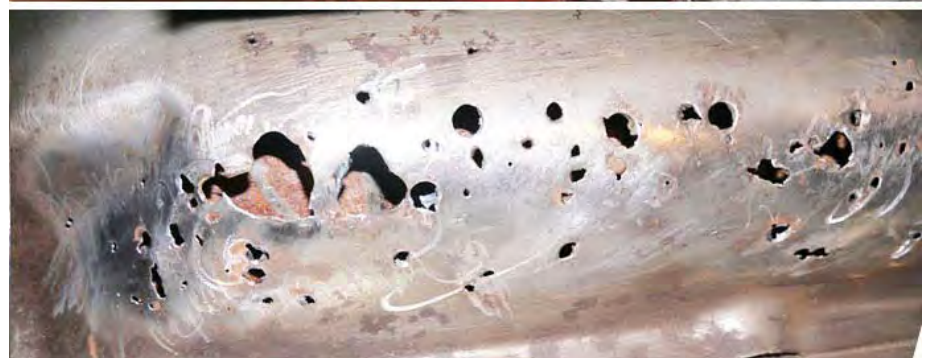
I should have expected that even though it was well undercoated, the bottom for the front cowl would be rotted since water can get in through the front grille. Here's images of the left and center sections of the under cowl (there was somewhat less rot on the right side)

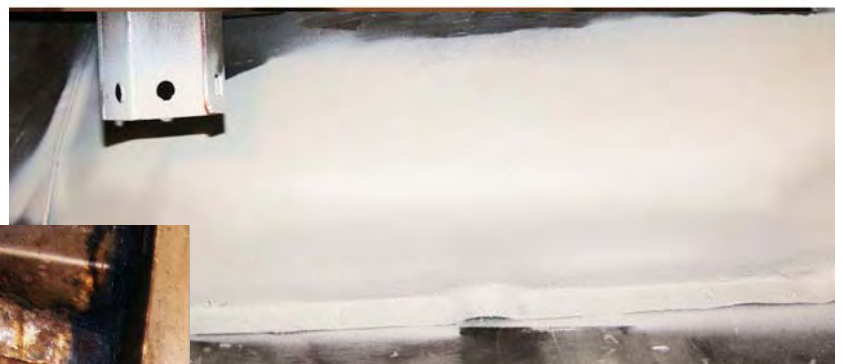
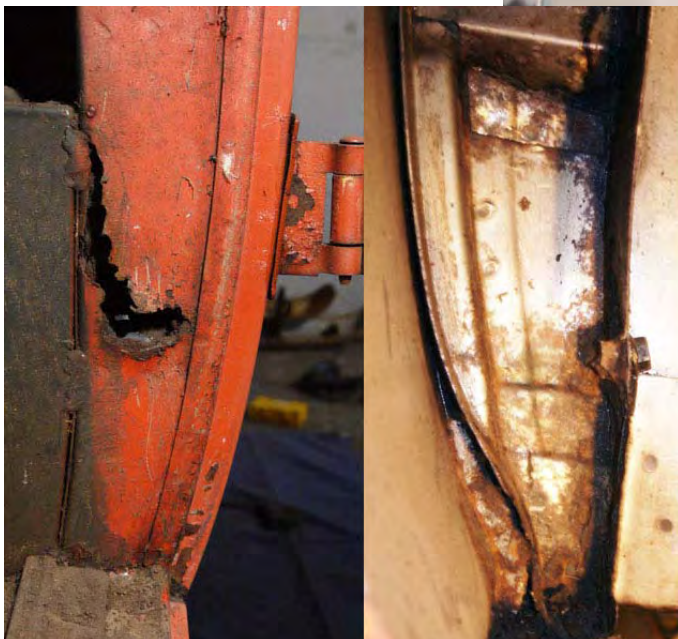
Another repair has been to the left side rear intermediate side door jamb, which was rotted on both sides. The picture of the back side shows the bracing below the hinge, most of which was beyond saving.

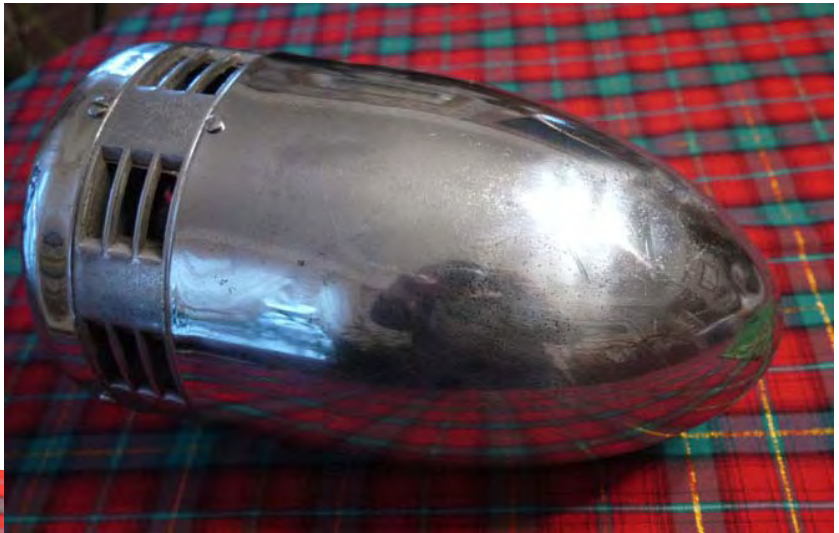
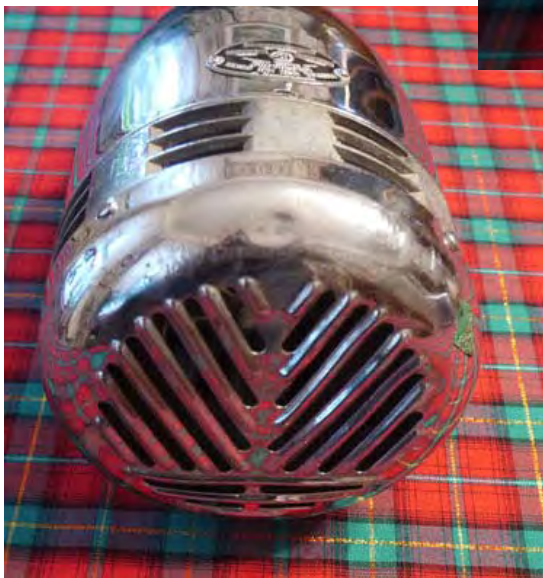
It was generously gifted by someone from the Malden West Camp Fire Company. This is a Federal Siren 66G siren - a monster of siren - and can be seen in the original painting of the Firebrier (back on thread page 1). Overall, it's in excellent condition. I'm looking into having it restored.

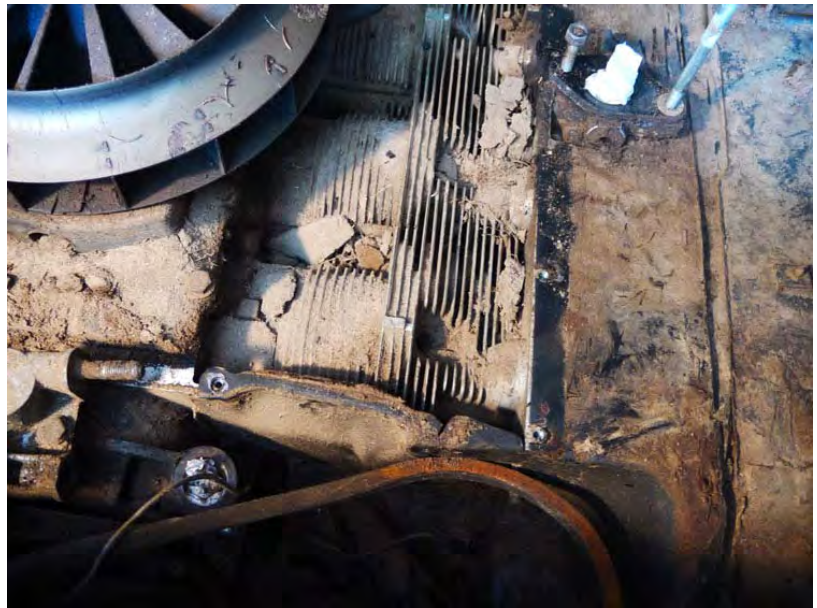
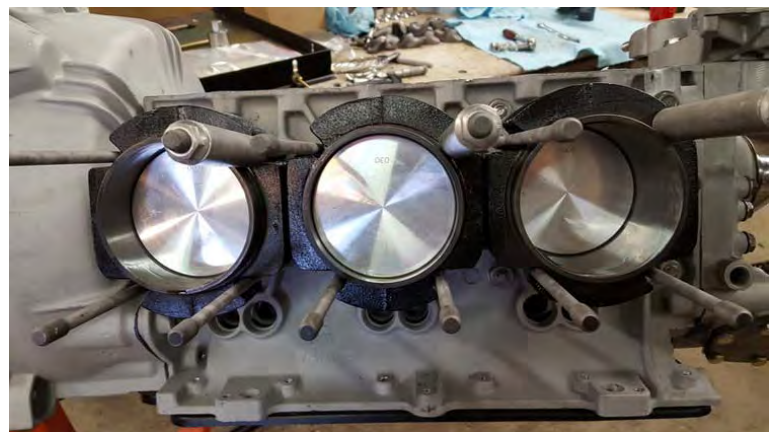
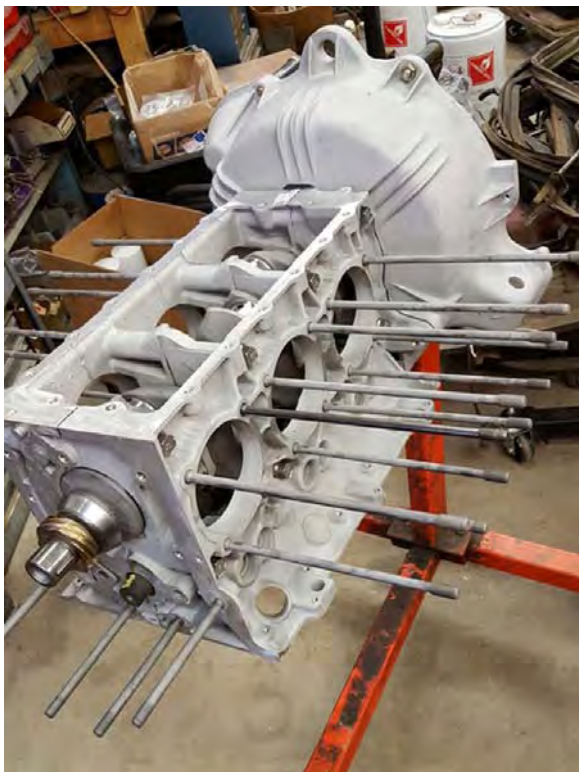
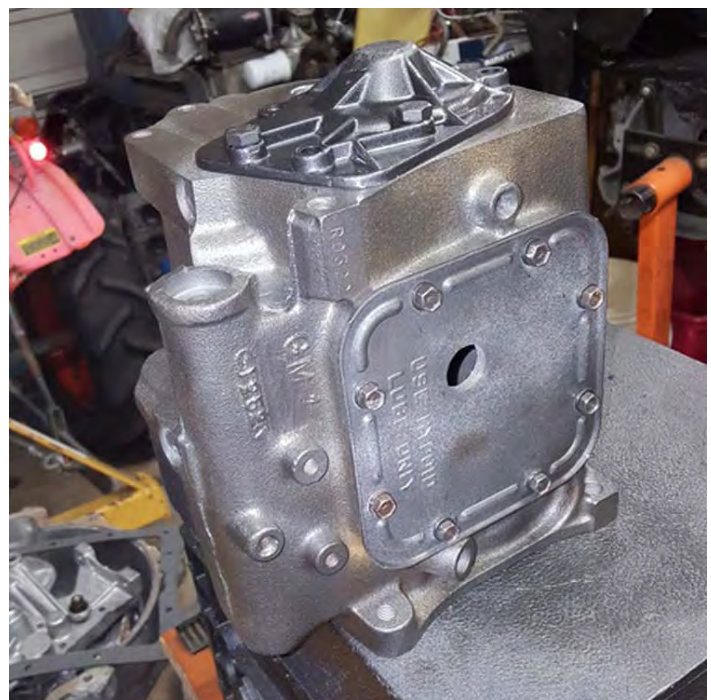
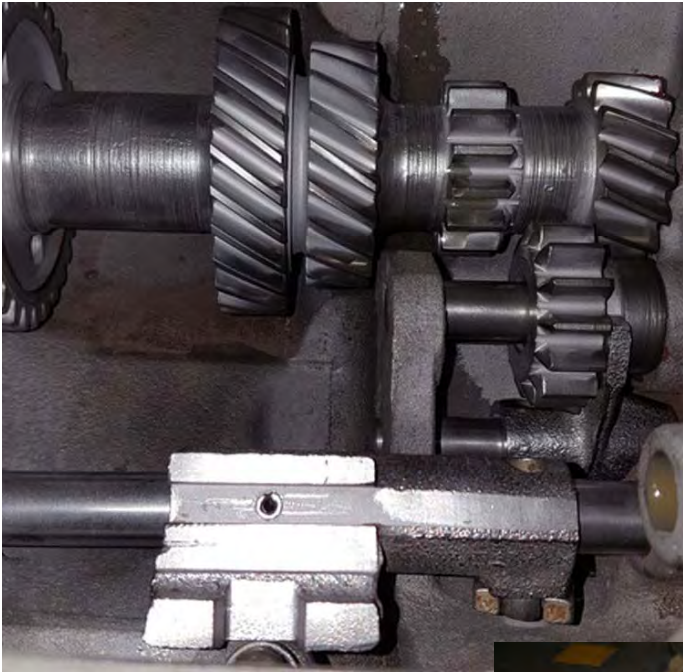
You may recall that essentially none of the internal moving parts of the engine nor the cylinders were salvageable. Three of the pistons had holes in them. But fortunately all of the major components that were coded and dated could be saved. This was important since the FireBrier was outfitted with a rare FC 102 HP engine and positraction differential that I wanted to save. Here are a few pictures Ken provided.

In the positraction differential a damaged postraction clutch housing needed to be replaced - provided by Jeff at the Corvar Ranch. Apparently this was a common problem.

So the powertrain is looking much better and has been rebuilt to last another 50 years, at least.

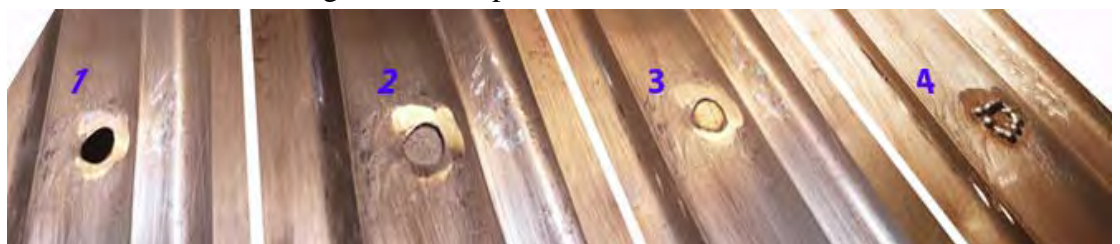
At any rate, there were about a dozen holes drilled through the metal over the powertrain and rear wheel wells, probably where fire equipment was once secured. I had considered leaving these holes, but then decided to fill them. I'll redrill as necessary when/if I can reacquire original fire equipment. The holes ranged in size from quarter to three-quarter inch diameter, and were resealed filler metal disks:

The metal around the holes was often quite distorted and needed to be work flat again (#1). A magnet covered with a thin sheet of aluminum was placed below the hole (#2) to hold the filler disk in place (#3), so that it could be welded in (#4). After grinding off the excess weld, some filler was used to smooth the surface. I also resanded the underside which will be repainted.

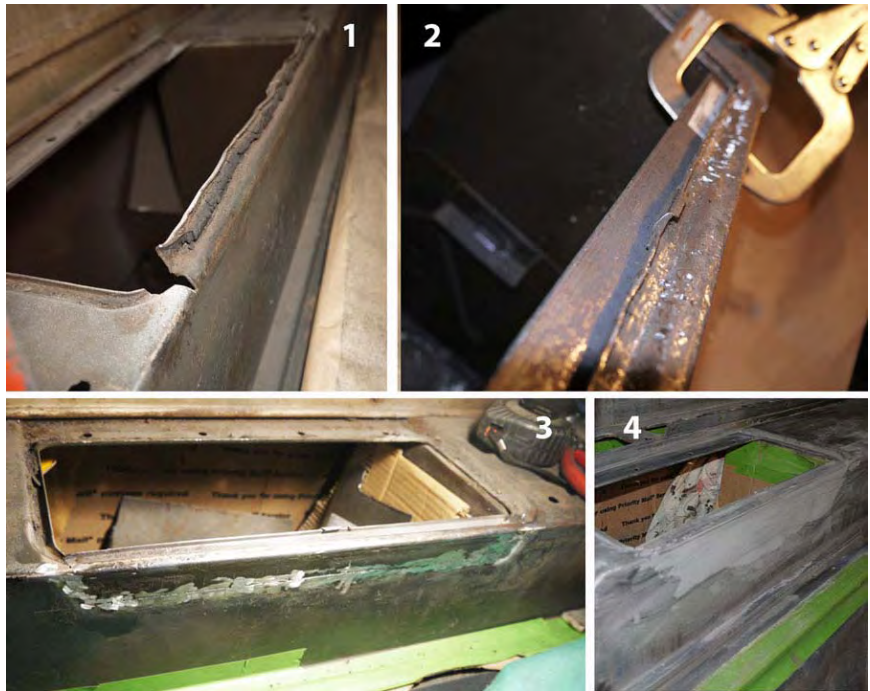
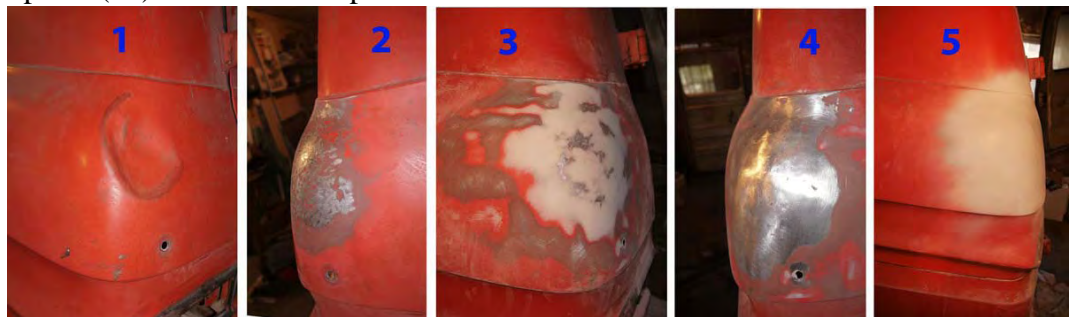
But along the way, a number of repairs were needed before priming. One of these was to the battery compartment opening. Some fool had cut and yanked out the front edge of the opening, undoubtedly to fit a larger battery (#1).

Plan A was to cut out the bent section and weld in a replacement. But when my local body shop guy stopped by to look at the FC he will eventually be painting, he said that it would be better to metal work the bent region back into place. Sounded like a good idea to me, and after about 4 hours work it was back in place (#2) but still so warped and uneven that I decided it never could be made right.

it often was not possible to position a dolly where needed while hammering. OK, so back to plan "A", and the front edge was cut out and a replacement (from the Corvair Ranch) was welded in (#3), after grinding down the weld, the surface was smoothed and contoured with filler (#4).

That rear corner also was the location of a significant dent. Metal working this back into shape was more successful. Working with a variety of hammers and dollies, from the inside and the outside, the metal was carefully roughed back (#2). To begin the fine shaping work, I apply a skim coat of filler and sanded it down to find the high and low areas (#3). The metal is then repeatedly reworked while resanding the filler until the surface has been largely smoothed (#4), and my goal is to do the finish work with high build primer. I have applied a temporary primer to prevent rust until the exterior is refinished (#5), and I won't really know until then if I will need to use any filler to get the final contours right. Although I didn't get a picture, the inside was also made right, with a little filler, so that the metal work will not be apparent. I'm sure a pro could do this faster, but this little project took me about 5 hours!

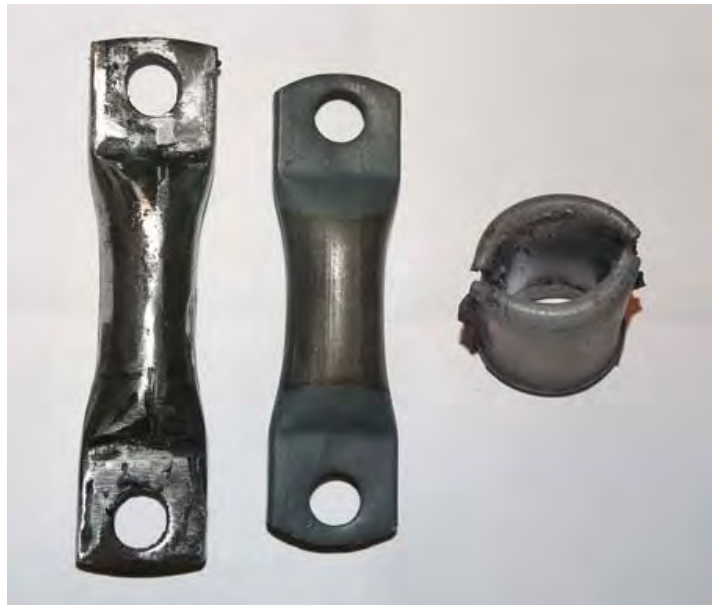
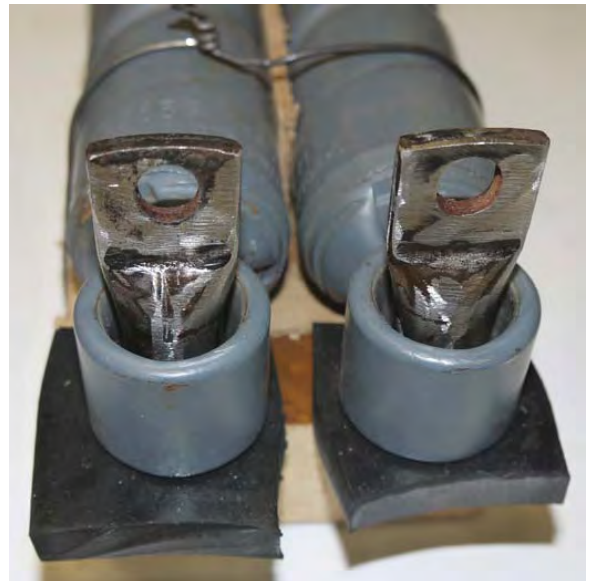
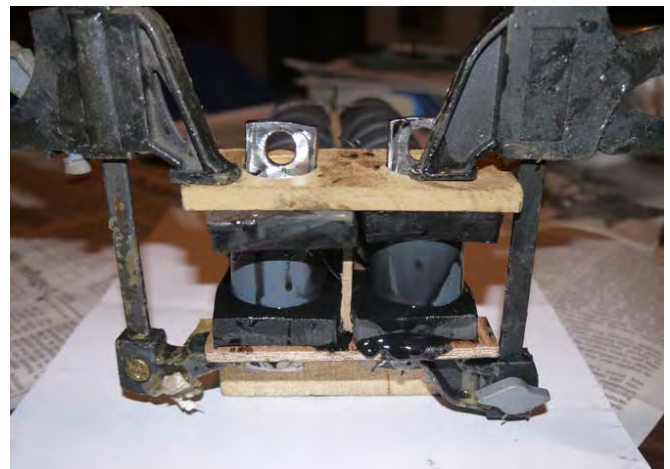
February 11, 2017 The extended length of FC rear shocks is 13½” , and 14¼“ seems appropriate for the fronts, unfortunately original FC spirals seem to be essentially pure unobtainium so I’ll have to make some substitutions. I have acquired NOS spiral shocks with appropriate dimensions for the Firebrier, and my intent is to match the extended length as best possible, recognizing that the valving may not be optimum.

I have NOS EM car spirals, and the fronts (3178178) have an extended length of 12 7/8” which is pretty close to the FC rear shock, so I’ll use these there, but with an extended length of only 12½” I suspect that the car rear shocks (3178179) are too short for the FC. I recently obtained two NOS 3197656 spirals which have an extended length of 14¼”, and I plan to use those in the front. The problem is that the bottom bracket has hole spacing of only 2½” and the FC requires 2¾ “.

So I pressed out the original bottom brackets and replaced them with brackets from corvair shocks. This is not simple because when the brackets are pressed out, the rubber grommets come with them and are irreparably damaged. I needed to recast new grommets, which I did using 70 shore urethane rubber. This required setting up a jig so that I could cast the rubber around the brackets within the casing of the shocks.

Rubber seals were placed around one end of the bracket to prevent the rubber from leaking while it set up. I used a two-part 70 shore urethane rubber and additional rubber seals where added to the other end; these seals also molded the extended ends of the new grommets, as you can see in the shocks with the replacement bracket and grommet

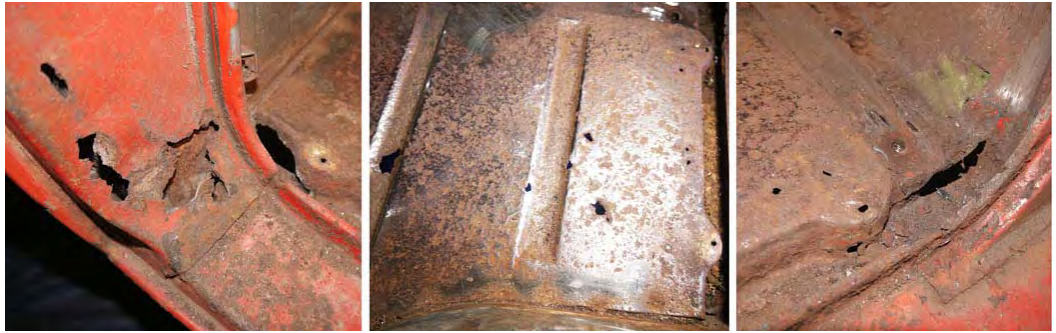
Finally more progress, and the last of the body rot to the undercarriage has been repaired.

The following pictures show an assortment of stages in the repair process. Some of the replacement parts were extracted from a good quality CA parts van by Mike Deklotz of Mike's Auto Parts, although some pieces needed to be fabricated.

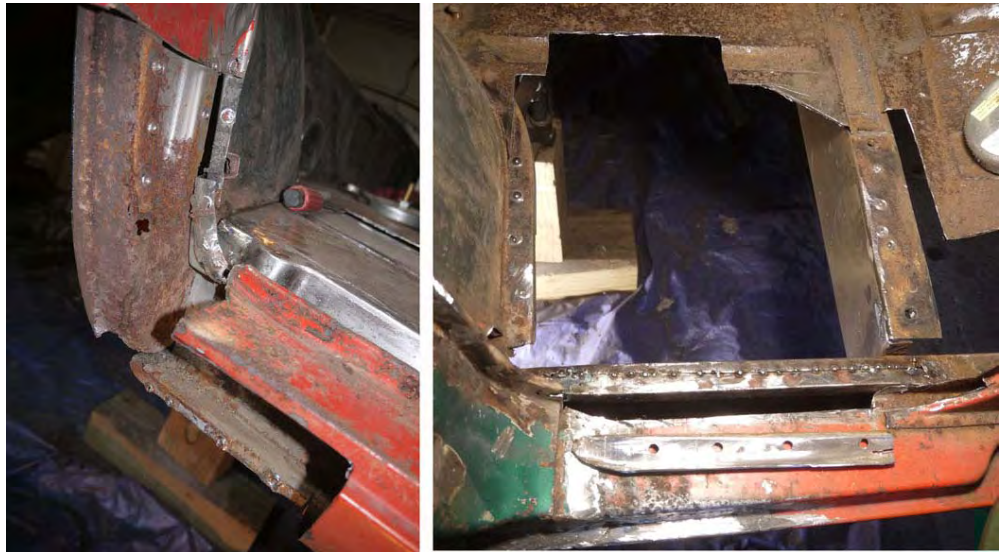
Like lots of rust-belt FCs, the dog-leg "ankle" was pretty well rotted, with serious rust extending down along the face of the rocker panel; and a good size chunk of the floor pan was also beyond salvage.

Above we see the rotted part of the "ankle" cut away (you can see the replacement floor pan set in place behind). That segment was replaced before the floor pan was replaced, and the right side picture shows the floor cut away. You'll also notice that even part of the sill needed to be replaced as well as section of the weatherstrip support frame.

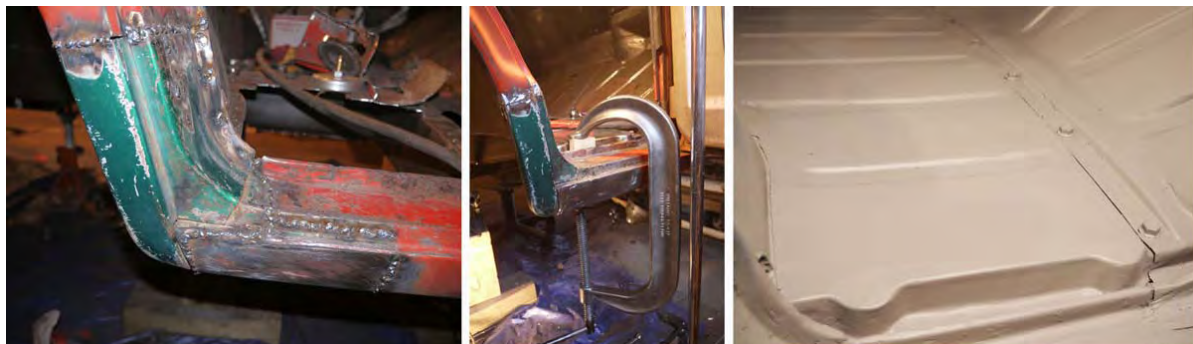
Here's a view of the dog-leg "ankle" partially welded in place. And there's my, mother-of-all, big-ass C-clamp that has solved a variety of clamping needs. To the right is the restored floor panel, primed with an epoxy base and 2K surfacer. Epoxy primer should be top coated within 72 hour, but if I'm not going to apply the finish coat soon, I always cover the epoxy with surfacer to assure proper bonding later on.

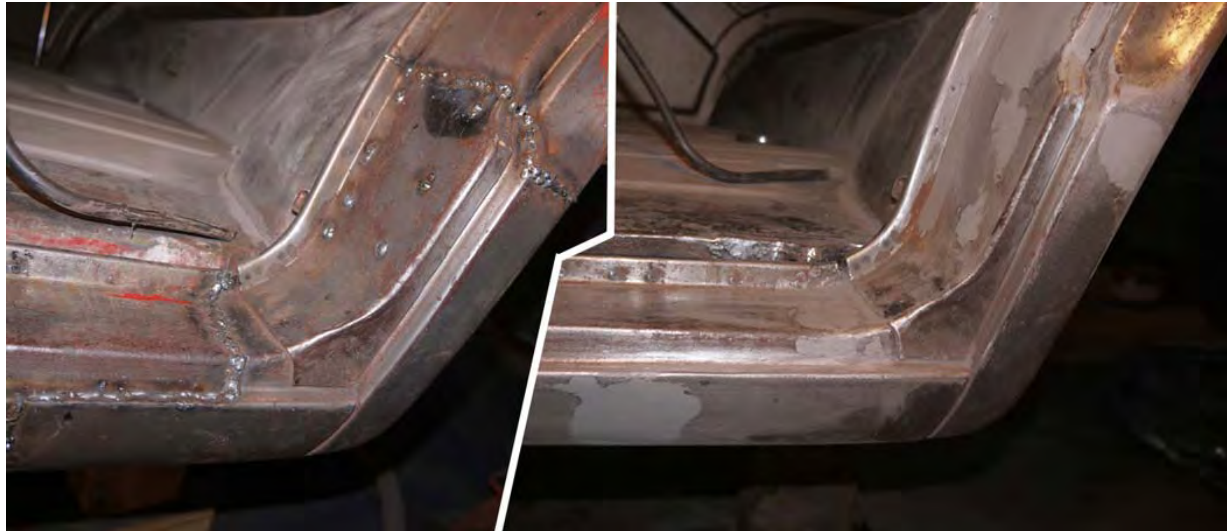
And here's the replacement piece spot welded in place, and then the weld lines after grinding and skimmed coated with filler.

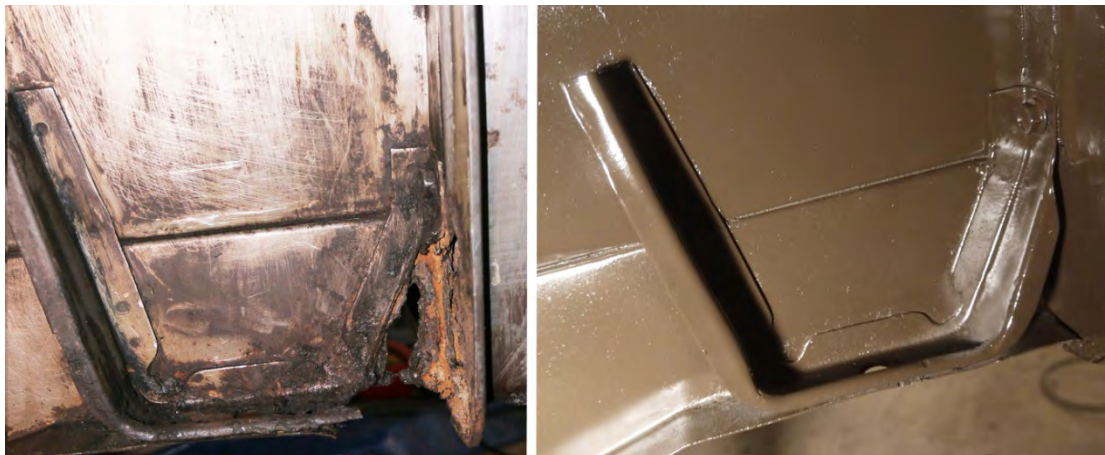
Meanwhile on the other side of the wheel well, the jacking brace and associated sill were a disaster, but now are now fully restored. Indeed, the undercarriage has now been fully stripped and repainted, and soon I will begin replacing the undercarriage control cables. But first I'll be priming the Firebrier interior.

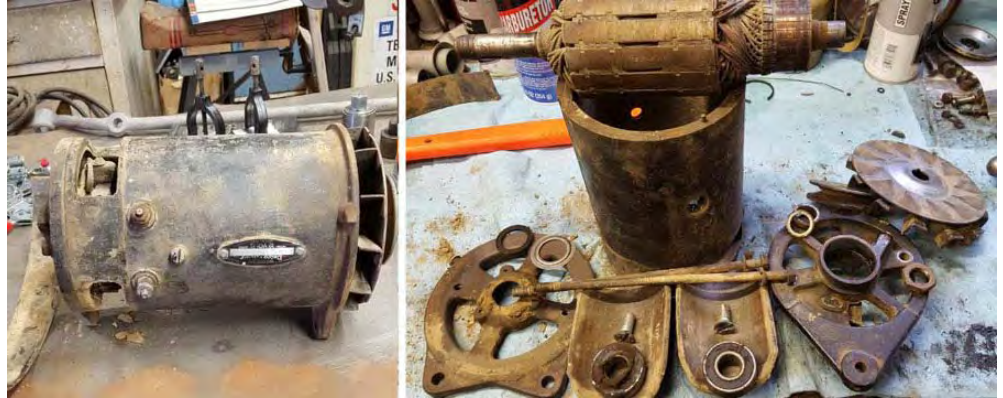
Here's the generator before restoration and after being disassembled. There was some initial confusion because the tag appeared to be black, and Delco 12 Volt generators always had red tags. Turns out the tag had been painted along with the entire generator at some point. And here it is restored.

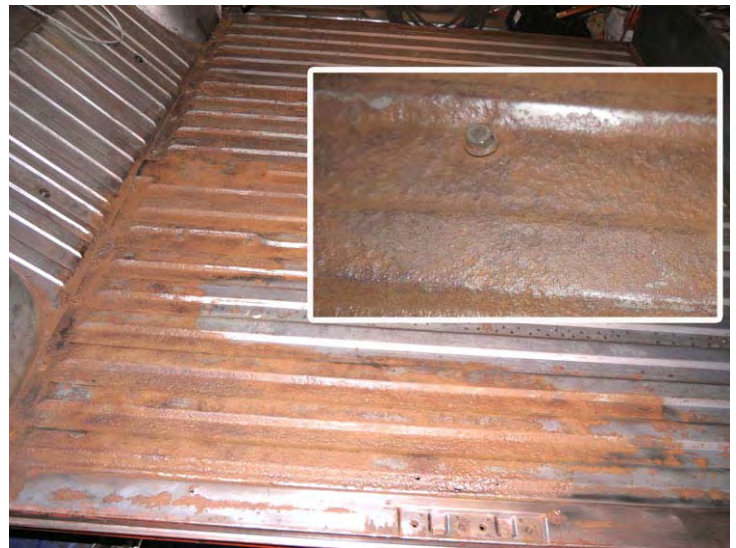
Finally finished the load floor of the Firebrier; straight forward but a lot of elbow grease. As it arrived there was some serious rust and pitting, apparent after the paint was stripped, particularly on the left side.

One small area needed to be replaced, but everything else was restorable. Filler could be used to cover the rust pits, but I decided high build primer would be better.

The surface was first thoroughly wire wheel brushed to remove as much rust as possible, and then prepped for POR-15. Here it is after the phosphoric acid treatment. All the floor bolts were removed and the holes plugged.

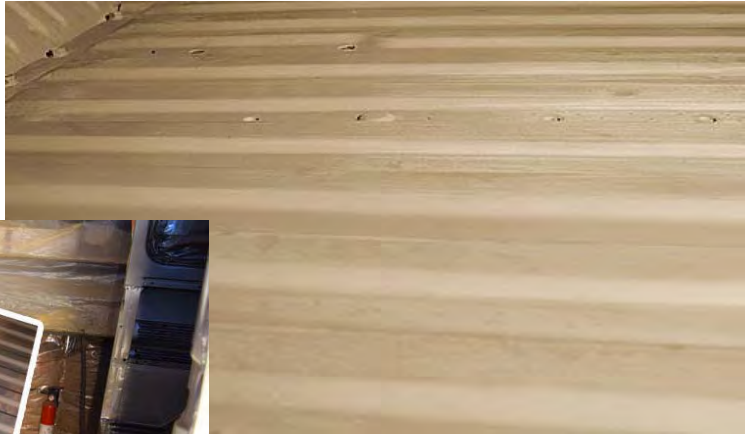
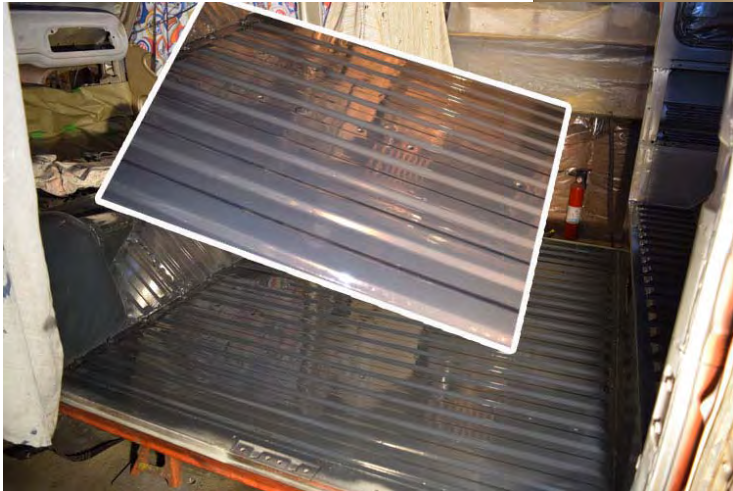
3-4 rounds of the high build primer and sanding were required to hide the rust pitting and yield a smooth surface. Here's with the final coat of primer.

The finish paint is several coats of acrylic enamel matching the stock color.

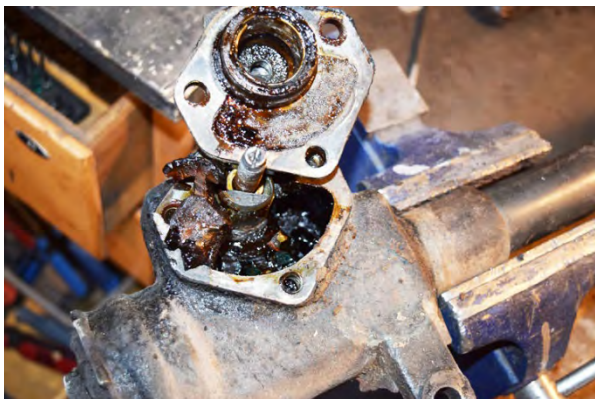
Well, not too bad. Much of the lube had coagulated into semi-solid chunks, but the gears, etc., were still oily. Here's everything cleaned up. Hint: avoid dropping balls on floor and wasting time searching for them.

I did not see any pitting or serious wear to the worm shaft, sector gear, balls, races, or bushings, so all were reused. After doing some research in previous threads and other sources, I opted to lube with "00" gear box grease. Reassembly was done following the instructions in the article Taming the Wild Steering Box Rebuild. Here's my setup to make adjustments:

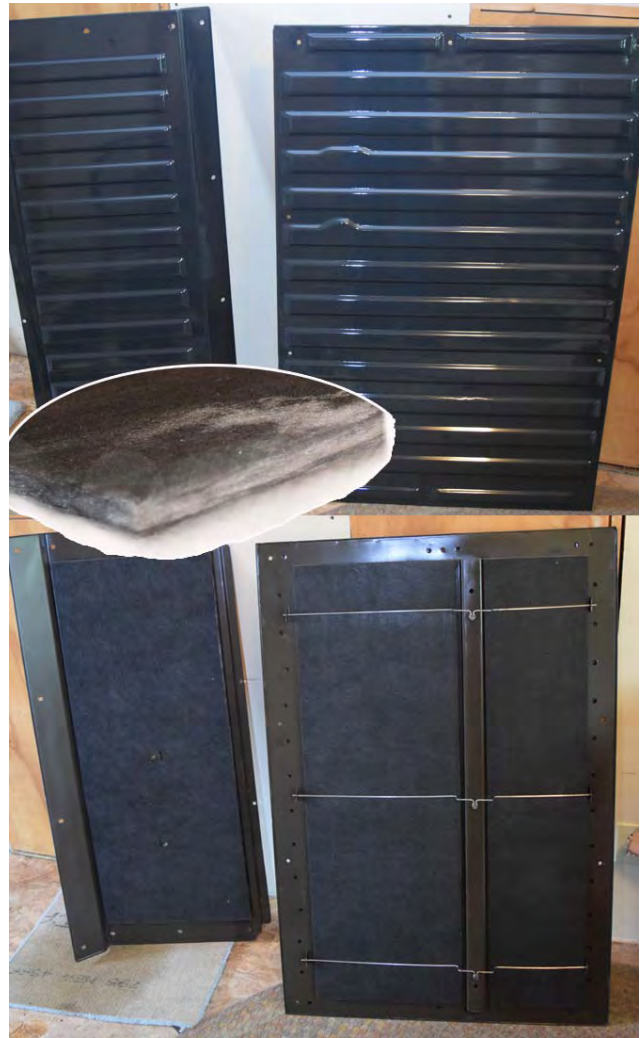
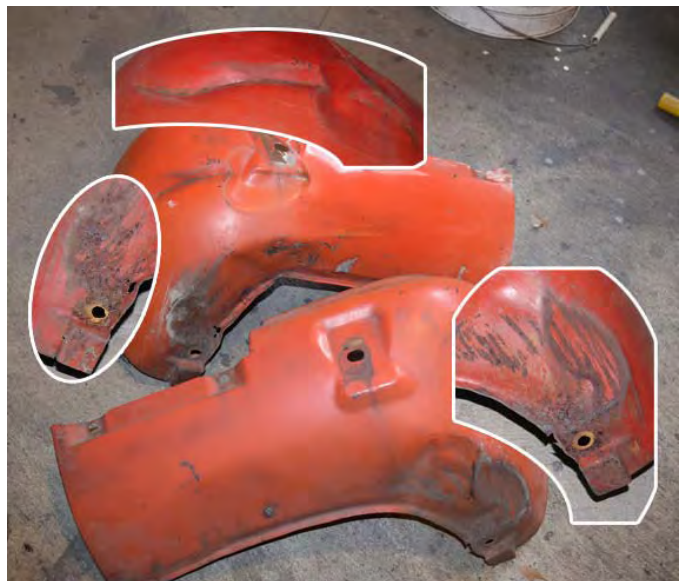
Originally, they looked horrible, surfaces entirely rusted. But after electrolytically derusting and wire-wheel cleaning, they turned out to be in excellent shape. The very end of one needed some of the metal replaced and some pitting needed to covered with All-metal filler, but the end result looks great; primed and painted with Rustoluem Matte Nickel.

Serious impact damage on both sides and enough rust in a few places to warrant new metal. Doing metal work on pieces like this is a pain - it's hard to hold the parts and also position a dolly and hammer; and there are a lot curves! I find the easiest way to do the rough metal work is in a sand box...

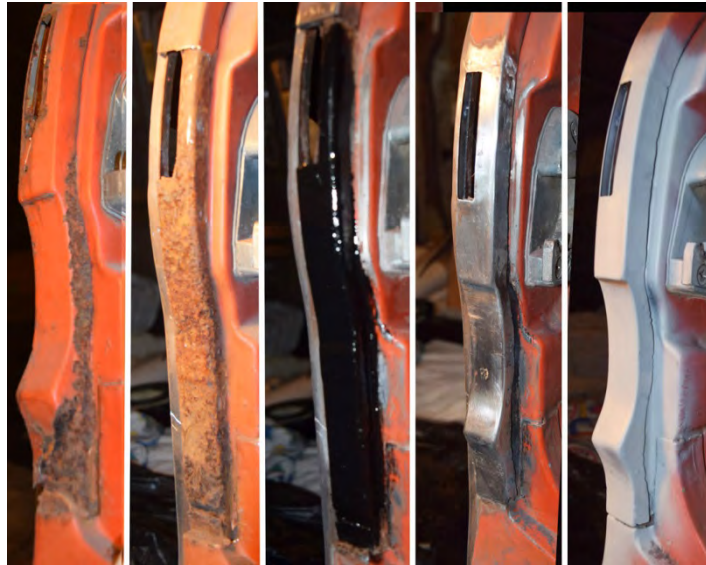
2- I did the cut-off along the top of the hinge opening - a reasonably reliable landmark for cutting the replacement. I was much relieved to find that rot was only "skin deep", and the subtending metal layer had only surface rust. When I did a similar repair on my 61 GB, everything was rotted, necessitating a much more complicated repair.

3- after cleaning off as much rust as possible, the underlying metal was prepped and painted with POR-15.

4 & 5 - and the replacement piece was welded in, welds cleaned up and then given a temp coat of primer.
