FC Fire Company Greenbrier Restoration August 06, 2016

This remarkable story begins with someone sending to me on May 12, 2016, scans of several Corvair 95 window stickers and car shippers for my ECL decoding project (the originals have gone to Dave Newell). Among these was the car shipper for a 1963 8-door Greenbrier sold to the Malden West Camp Fire Company in Saugerties, NY. It was a very interesting FC, with an optional (but non-RPO) engine. Twelve days later, my good friend Ed Bittman emailed that he has spied several Corvair cars and FCs on Craigslist in a neighboring Florida city, which he soon visited and dutifully reported back the FC VINS and data plate codes. Incredibly, one of them is the Malden West Camp Fire Company van! After some tough haggling with the owner, we decided to buy it. Ed made the initial purchase, and then sold it to me. I just had the van flat-bedded to Marietta, OH.

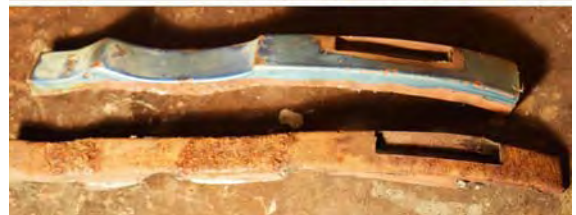
3- Here's the replacement freed up from the sub-metal. Definitely not from a west-coast vehicle. After stripping the paint, it became apparent that rust in a

few places would necessitate metal replacement. Eventually several small holes were drilled along the sides for plug welding to the door pillar, and the inside was treated with POR-15.

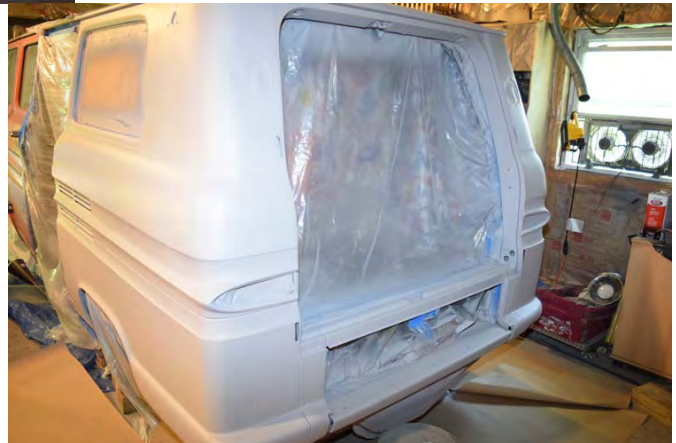
The rear doors were also done. The downside of restoring an 8-door is ... all of those doors, which have an awful lot of surface area. The inside of these rear doors had a lot of dings and bends, which I suspect was from fire equipment banging against them. Indents are very difficult to correct with metal work because there's no way to work from the inside of the door. Most of the dings are small enough to fill, but several needed to be pulled with a stud welder, such as the 1/4" indent to this contour feature.

The Harbor Freight stud welder I purchased when I did my 61 GB came in handy. It takes a fair number of studs to pull the metal without creating a dimple. Rather than using a traditional stud puller, I feel I have better control pulling on the studs with a leverage bar.

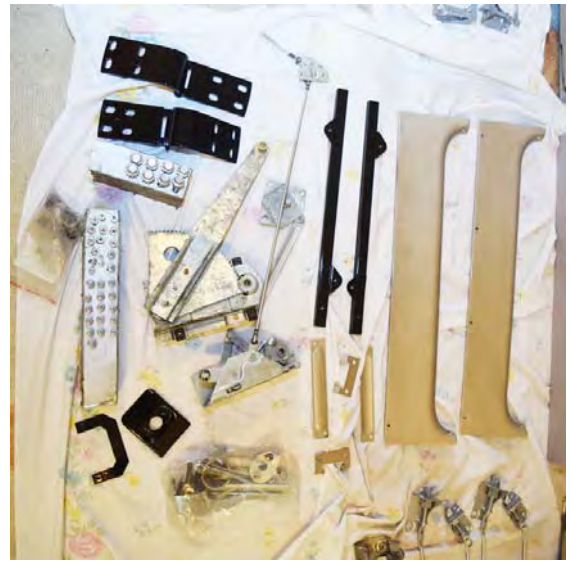
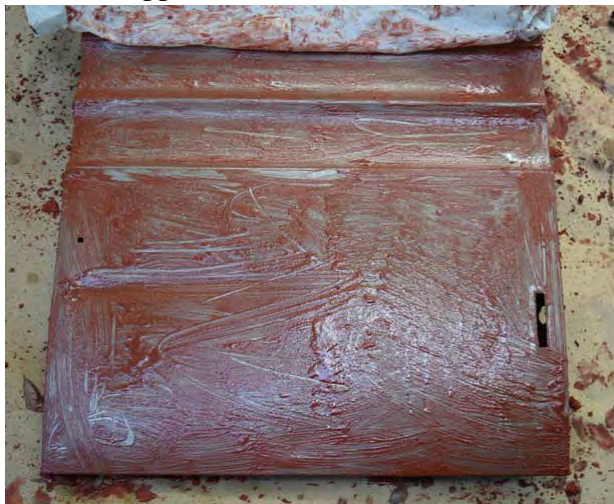
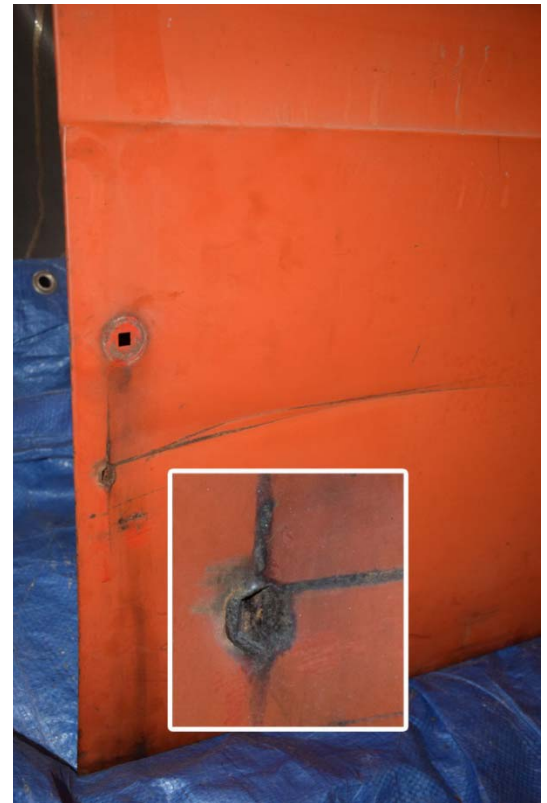
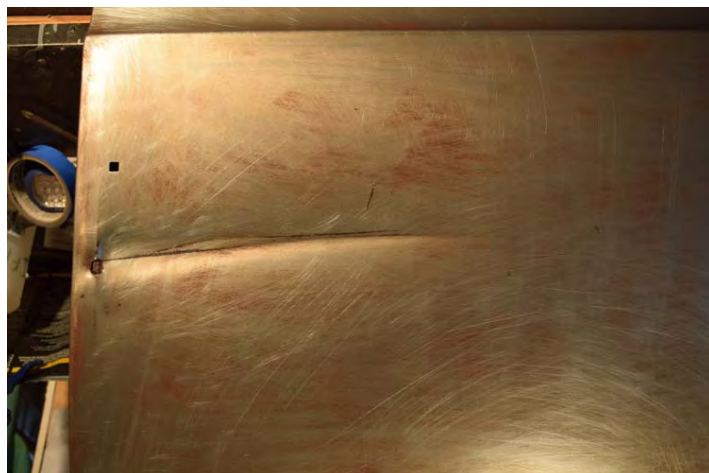
The doors themselves has a variety of issues; and here's a sampling of the repair work that was needed. The most obvious damage was the long indent and puncture to the outside of the right-front side door:

which shows the damage more clearly

Like all the doors, this one was first stripped with aircraft stripper

This was another job for the stud gun, which allowed pulling out as best possible the indent. Unfortunately, damage like this extends much further across the door than what seems obvious from the gash itself, so even with the indent pulled out almost to the original level, a thin layer of filler will be needed to recontour the door surface.

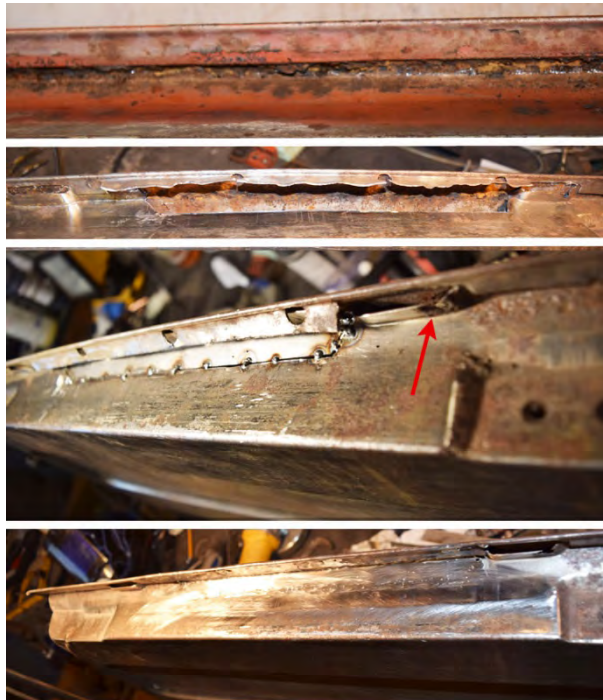
Careful inspection of any suspect area is necessary, and subtle rust damage sometimes is only revealed by using an aggressive wire wheel. For example, one door was found to have thin track of rot holes near the bottom edge, shown at the bottom of this image series:

I choose to carefully plug weld over the whole area and then grind smooth.

Replacing a large piece of the outer skin

seemed superfluous and likely to create bigger headaches. When done correctly, plug welding typically blows through any rotted metal and only fuses where the metal is adequately secure, and one only hopes that the result isn't a god-awful large hole that need to be welded closed. Fortunately, this repair went relatively smoothly. Speaking of door repairs, has anyone ever encountered a factory repair like this?

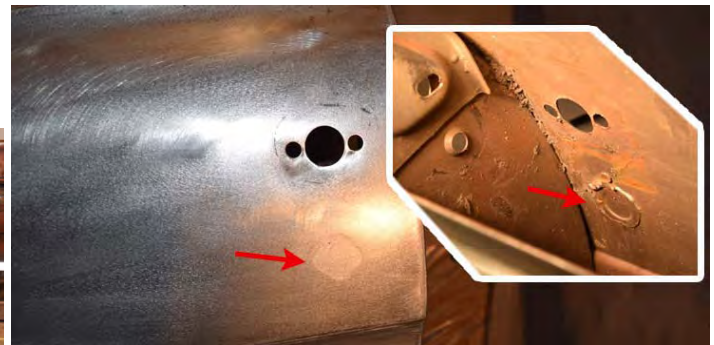
From the outside, the metal has a slightly different color, and on the inside we can see where a metal insert was welded into place. Mistake when punching hole for handle? Actually, this door has two repairs like this, and I wish I could do it so elegantly!

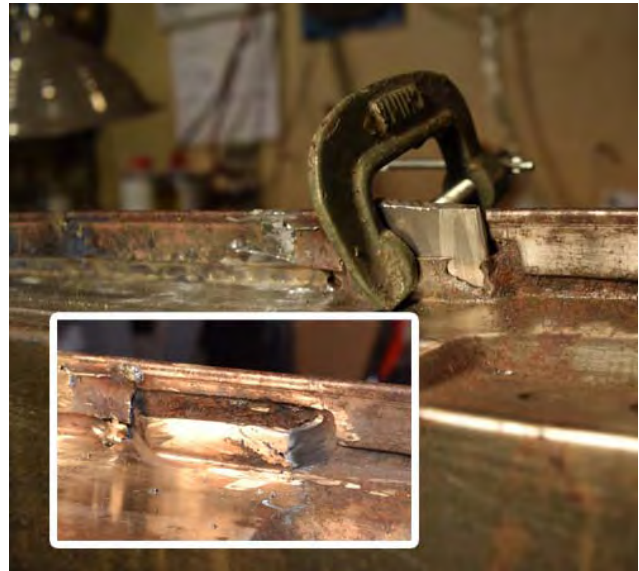
The bottom of the doors always are subject to rust damage and need to be carefully inspected. This image series shows, from top-down, repair of rot on one of the doors where the outer skin folds over the inside:

And this repair required drilling out the spot weld allowing the outer skin to be peeled back, the rotted metal cut out (second frame down), a refabricated piece welded in (third frame down), and weld ground smooth (bottom image). Unfortunately, the water drain outlet also had some rot (see arrow) that needed repair.

This was done by grinding an aluminum block to fit the inside of the drain, and clamping in place as a backer. Since the weld does not stick to aluminum, the gap could be plug welded and ground smooth, and the backer then pulled out.

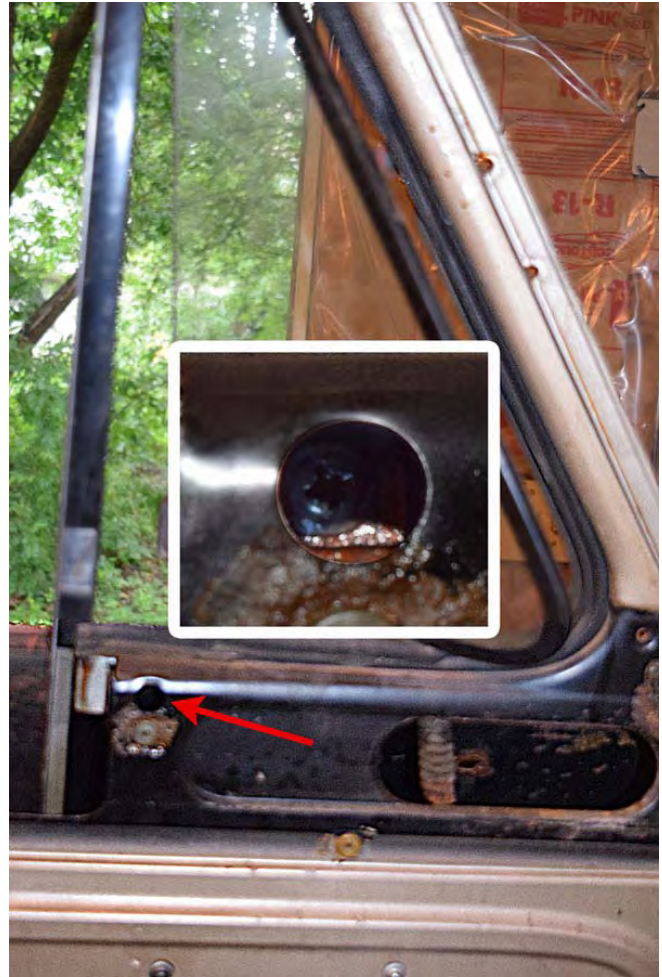
2. Here's a tough nut - well actually a bolt: Ever notice that it's always the "last one" that causes the headache...well, maybe it just seems that way. This is the last of the 8 doors being disassembled before removal, and a bolt securing the vent window is inside the door accessible through this hole. And this d**m bolt was rusted tight in place. After two days of penetrating spray and persistent screw driver work, it would not budge, and the head was getting damaged. The bolt goes into a nut welded to sheet metal, so an impact driver was out, and too deep to drill and then use an extractor. The rest of the door cannot be disassembled without first removing the vent window, so I'm starting to think I might need to cut away the metal to access the bolt and then reweld back together, but then came a simple solution, and the bolt came right out. How would you do it?

I used a Smith mini torch, the white-hot flame directed through the hole directly onto the bolt head. When it was red hot, I immediately squirted water to rapidly chill it - the temperature shock freed the threads, and it easily came out with a screwdriver.

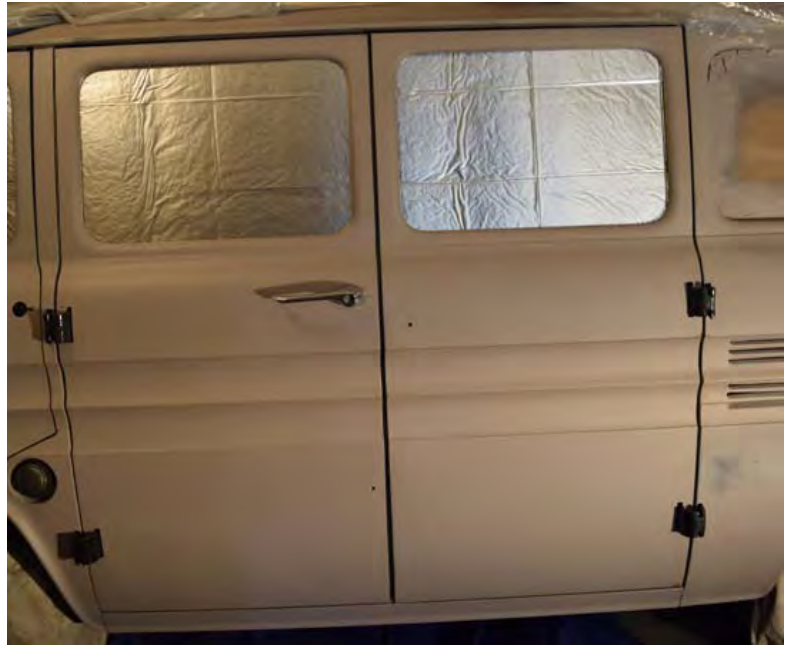
All the doors have been temporarily reinstalled so that alignment and spacing can be established. Alignment of most of the doors was still pretty good, but these left side intermediate doors needed a lot of work. As it arrived, the lower hinge of the forward door was damaged. Someone had drilled out the pin and replaced it with something resembling a large nail. The hinge was restored with NOS replacement hinge leaf, bushings and pin. That was essential, but a lot more work was needed - I took a tip from assembly plant lore and used my HF press to bend the hinges. This worked remarkably well, and only slight bending was needed to get good alignment and gaps. Oh, those are foam insulation boards I've cut to fit the windows to keep dust out.

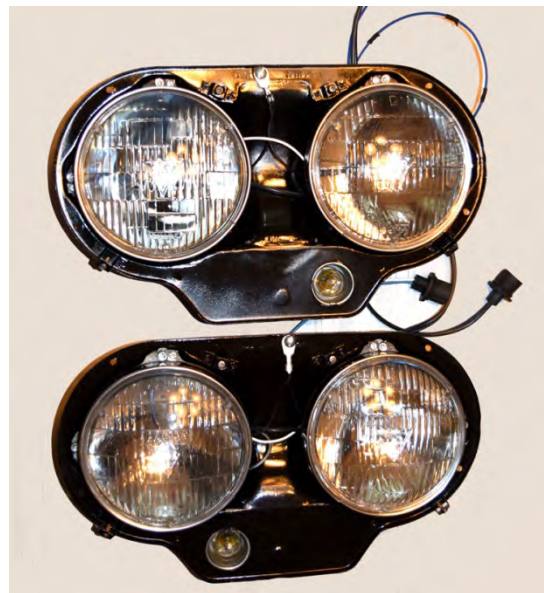
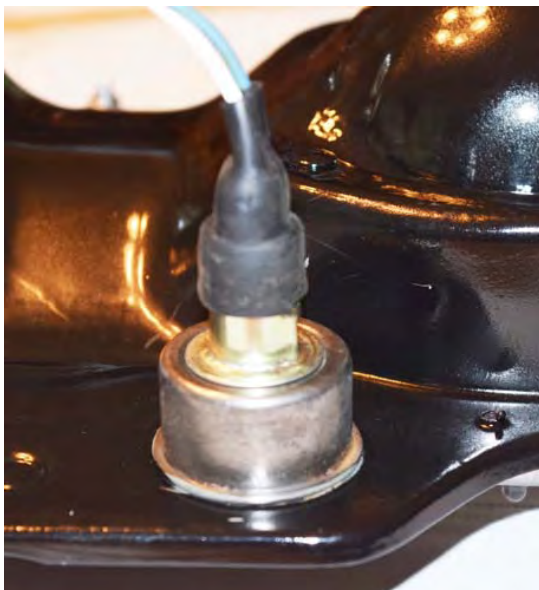
Headlight assemblies are ready for reinstallation when the time comes. The original headlight buckets were rusted beyond repair, and Mike Deklotz was able to provide nice CA replacements. They were thoroughly stripped, primed and painted with gloss black enamel. Mike was kind enough to provide all new adjusters, and I replaced one spring.

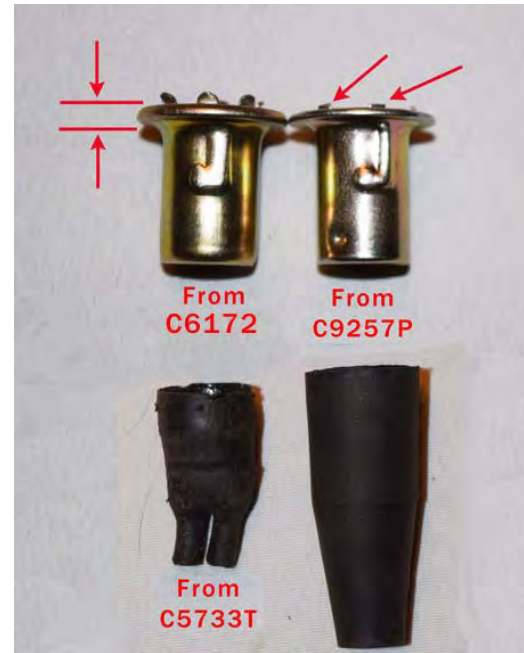
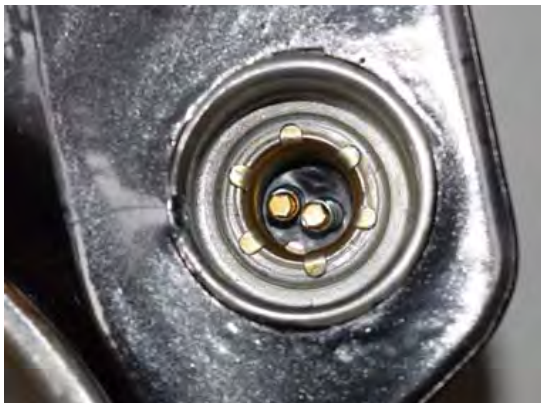
The FC directional/parking light harness that Clarks sells (C9752P) has a couple of issues, which was surprising since it's manufactured by M & H, from whom I've always gotten quality harnesses in the past. As you can see that boot looks nothing at all like the original. Since Clarks' FC tail light wiring replacement harness (C5733T) comes with the correct boot, I decided use those boots instead. Then I ran into the second problem, the metal tangs of the C9257P socket simply snapped off when I tried to peen them over. (I've reported this to Clarks and they are looking into it, and they compensated for the problem.)

So I decided to use Clarks replacement taillight sockets (C6172) instead, and it wasn't until I had everything done that I discovered (as did Jack) that the bulbs wouldn't seat. As best I can tell, the problem is not the length of the housing per se, rather, the thickness of the socket rim and the recessed hole into which it fits conspire to prevent the bulb from seating. So everything was disassembled, and I substituted AutoZone 1157 bulb replacement sockets; the tangs on these also peened over and the bulbs seated just fine.

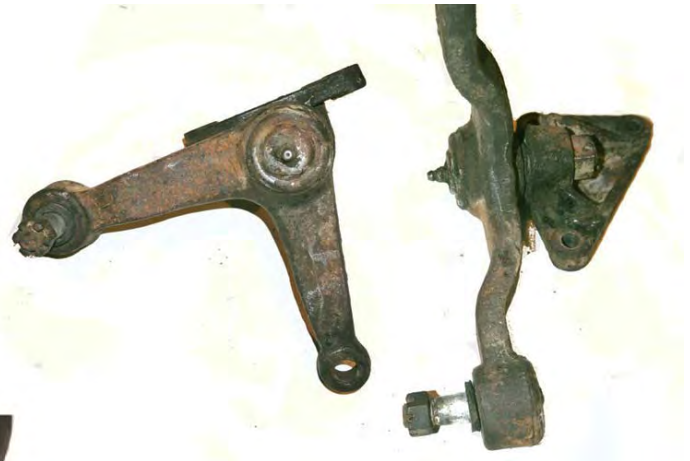
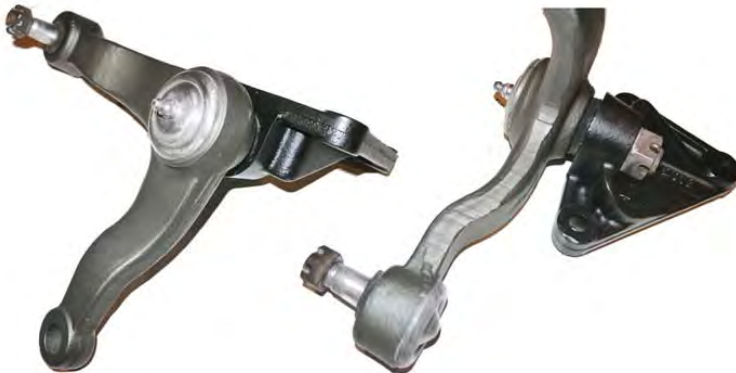
The boomerang was in good shape and didn't need to be replaced. Considering the Firebrier has only ~16 K miles on the odometer, no surprise the relay arm is in good shape. Dirty as all get out (but not as bad as some I've seen), and with a good tight idler joint; the center pivot moved smoothly with new grease. It was cleaned, primed and repainted.

The arm was painted with Eastwood Spray Gray and the mounting bracket with Blitz Black; the rear caps of the idler joint and center pivot were painted with Eastwood Detail Gray.

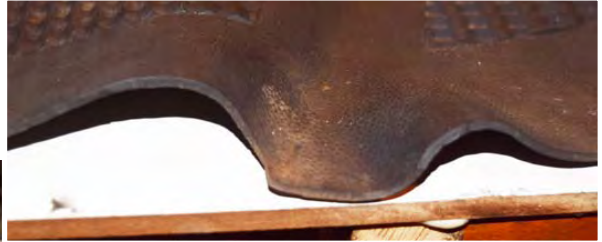
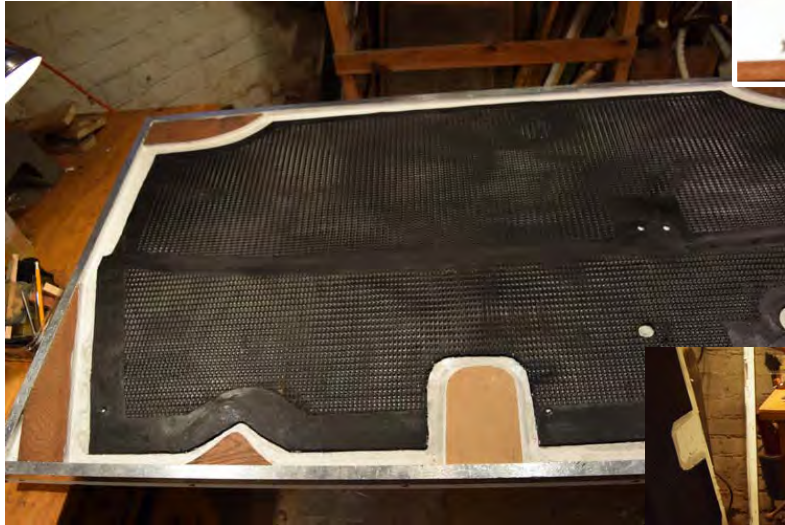
I decided to repop an actual stock GM FC front mat with the original embossed pattern. This was not simple since a NOS mat wasn't available and I had to work with a used mat. I decided to use the Firebrier's original mat, which was in pretty good shape. However, to make the mold the mat must be glued perfectly flat onto a surface, which is very difficult to achieve since used mats always have entrenched folds like these ...

... that will not flatten. The only solution was to cut out all of these areas and replace with new rubber cast with a matching pattern.

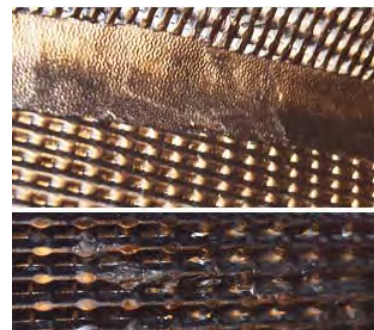
The rubber is quite flexible but of a strong industrial grade that will hold up well. I believe the repro is very good and is a little thicker than the original. There are some minor surface imperfections, such as these:

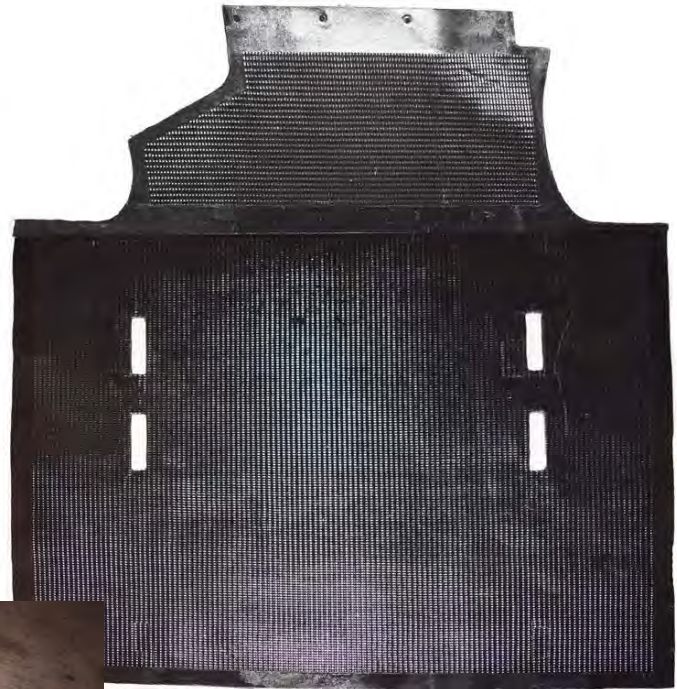
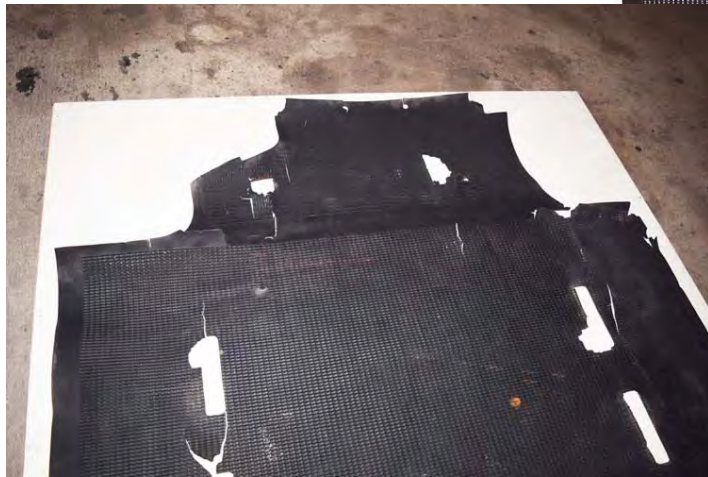
Much thanks to Dale Dewald for providing a used mat that was good enough. The forward area was in rough shape, and rearward there were many lost pieces and tears.

First I had to build a large flat reinforced platform upon which the mat could be secured. As for the front mat, flattening the mat is essential. This is the bottom of the platform

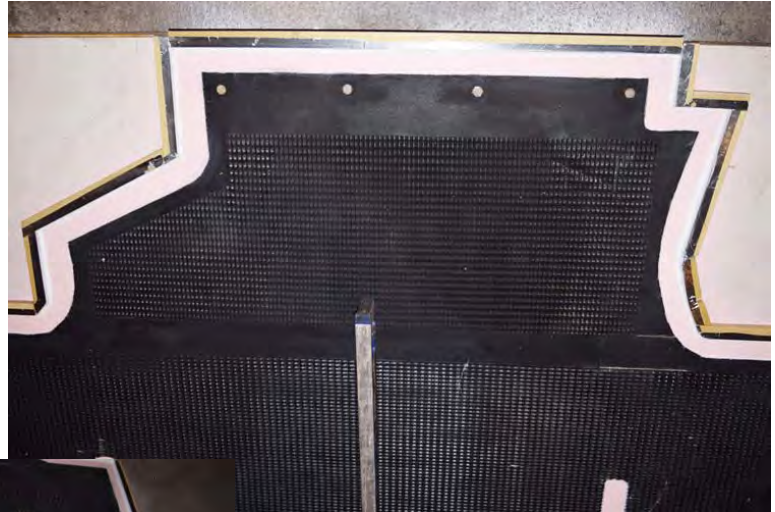
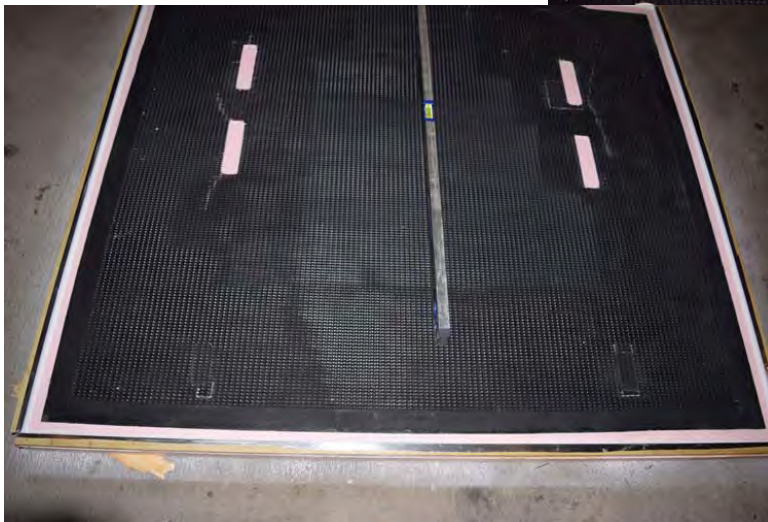
The mat was then glued to the surface of the platform, annealing the tears as best possible. Then all the damaged areas were carefully patched with pieces cut from other mats. Here's the forward area after restoration. Most of this was replaced with a chunk of the mat from the Firebrier. That's a level resting in the center of the mat.

In the rearward area, especially around the seat mounting bracket cutouts, old damaged mat was cut out and replaced. You can see a white putty that was used to fill cracks.

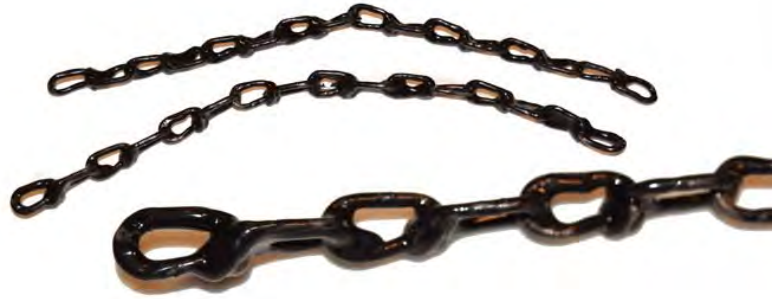
Back in a February post I had shown how a number of parts were given a new rubber coating (clips, spark plug wire retainer, etc.). Here's another one. Beginning in 1963 the rather elaborate checkarms of the FC rear engine access door were deleted (cost savings) and replaced with chains. The chains were originally rubberized, most of which was gone from those of the Firebrier.

Having some extra polyurethane from the aforementioned projects, I used it to recoat the chains. It takes a bit of work to adequately clean and derust the chains first (tough to use a wire wheel), but end result resembles the original.

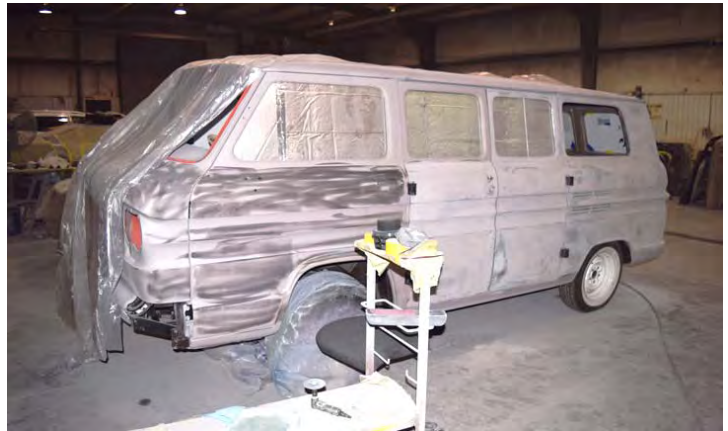
The first stage is to do several rounds of block sanding. The black paint is called a glide coat, which is block sanded to reveal any low points and dimples that will need to be filled. And they have found several.

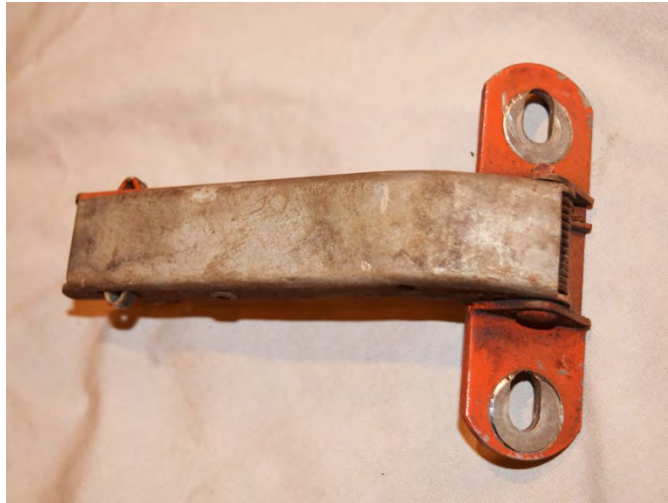
Here's one of the unrestored arms.

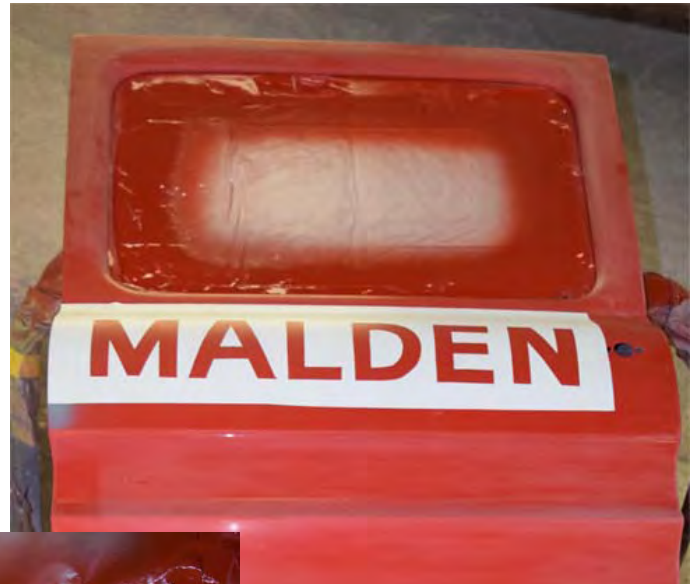
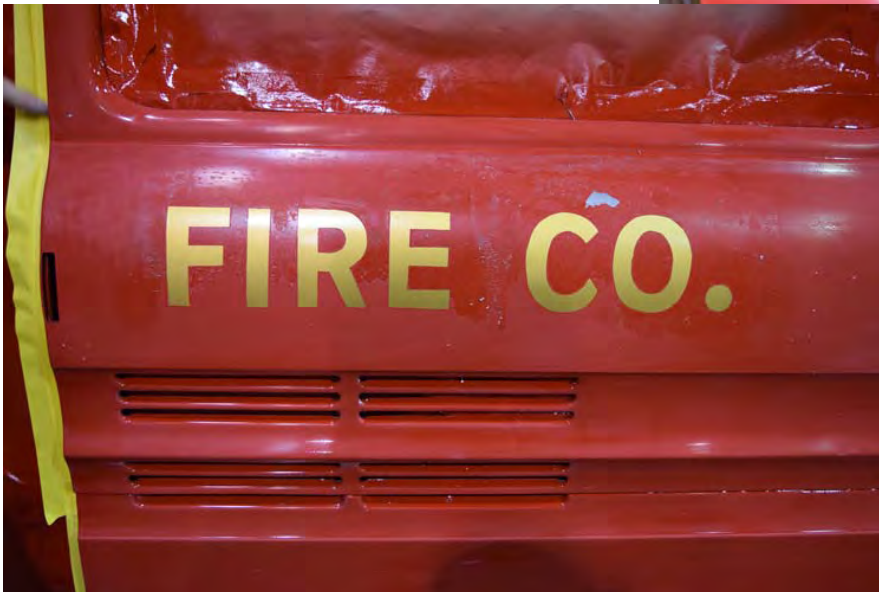
...when disaster struck. Unfortunately the vinyl adhesive reacted with the scuffed base coat and would not come off. If you look closely, you can see the adhesive around the letters; the vinyl adhered so tightly that in one place it pulled off the paint. So all the panels will need to be resanded and repainted. Bummer on several accounts.

Rick, my body shop guy, believes that he can reproduce all of the original panels almost exactly using his lettering software and computer-guided laser vinyl cutter. In some regards this can yield a better final result. He is going to prepare a test panel and we'll then decide how to proceed.

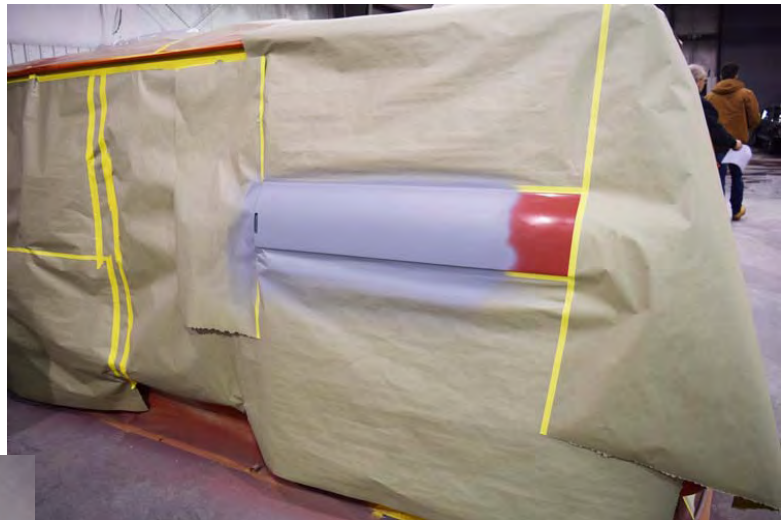
So, we're getting back on track, the damaged paint and lettering on the side panel and most of the doors have been removed (all the way back to bare metal) and reprimed. The consensus view is that the first attempt failed because the base coat had not adequately cured (lettering had been applied after about 18 hours).

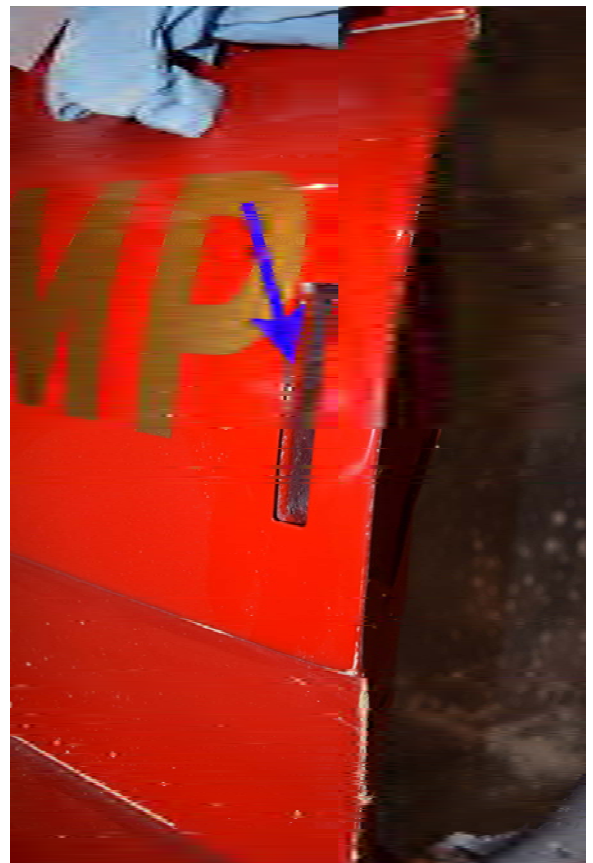
And this is a particular problem because on some doors the internal frame is positioned so close to the hole that there's very little room for the internal flange of the grommet. I'm not sure how the factory fit the original grommets (wish I had looked more closely when I pulled them off) with such constraints, but on my '61 GB in these situations the grommets often became damaged and would not lie flat.

My solution this time was to make some custom grommets with extra thin flanges on the back side (the bottom one in this pic): which, with additional extra trimming, fit cleanly into these extra tight holes.

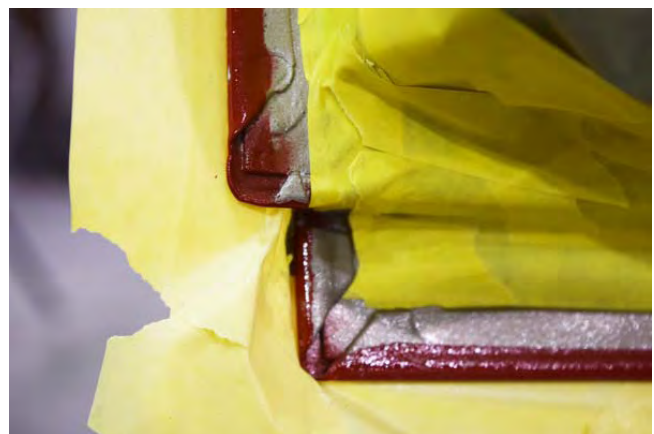
When I looked at the inside of the doors, I found that the exterior red paint had been allowed to overlap about 3/16 inch on the inside of the doors:

I'm not sure if the FC doors were always painted the same way, but on the Firebrier, the interior paint extended to the edge of the door. Fixing this is going to entail a lot of time remasking just to paint over a thin line of red paint.

Repainting the door edges is taking a lot of work, and time. I thought I'd mention, as shown above, each door interior must be carefully masked along the edge of the outer skin, and the outside masked but with the tape extending flat from the door edge (not wrapped tight), to avoid getting a hard edge between the interior and exterior paints.

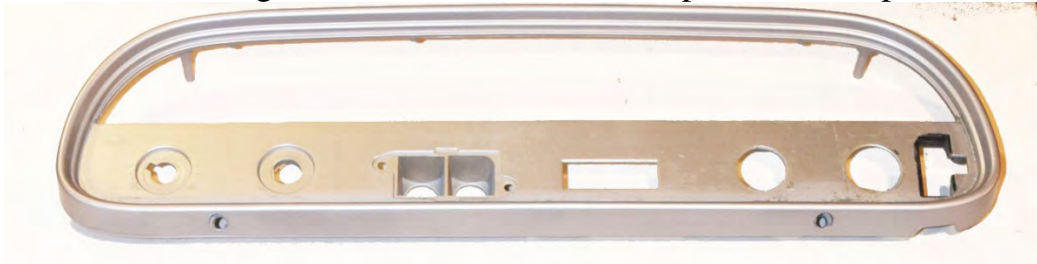
Overall it was in petty good shape. The frame paint had taken a beating below the ignition switch and headlight switch. So it was sanded, primed and repainted:

and everything else was cleaned, and the chrome parts buffed.

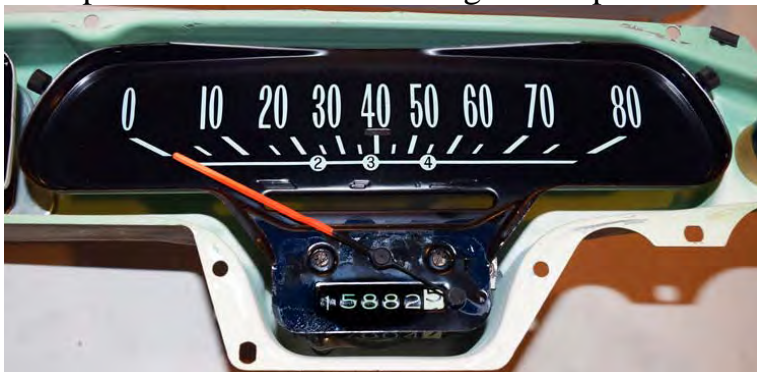
Likewise for the odometer, showing the original 15882 miles, with no evidence of the typical flaking of the numbers.

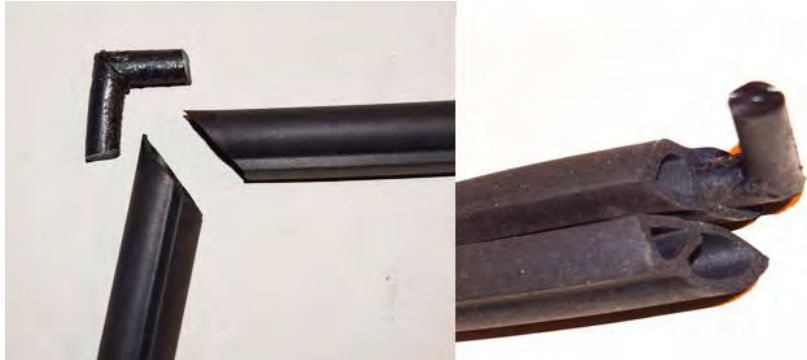
Something I noticed when I removed the original weatherstrip was that the corner seams were reinforced with a "L"-shaped rubber insert. I had never seen this before and did not find it in the assembly manuals, but it must be original, so I decided to reproduce it.

Sized to fit the larger weatherstrip inner hole, with some weatherstrip applied inside and on the cut surfaces, they work marvelously to hold the corners together while the cement dries. They are really useful to temporarily hold the weatherstrip together when making preliminary cuts. I use them to cut and cement together the weatherstrip for a door before installing it.

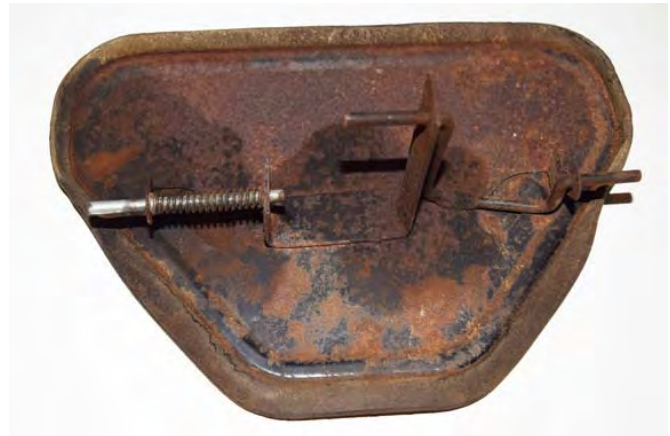
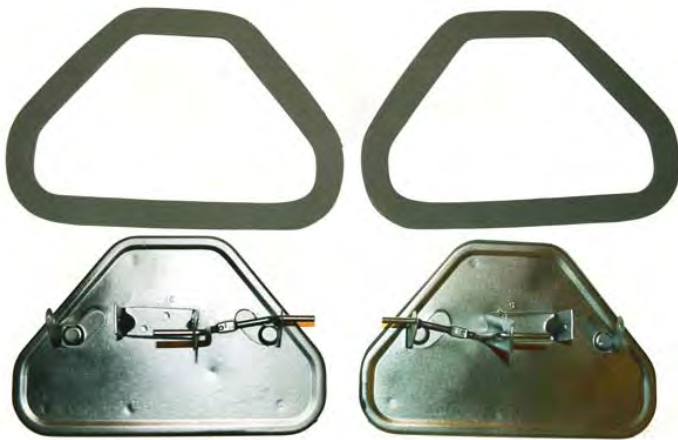
Front air vent flapper doors - today's project. Firebrier's were structurally sound but with a lot of surface rust.

First step was to remove the old rubber seal, and then the doors were juiced in the electrolytic deruster tank overnight, wire wheeled to remove residual oxide, primed and painted. Now ready for replacement of the seals.

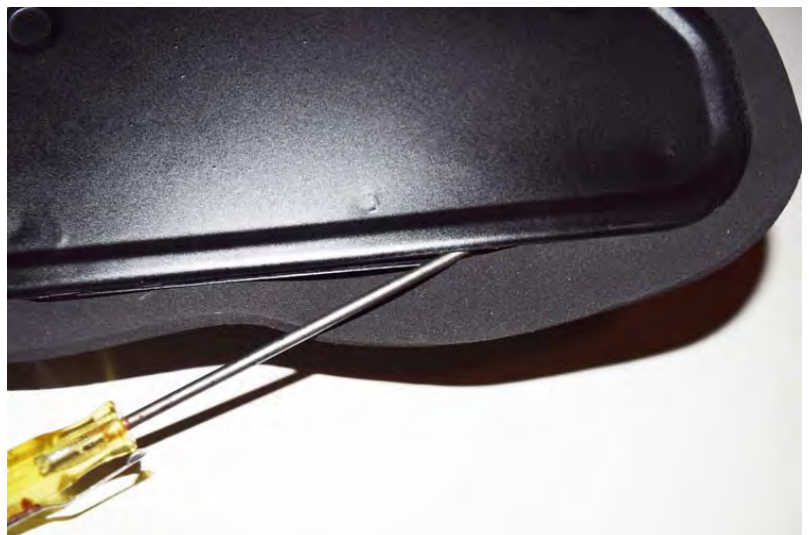
where Clark's instructions end, which leaves the rubber seal extending flat from the sides of the door - which will not allow the door to close. In order for the door to be functional, the seal must be folded back upon itself at two points so that it curves away from the door in opposite directions on different edges. On the original doors the seal is cemented where it folds across, as shown in the image insert below.

Recreating this is the tricky part. I had dealt with this problem when I restored my '61 'brier a half dozen years ago, and fortunately I still had the simple tool I made for the task.

It's a 1/2" aluminum metal strip bent to follow the contour of the door then pulled tight to hold the rubber seal in the needed contour. I apply a little weatherstrip cement in the fold. I also apply a little paint along the folded edges to lock them in place (I have always used POR 15 for this because it works, but maybe any type of enamel would work as well). Here's a completed door.

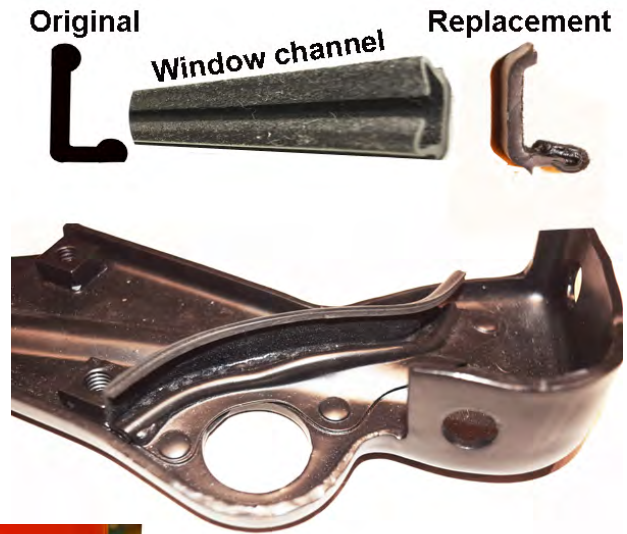
The two large brackets have rubber seals. Since these seals are found on the brackets of rear bumper but not the front, I assume they are intended to block air flow into the engine compartment. The seals on the Firebrier were pretty well obliterated, but Bob Marlow sent me photos of some seals that were in better condition, and the profile is shown in this diagram.

Unable to find a weatherstrip or seal that matched this design from any commercial supplier, I created a pretty good replacement by trimming FC side door window channel - the shape and dimensions matched well. The original seals were removed by carefully bending up the retainer, and this was reversed to reinstall the replacement.

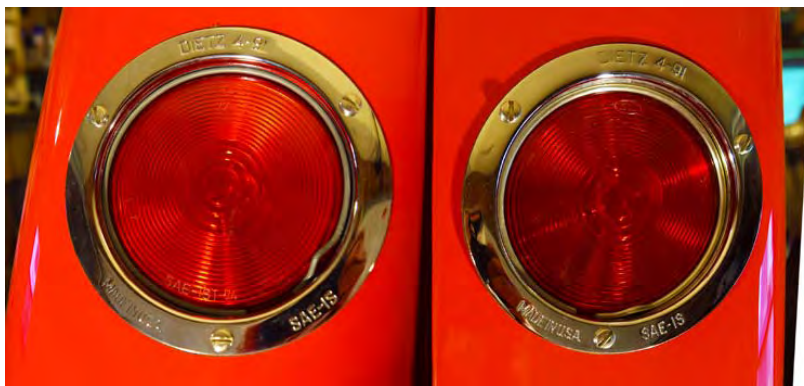
The emergency flashers on the back were manufactured by Dietz.

The originals couldn't be restored, but I was able to locate NOS replacements. However, the replacements were painted, so I had them chromed to match the originals.

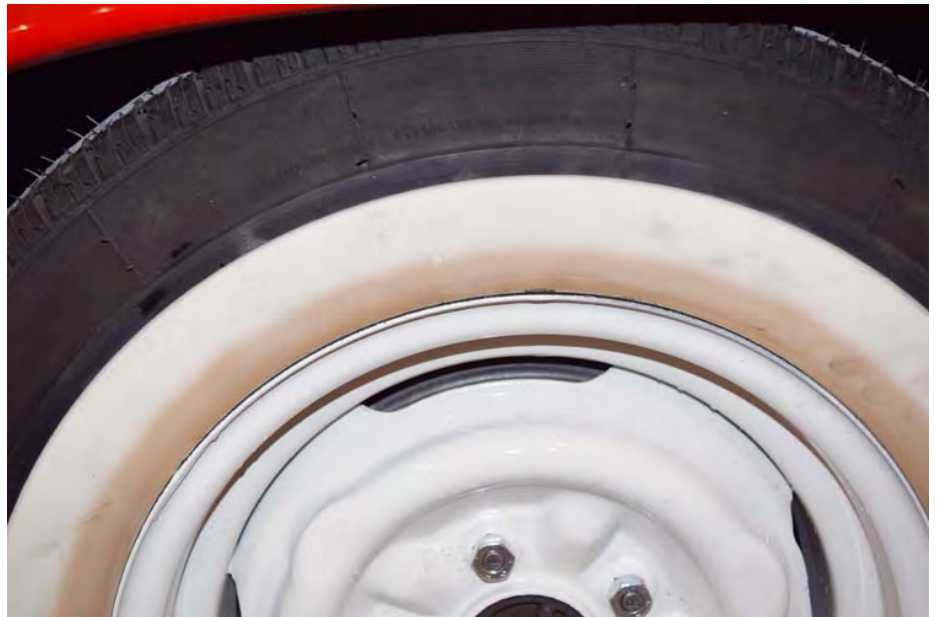
I had noticed this discoloration of the whitewalls spreading from the rim, but thinking it was just dirt or a stain from the body shop. Nope, absolutely permanent;

turns out to be a manufacturing defect. Good news is the Coker Tire Company has agreed to replace them, but I have to pay up-front for the replacements - \$\$\$ - (which they refund when the defective ones are returned) and pay to have the defective tires removed and the new ones mounted and balanced. - all without damaging the paint on the wheels. PITA

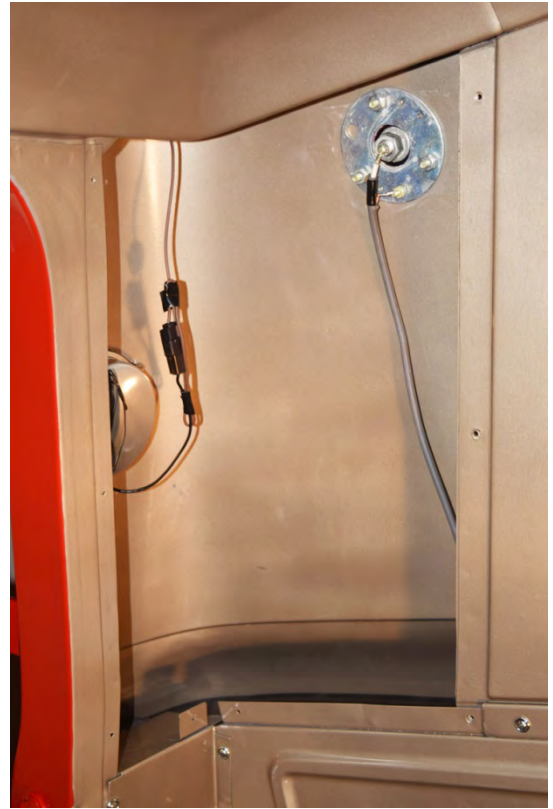
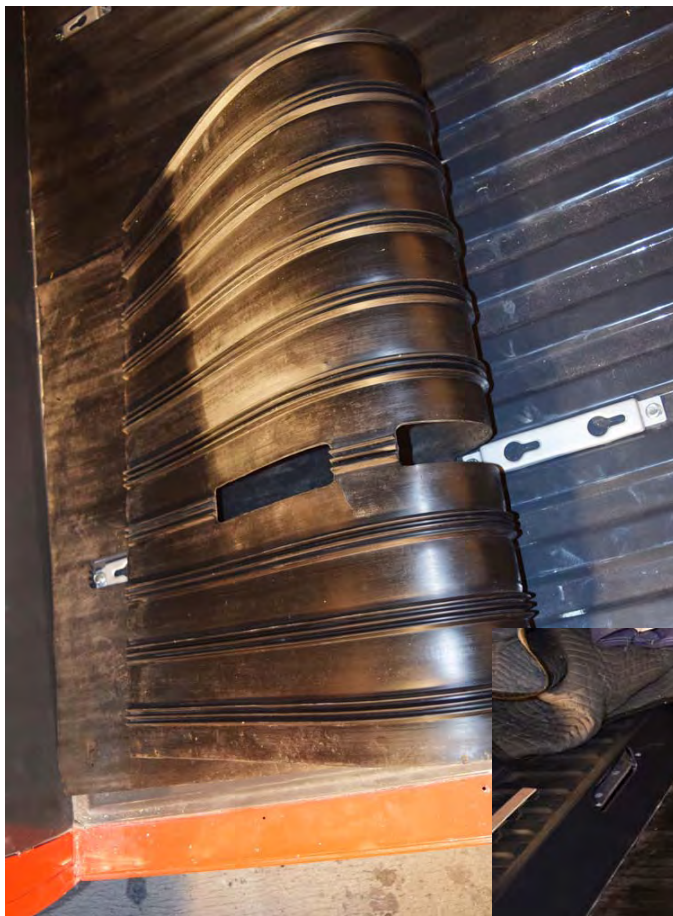
Here's the left side before installation of the cardboard corner piece. The antenna coax cable for the two-way radio is wired up to the bottom of the front seat (more about that later). A nice repro cardboard piece is available from Clarks. However, some work will be needed to make it look right.

The color of the repro panels was not a good match, so I painted them the interior fawn. I needed to do some trimming with a straight edge and exacto-knife to allow the panels to fit correctly.

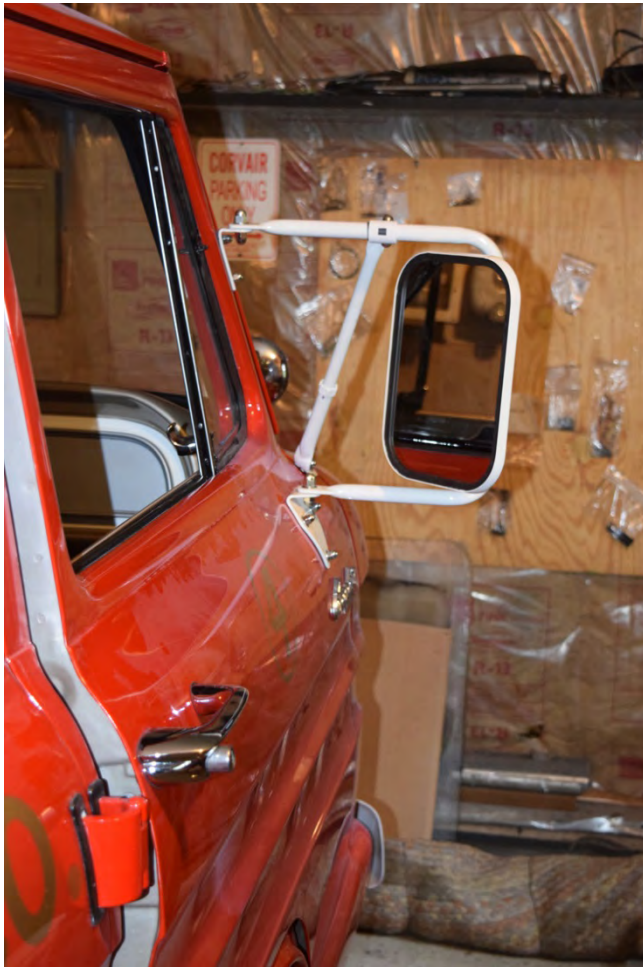
The above picture also shows that the outside rear view mirrors are mounted. !963 was the last year these larger West Coast Jr mirrors were a dealer installed option.

I've heard other people denigrate these mirrors, but I've always liked them - really ruggedly constructed . . .

. . . but difficult to install. If they need to be painted (as these were) be sure to pre-mount, bending the brackets as necessary beforehand.

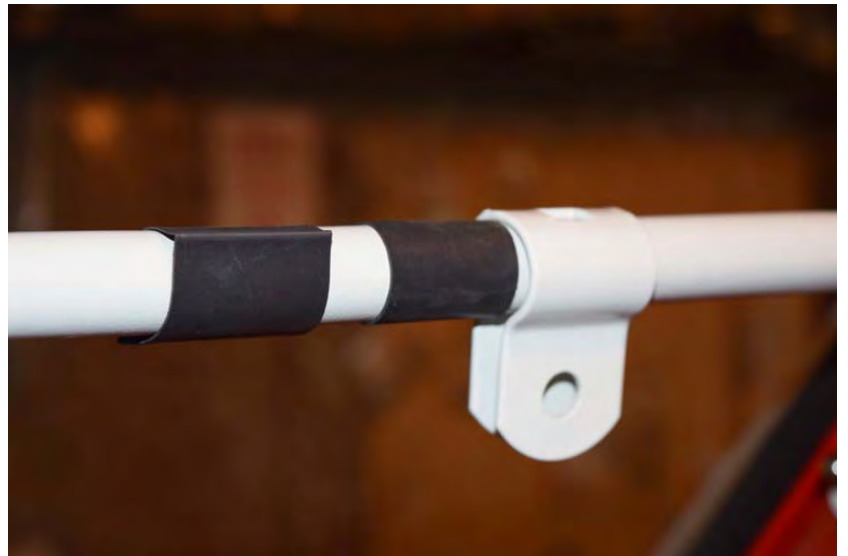
Positioning the clamps with the black gaskets in place is a real pain, but here is another great new use of electrical shrink tubing.

1" diameter heat shrink tubing will collapse down to the perfect diameter to serve as the gasket. And you can tighten and loosen the clamps as needed and the tubing will slide with the clamp as its position is adjusted

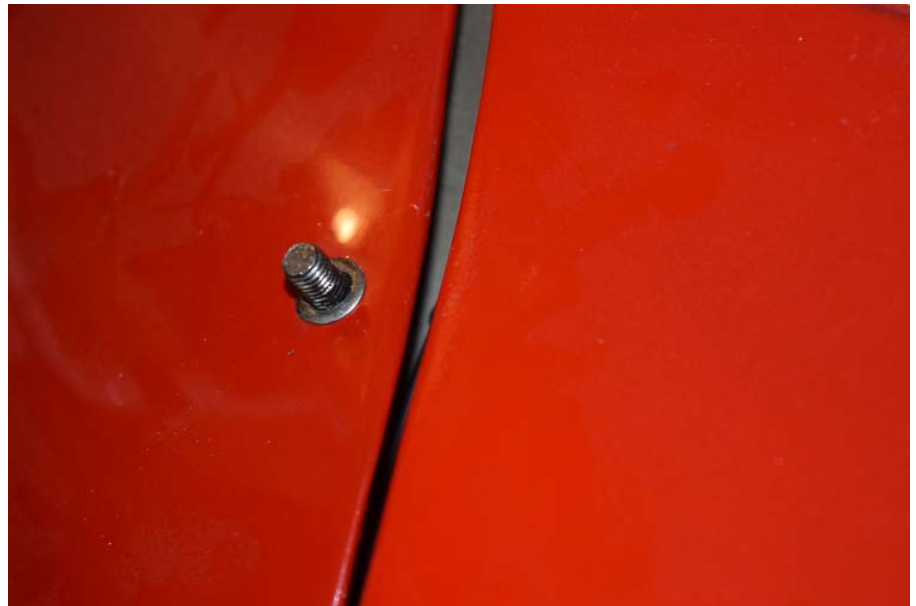
Unfortunately, the rear doorway of the enclosed trailer I've ordered (scheduled to arrive next week) will not be wide enough to fit the van with the mirrors, so I've made arrangements to allow easy removal of the mirrors. Actually, the only real problem to doing so is the third support arm that mounts directly to the door. Loosening the nut risks losing the unusual shaped bolt that fits into the door jamb. My solution was to secure this bolt permanently in place.

I made a small sleeve that fills the excess space in the hole through which the bolt passes; with a little JB bond on the back side the bolt is locked in place exactly where needed.
