FC Fire Company Greenbrier Restoration August 06, 2016

This remarkable story begins with someone sending to me on May 12, 2016, scans of several Corvair 95 window stickers and car shippers for my ECL decoding project (the originals have gone to Dave Newell). Among these was the car shipper for a 1963 8-door Greenbrier sold to the Malden West Camp Fire Company in Saugerties, NY. It was a very interesting FC, with an optional (but non-RPO) engine. Twelve days later, my good friend Ed Bittman emailed that he has spied several Corvair cars and FCs on Craigslist in a neighboring Florida city, which he soon visited and dutifully reported back the FC VINS and data plate codes. Incredibly, one of them is the Malden West Camp Fire Company van! After some tough haggling with the owner, we decided to buy it. Ed made the initial purchase, and then sold it to me. I just had the van flat-bedded to Marietta, OH.

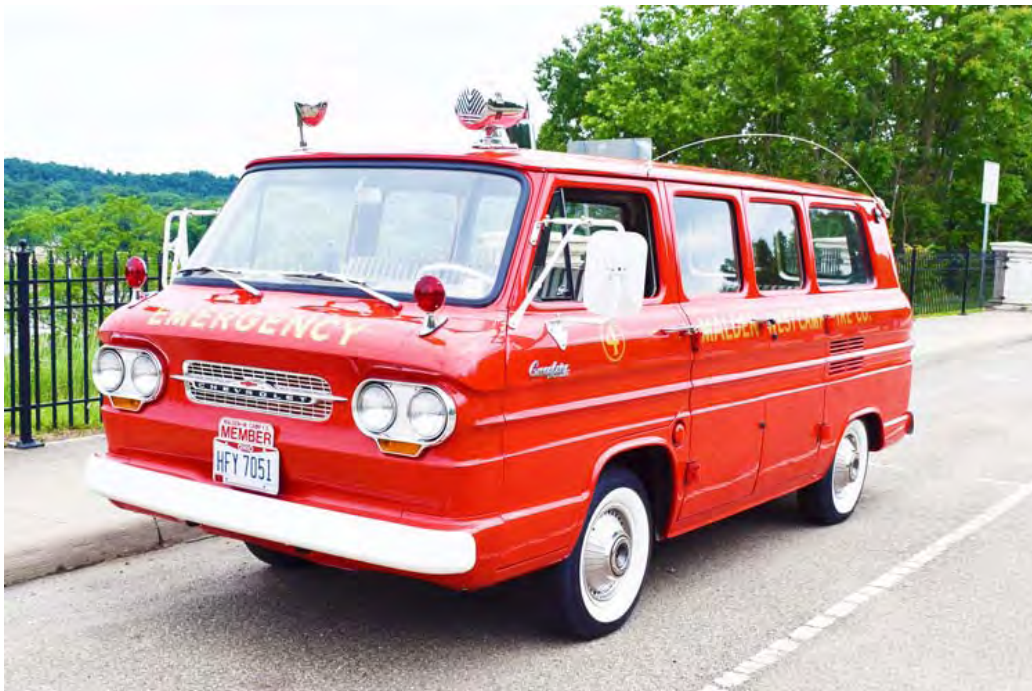
I had noticed this discoloration of the whitewalls spreading from the rim, but thinking it was just dirt or a stain from the body shop. Nope, absolutely permanent;

turns out to be a manufacturing defect. Good news is the Coker Tire Company has agreed to replace them, but I have to pay up-front for the replacements - \$\$\$ - (which they refund when the defective ones are returned) and pay to have the defective tires removed and the new ones mounted and balanced. - all without damaging the paint on the wheels. PITA

The antenna will be cut down to 58". Those are GM restoration part reproductions of the original 1963 wheel covers. The replacement whitewalls arrived and are installed.

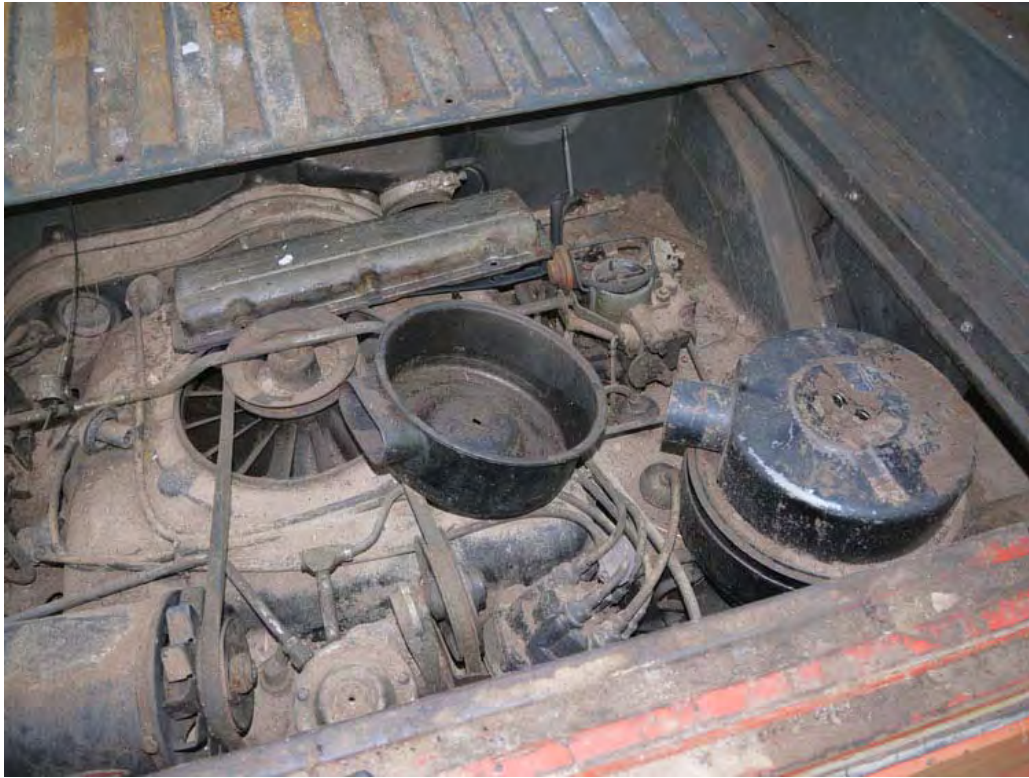
The engine before

Although the van may have seen some challenging times, it is in exceptional condition, as you can see in the pictures, it still has the original paint and most of its service lights, having lost only the beacon light and siren. Only a couple of dents, essentially no undercarriage rust; it seems to be solid. There must have been a two-way radio originally, but that also is missing. The engine is in very rough shape, but more about that later.

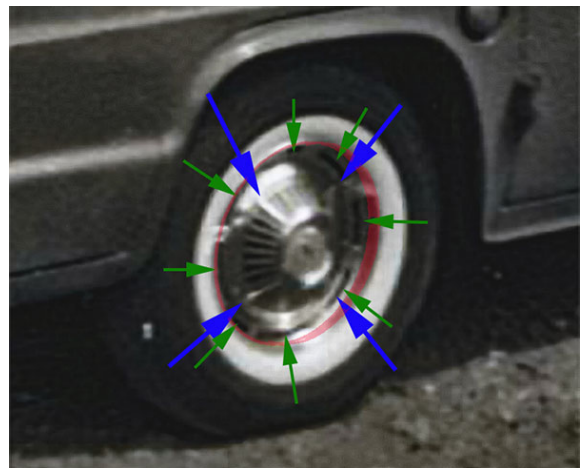
But Danny Davis studied more carefully one of the historical pictures, the one to the far right of Emmett Vedder stationed in the cab of the little fire truck he drove. Danny's more experienced eye picked out features that I would not have recognized – rather than a wheel cover, it was a wheel trim ring around a poverty hubcap. This Photoshopped close-up shows more clearly a trim ring with 8 concentric slots and the distinctive 4 ribbed design of the '63 Chevy car poverty hubcaps.

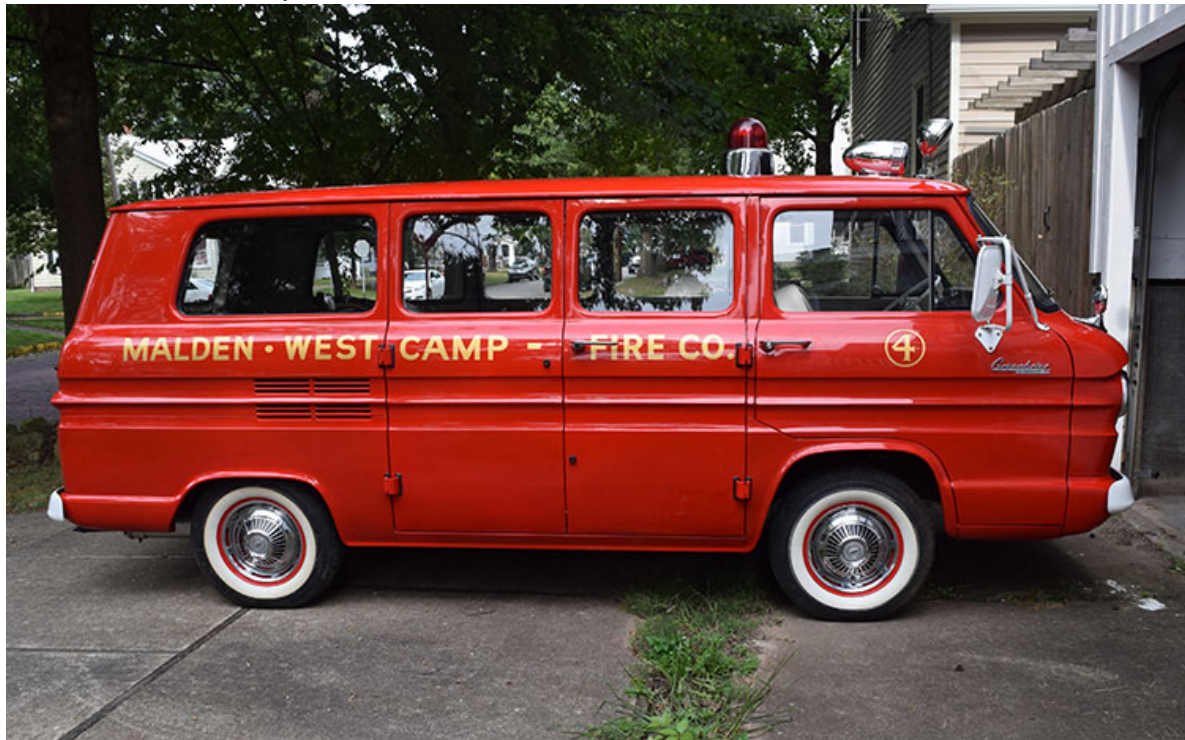
It took a while to find excellent quality hubcaps that did not cause poverty – NOS or excellent quality caps were listing for around a grand – but I recently found a set more reasonably priced. The Photoshopped image also revealed a darker perimeter around the trim ring, which I now believe was the red wheel – at least this would agree with the stock color. So I've repainted the rims red and installed the new trim rings and hubcaps.

And here what they look like on the Firebrier:

I do feel the red rim looks much better.
