SERVICE NEWS

VOLUME 32

NOVEMBER, 1960

NUMBER 11

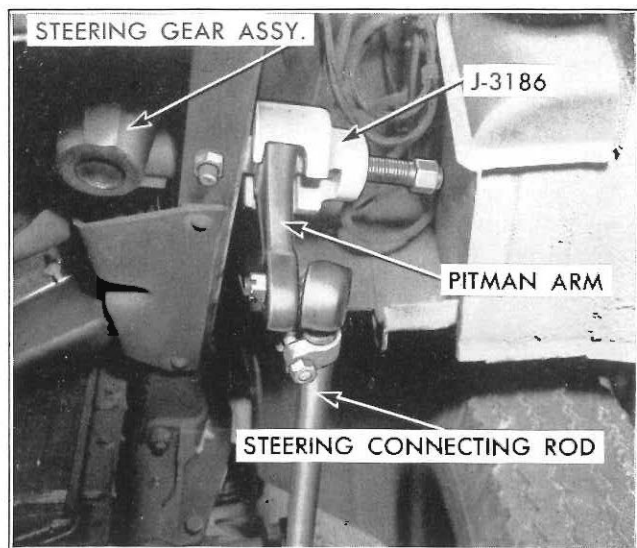
Fig. 5—Tilt Cab Pitman Arm Puller

To facilitate removal of the pitman arm used on 1960-61 Tilt Cab steering (Fig. 5) Pitman Arm Puller J-3186 is now available from Kent-Moore Organization.
