CONTENTS

CORVAIR "95" ACCELERATOR LINKAGE

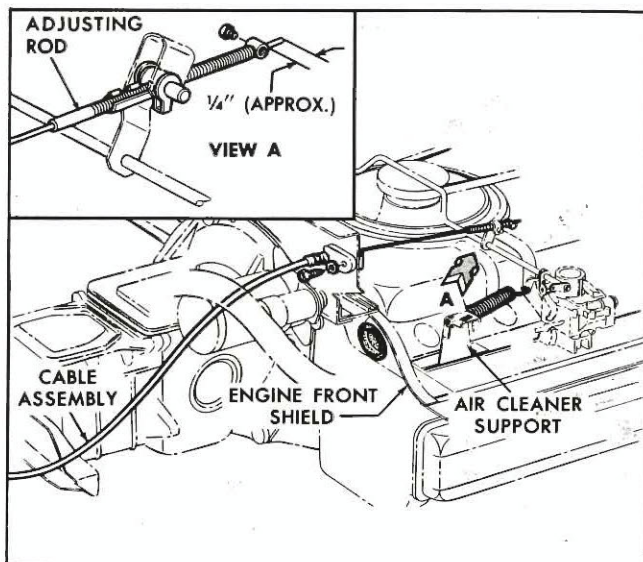
Fig. 1—Acceleration Linkage—Carburetor End

above the rear crossmember and under the heater duct to the engine compartment. The cable housing attachments and linkage connections are shown in Figures 1 and 2.

1. Adjust carburetor cross-shaft linkage as outlined in "Carburetor Synchronization" procedure in the 1962 Corvaire Shop Manual Supplement.
2. Place a 3/4" spacer between the floor mat and the upper end of the pedal. Block the pedal to retain it in this position.
3. Rotate carburetor cross-shaft lever to obtain wide open throttle position, then unsnap the adjustment rod clip and rotate adjusting rod to remove all slack from cable. Re-install the clip.
4. Return linkage to idle position and unhook the return spring from the accelerator pedal lever.
5. Check clearance between accelerator lever and cable shield (shown in View B, Figure 2) while holding the lever arm upward to remove play. Clearance should be approximately 1/8". Adjust, if necessary, by moving the shield in the desired direction and retighten the two mounting screws.
