SERVICE NEWS

VOLUME 33

MAY, 1961

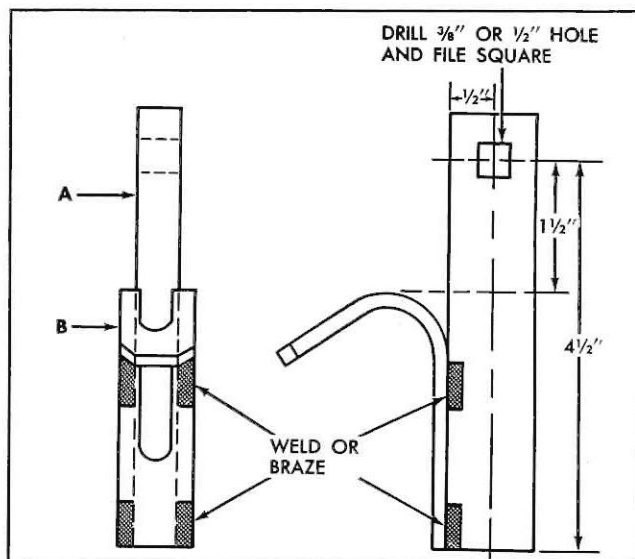
Fig. 5—Blower Belt Torque Tool

The blower belt tensioning tool that utilizes a torque wrench, can be made from two pieces of metal (fig. 5). The shank (part A) is made from a steel bar approximately $\frac{1}{4}$ " thick, $\frac{3}{4}$ " wide, 5" long. The hook (part B) has a 5" developed length and is fashioned from the slotted end of a generator brace (Part No. 3836330 or 3739845).

a thick nut is to be welded to the side of the shank. The dimensions (fig. 5) must be held to plus or minus $\frac{1}{16}$ ". This will insure the correct amount of belt tension when the specified torque is applied.

1. Loosen idler pulley attaching bolt and nut to eliminate frictional drag between pulley bracket and engine mounting.
2. Pull the wrench toward rear of vehicle to apply 20 ft. lbs. torque for new belts, 15 ft. lbs. for old belts. Tighten the pulley mounting bolt and nut while maintaining constant torque load.

CAUTION: Do not allow torque to even momentarily exceed specifications. Slight torque increases will produce excessive belt tension. If torque wrench is allowed to "wander" above the specified torque, the belt must be completely loosened and freed-up. Otherwise, the belt tends to pull into the pulley grooves, and the final running tension will be excessive.
