This booklet contains a complete review of the discussional slidefilm, Major Collision Damage Repairs on the Corvair.

This training film (Part I and Part II) contains practical repair information about major collision damage to the Corvair unitized body with emphasis on misalignment of the unitized lower structure.

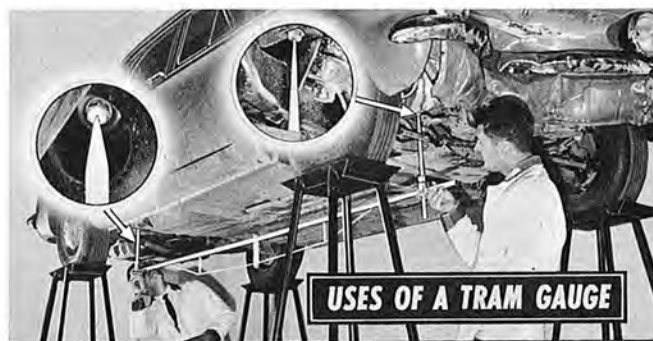
When using a tram, two persons should support the bar, to prevent sag or pointer deflection. The measurement specifications needed to set tram bar pointers horizontally and vertically are given in the Corvair Shop Manual.

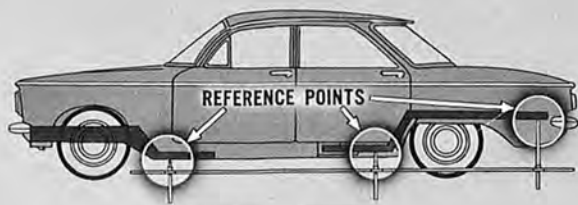
**THREE-POINT CHECK**

Another use of the tram is to compare a suspected sag or raise on one side with the opposite side (if undamaged) or with another undamaged automobile. Three pointers attached to the tram bar are required. Reference points must be in a straight line.

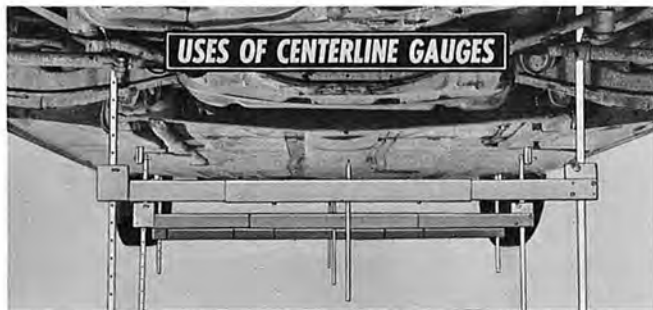
**USES OF CENTERLINE GAUGES**

Sagged, swayed or raised members can also be checked through the use of three centerline gauges. By sighting along the centerline pins and the level of the cross bars, the extent and location of damage to the lower body structure can be easily determined.

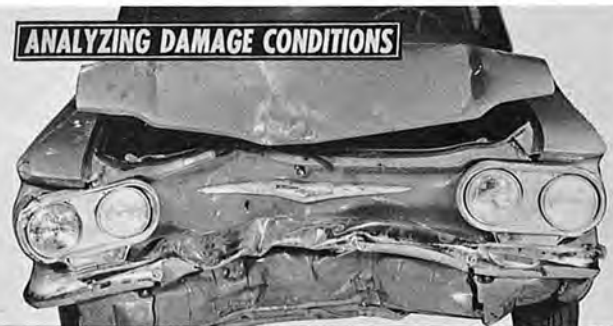
**ANALYZING DAMAGE CONDITIONS**

The impact which caused this major damage struck from an angle of about 25 degrees. On the exterior, the deeply dented front panel has twisted and drawn the front fenders inward. On the interior, the condition of —

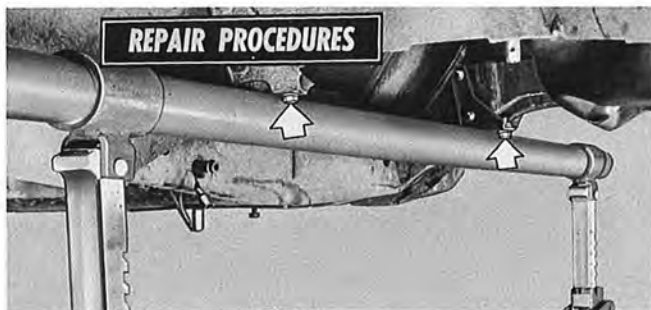
Before straightening operations were started, the front suspension system and gasoline tank assembly were removed. Two bolts were then reinstalled in the brackets as shown to prevent the support bar from slipping out of position.

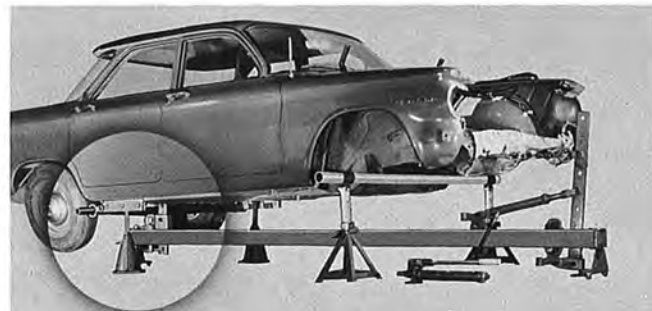
The portable frame machine was set up and used to partially straighten the front section of the compartment pan. The machine was anchored at the rear by—

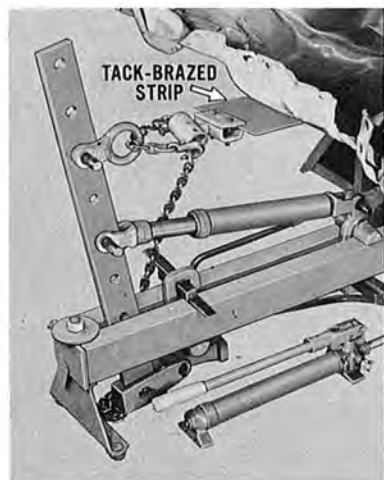
The front end of the frame machine was attached by tack-brazing a metal strip to the underside of the front compartment pan. This was then pulled forward just enough to relieve the inward strains on the side members.

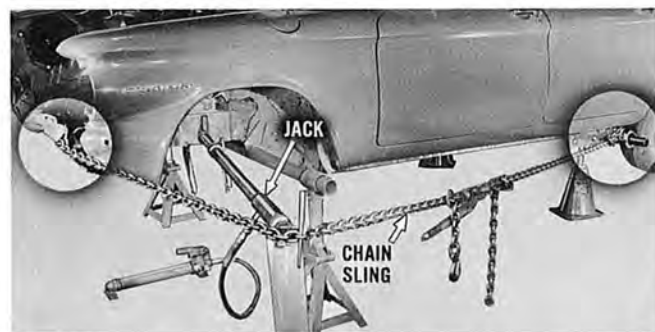
A jack and chain sling was set up to pull the front end of the left side rail outward. The rear end of the chain sling was hooked around the anchor clamp. The front end was bolted to the end of the side rail.

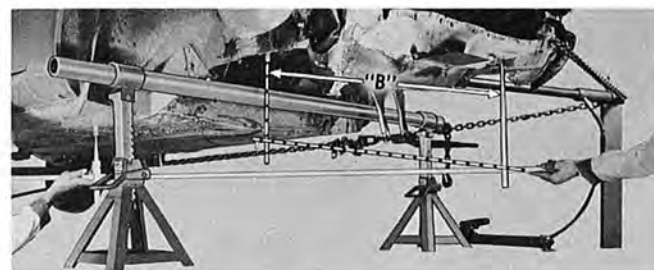
To check the result of the chain sling setup, two diagonal tram measurements were made from different reference points. The tram was first set to reference points shown and then checked on an undamaged automobile. A second check was made by using the "B" specifications listed in the Shop Manual.

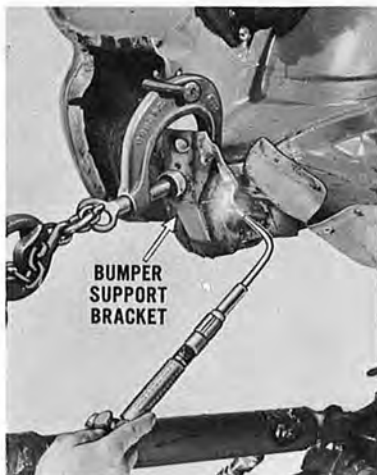
The bumper support bracket on the right side rail was then straightened by connecting the frame machine to a chain and heavy clamp as shown. Heat was applied to the sharp buckle to aid straightening.

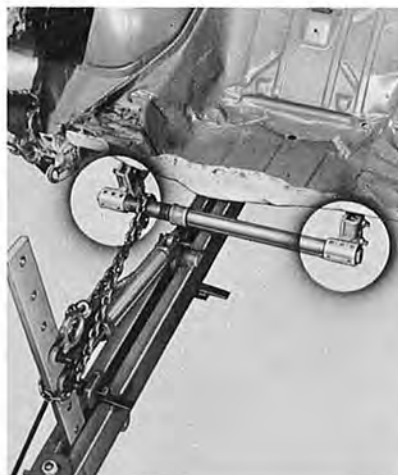
The frame machine was set up diagonally to straighten the inward bend. The correct angle of the side rail was held during this operation by a chain sling.

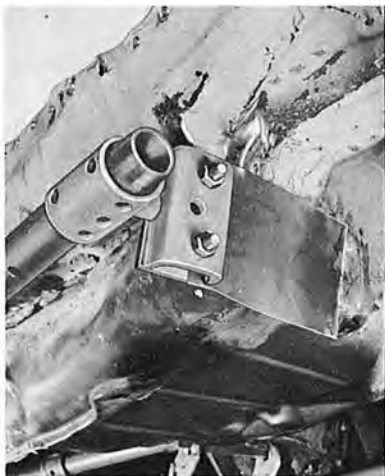
To rough out the compartment pan, metal tabs were soldered to the outer surface and connected with a bar. This permitted pulling both sides at the same time. The chain was shifted as necessary. Hammers and a dolly block were also used.

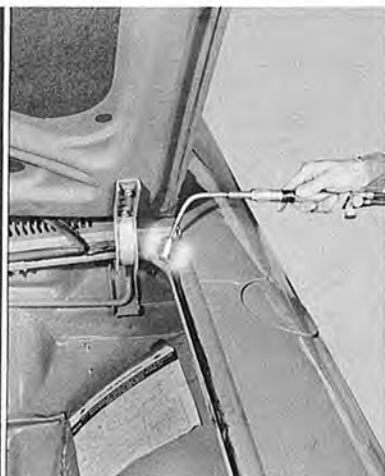
Heat was applied to the left rear corner to relieve buckles caused by the original twist. This was necessary to avoid the use of excessive force.

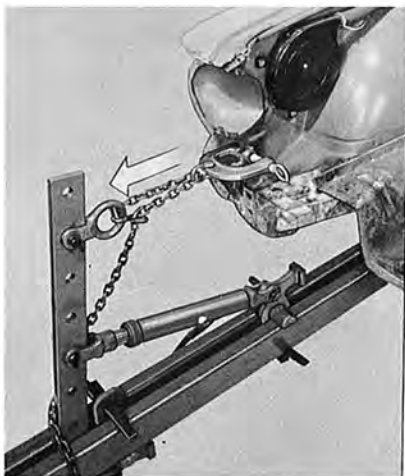
A pull under the headlight closed the gap between the front wheelhouse extension and front panel. This was found by setting the front panel in place temporarily as a final check of the over-all fit of the front fenders.

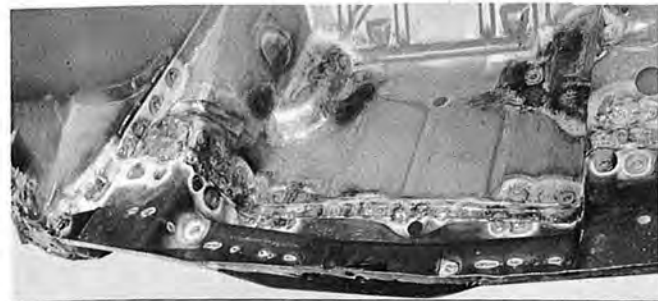
The front compartment pan was completely welded before installation of the new front panel to provide easier accessibility. The oxyacetylene torch was used for this operation. However, an arc-spot welder (if available) may be used.

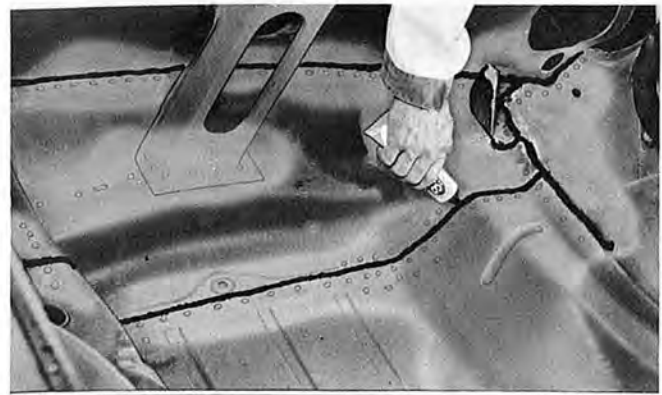
After priming, body sealer was applied to both the inner and outer edges of the weld joints.

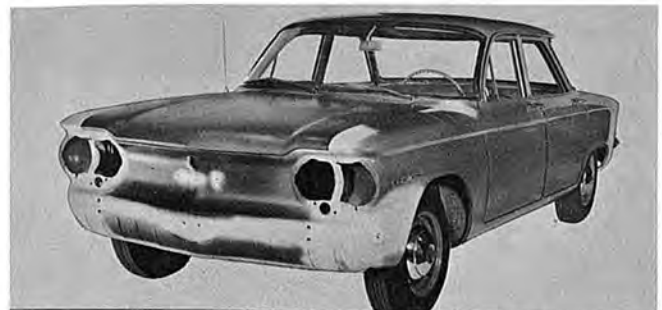
The finish job is shown, primed and ready for final painting. The bumper and headlight assemblies, emblem and lock cylinder have not been installed to insure that all surfaces will be painted. This provides protection against rusting.
